SHORT REPORT

# Effects of topographic and geological features on building damage caused by 2015.4.25 Mw7.8 Gorkha earthquake in Nepal: a preliminary investigation report

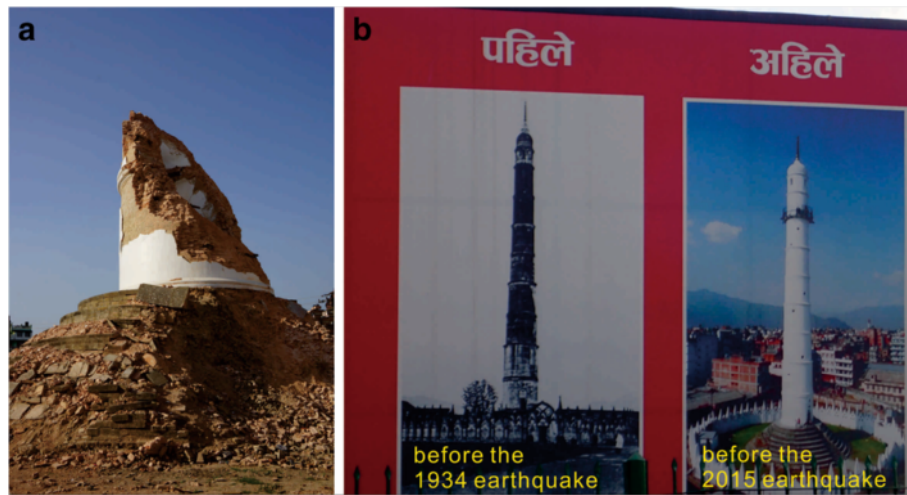
**Fig. 5** The collapse of Dharahara tower. **a** damaged Dharahara tower; and **(b)** a poster showing two photos of the tower before the 1934 and 2015 earthquakes

During the earthquake, the Dharahara tower collapsed and more than 180 people lost their lives. The main body of the tower collapsed under the attack of this earthquake, only the base remained (Fig. 5a). According to Wikipedia (2015), the Dharahara tower, was a nine-story, 61.88 m tall. The former Dharahara tower was built in 1832. The tower had a spiral staircase with 213 steps. It can be seen from Fig. 5(a) that the main trunk of the tower is made by bricks with lime mortar cemented, which is weak for seismic action.

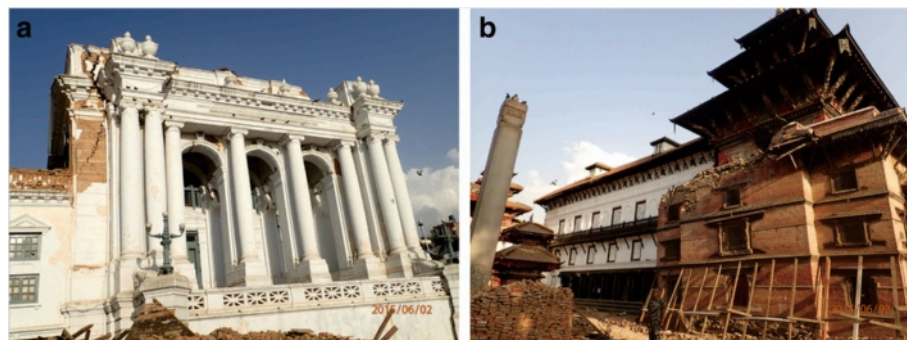
In Durbar Square, it is full of temples and cultural architectures. During the earthquake, lots of ancient temples were damaged severely (Fig. 6). Some of them were completely destroyed (Fig. 7). In Fig. 7, the

**Fig. 6** Damages on temples and buildings near the Durbar Square. **a** Gaddi Baithak in Basantapur Durbar Square; **b** one building in Hanuman Dhoka

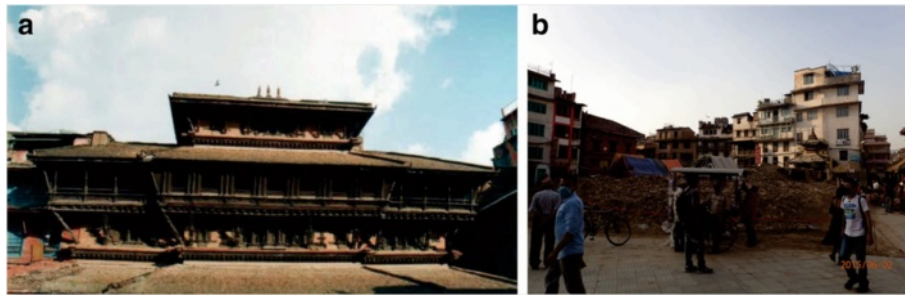
Kashthamandap temple, from which the Kathmandu city got the current name, was completely destroyed.

**Fig. 7** The collapse of the Kashthamandap temple. **a** The temple before the earthquake; **b** the situation after the earthquake

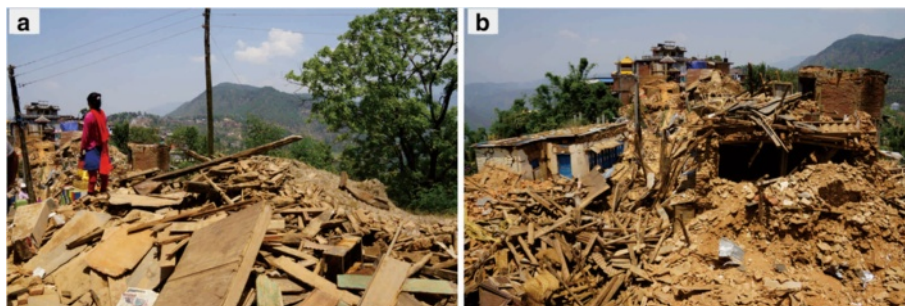
The Chautara town consists of two parts: old town and new town. In the old town area, the buildings had a simple structure with bricks and wooden slabs. In the new town area, concrete buildings were built three stories or higher. Figure 12 shows the damage in the old town area. More than 80 % buildings were destroyed by the earthquake.

**Fig. 12** Almost completely destroyed old town in Chautara. **a** Completely flattened buildings; **b** Destroyed buildings with standing walls

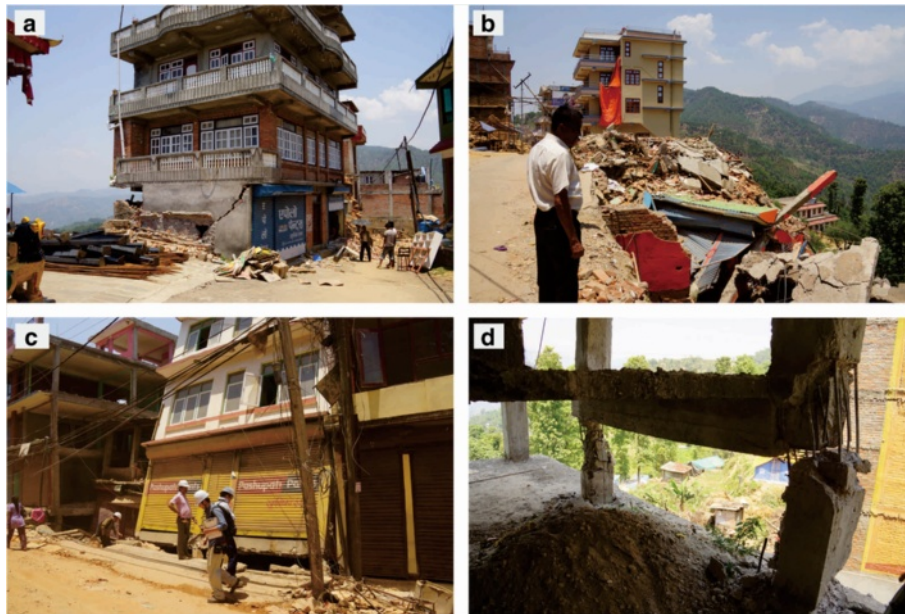
Figure 13 shows the damage in the new town area. The buildings were made by reinforced concrete, with

three or more stories. Some of the concrete building had cracks at the first floor (Fig. 13a). Some of them completely collapsed (Fig. 13b), and some of them tilted to the slope side (Fig. 13c). Breakage had occurred even at the pillars of some buildings under construction (Fig. 13d). In the case shown in Fig. 13d, the so-called short column effect may have occurred. According to Murty (2016), poor behavior of short columns is due to the fact that in an earthquake, a tall column and a short column of same cross-section move horizontally by same amount. Because the short column is stiffer as compared to the tall column, it attracts larger earthquake force. Stiffness of a column means resistance to deformation. The larger the stiffness is, the larger the force required to deform it. If a short column is not adequately designed for such a

**Fig. 13** Partially destroyed or damaged new town area in Chautara. **a** Cracks in the concrete building; **b** completely destroyed building; **c** building tilted to the downslope side; **d** breakage in pillars of new uncompleted building

large force, it can suffer significant damage during an earthquake.

The damage to the Chautara town was very severe though it is far from the epicenter and earthquake fault. The reason may be the amplification of the narrow mountain ridge, combined with the special

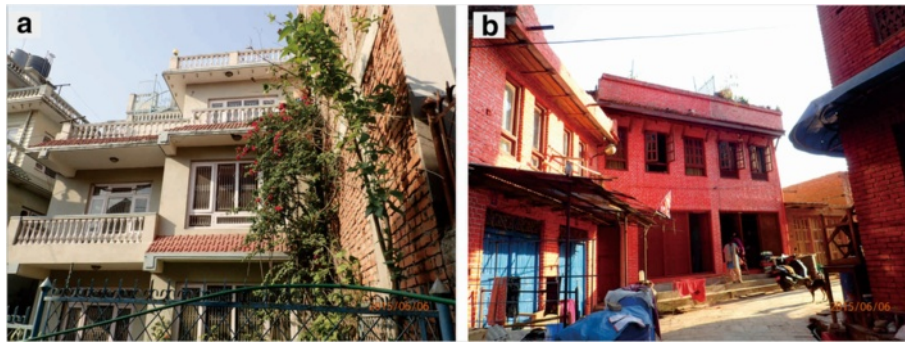
**Fig. 15** Solid buildings in Changu Village. No obvious damage can be observed to these buildings **a** & **b**

Figures 15, 16 and 17 show the different buildings and their degree of damage in Changu village. The newly-constructed RC structure building has not suffered obvious damage during the earthquake (Fig. 15), while the old-style brick structure building collapsed or separated by cracks (Figs. 16 and 17). From the collapse sections or faces, it can be found that the mortar was sparse and inadequate.

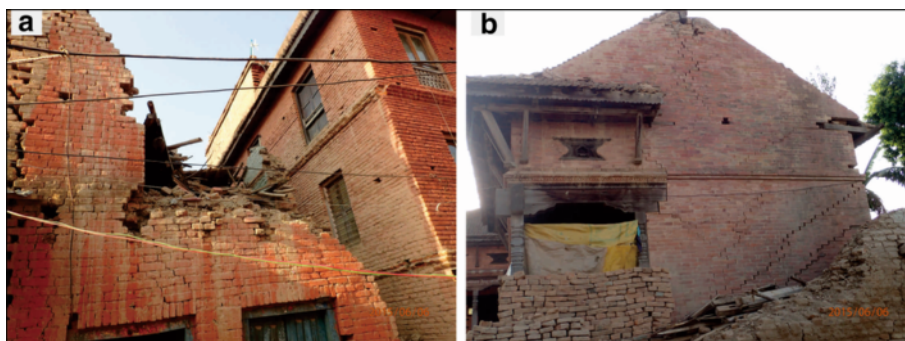
**Fig. 16** Damaged buildings with brick structure in Changu village. **a** Heavily damaged brick building; **b** cracks in the brick building

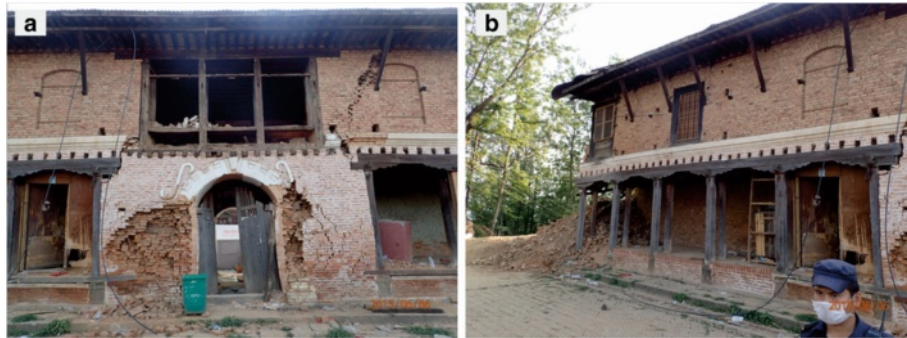
**Fig. 17** Damages occurred on the main gate building at the entrance to Changu Narayan. **a** Collapse around the main gate; **b** Collapse at the two sides of the gate building

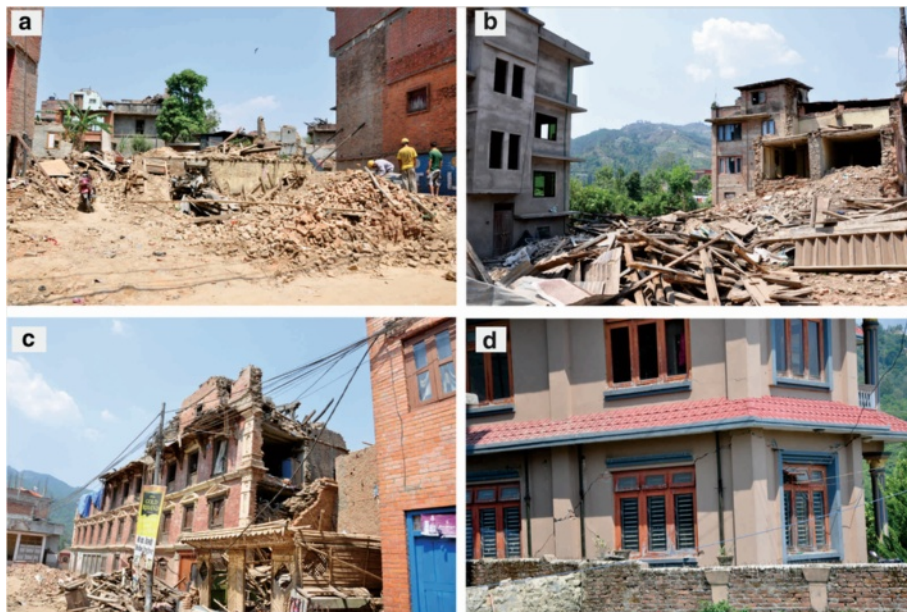
Sankhu area suffered from an extreme damage to the residential buildings. Figure 18 shows some typical collapses occurred in different buildings in this area. The old buildings with brick structure completely collapsed or were severely damaged. While on the new

buildings with concrete slabs in the brick structure or reinforcement by concrete on the walls, inclining occurred or X-shaped cracks were observed, indicating a strong vertical compression stress.

**Fig. 18** Building damage situation in Sankhu area. **a** and **b** Completely destroyed wooden and brick buildings; **c** Partial collapses of a three-story building; **d** X-shapes cracks in a new concrete building

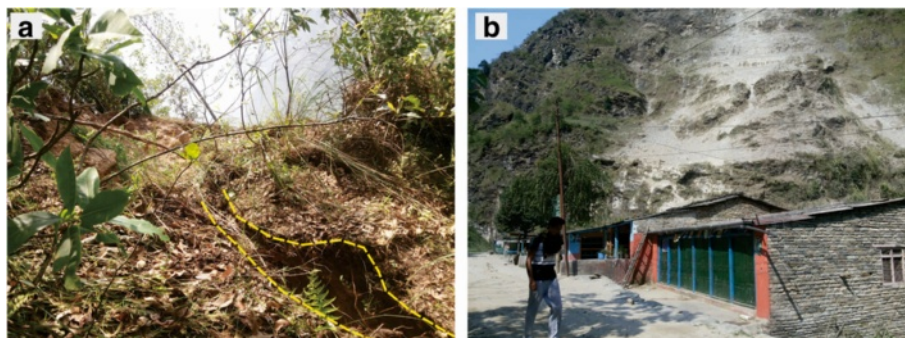
**Fig. 24** The situation of the Kaligandaki village on 23 May 2015. **a** Large crack was evident on the top of the cliff; **b** small-scale rockfall occurred and rolled down along the slope causing dust (Photos supplied by Nepal Army)

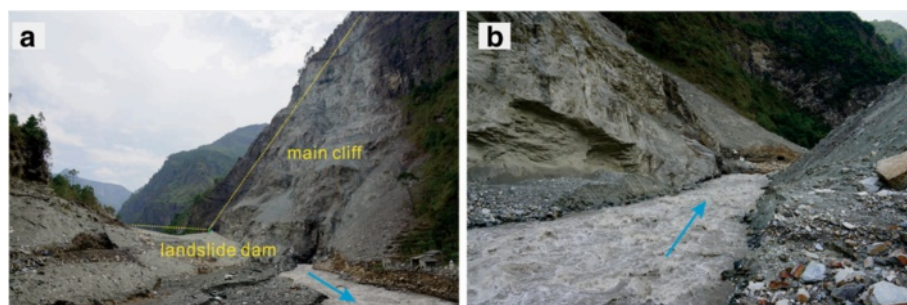
Figure 26 shows the situation for the landslide dam when the field investigation was conducted on 4 June 2015. The surface of the main cliff where the rock fall was generated was fresh, and the main cliff was steep. The channel was fully open and the water flow was rapid. During the investigation, the central longitudinal section was measured with a hand-held laser range

When we conducted the investigation at the Kaligandaki landslide dam, it was found that the landslide dam surface was covered by fine particles. The thickness of the fine particle layer was about 0.4 m. It was so loose that footprints can be easily seen (Fig. 28a). Some soil samples were taken from the surface, and the grain size distribution analysis was conducted (Fig. 28b). It shows the soil sample is well graded silt, and the mean grain size is 0.02 mm.

For the purpose of time prediction for landslide dam failure, we learned from that the collapse of the landslide dam by overflow only took 30 minutes. One of the possible reasons might be the crushing of the thin rock mass when the rockfall fell to the ground. The bedrock of the cliff is thin bedding phyllite which

is relative soft and composed of fine scale-like minerals. Because of the strong collision from about a 700 m high position, the structure of the rock mass was pulverized. We concluded that the landslide dam consisting of loose deposits of the rockfall might be vulnerable for overflow, and the longevity of the dam will be short.

**Fig. 26** Main cliff from where the rockfall occurred and the landslide dam (a) and the open channel of the collapsed landslide dam (b)

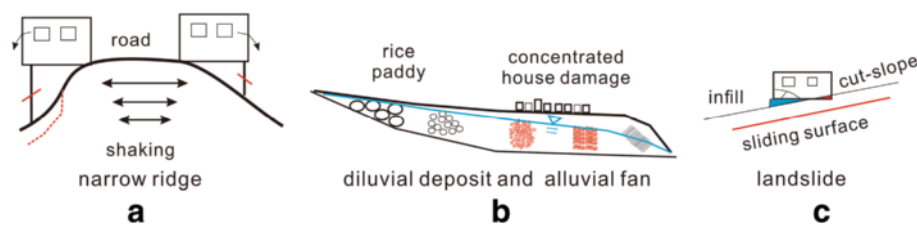
Figure 29(a) shows the case on the narrow mountain ridges. The Chautara town belongs to this type. Because the ridge is narrow, buildings used non-homogeneous foundations. One side of the building is

directly located on the ground, and the other side is supported by piles, bricks, or concrete structures. Generally, the mountain ridge experienced stronger shaking, and this may cause the failure at the outside foundations. If the outside foundation is located in a landslide area, the foundation will be prone to collapse even if the landslide does not show obvious displacement; if all of the mountain ridge is located in a landslide, the amplified shaking can cause any types of failure because the ground shaking may cause not only horizontal displacement or vertical displacement, but also rotational displacement. The building damage

Figure 29(b) represents the geological structure in Sankhu town. In the upstream side, gravels and surface water is abundant, while as it goes to downstream side, the grain size of the soil becomes finer and finer, surface water becomes to groundwater, and the groundwater gradually becomes deeper. The reason for the concentrated building damage in Sankhu

town may be resonance effect of the buildings to the deposit layers.

Figure 29(c) shows the failure pattern at Purano Naikap area. The similar pattern may be widely distributed around the Kathmandu basin. In this kind of area, the structure of the lacustrine deposit overlaying the bedrock can form an enhanced structure for the occurrence of landslides. If there is no earthquake, the gentle slopes are good for agriculture and housing. However, during a large earthquake, existing landslides can be reactivated. Because the lacustrine deposit landslide mainly consists of clay, generally they will not move for long distance during earthquake, but they can amplify the vibration and cause general destruction to the buildings, especially if the buildings in this area were located on shallow foundations on cut-slopes at the upper side, and infilled ground at the lower side. The amplified shaking may cause intensive settlement at the infill and cause non-homogeneous deformation at the foundation. When a building is located at the boundary of a landslide, it will suffer much more severe damage.

**Fig. 29** Three main patterns caused the building collapse and damages in 2015.4.25 Gorkha earthquake. **a** Building damage along narrow mountain ridge; **b** concentrated building damage on alluvial fan; and **c** building damage on existing landslide
