Torrent rainfall-induced large-scale karst limestone slope collapse at Khanh waterfall, Hoa Binh Province, Vietnam

Ngoc Ha Do^{1,4}, Satoshi Goto^{2*}

Abstract

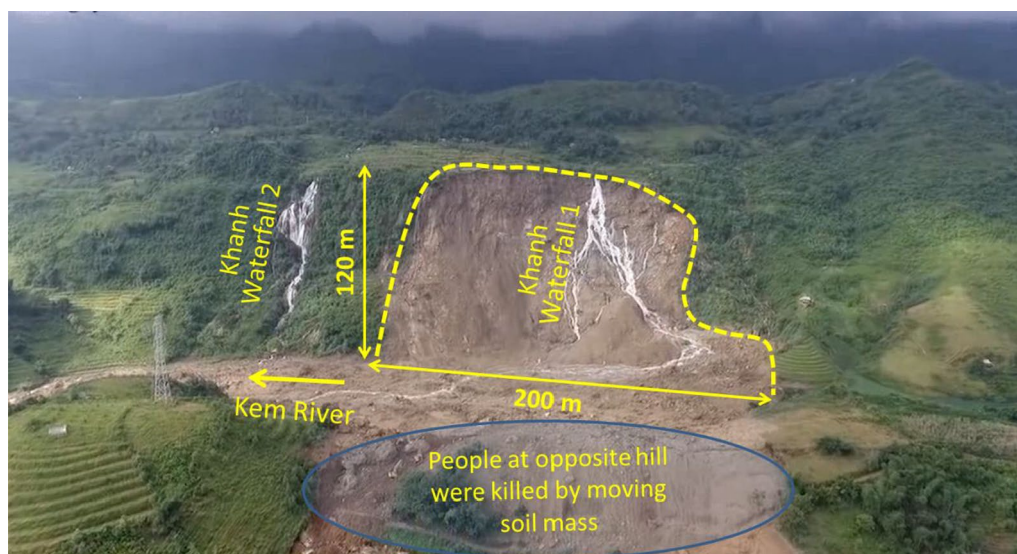
branches of the fall named Khanh waterfall 1 and Khanh waterfall 2 (Fig. 4).

When the landslide occurred, only Khanh waterfall 1 collapsed. Khanh waterfall 2 did not collapse. According to the survey of the upper stream network of Khanh waterfall, waterfall 1 and waterfall 2 have the same water source. However, the main stream flows towards waterfall 1, the secondary stream flows towards waterfall 2. Therefore, when the heavy rain occurred, more water was directed to the waterfall 1 area due to its geological characteristics that resulted in the slope collapse. The original dimensions of the Khanh waterfall 1 were a height of approximately 120 m, a maximum thickness of 50 m, and a width of 200 m. A part of the landslide mass deposited at the Kem River forming a natural dam. Other parts of the mass crossed the Kem

Fig. 4 The overview of Khanh waterfall landslide (Photo taken by Tuoi Tre Media 2017)

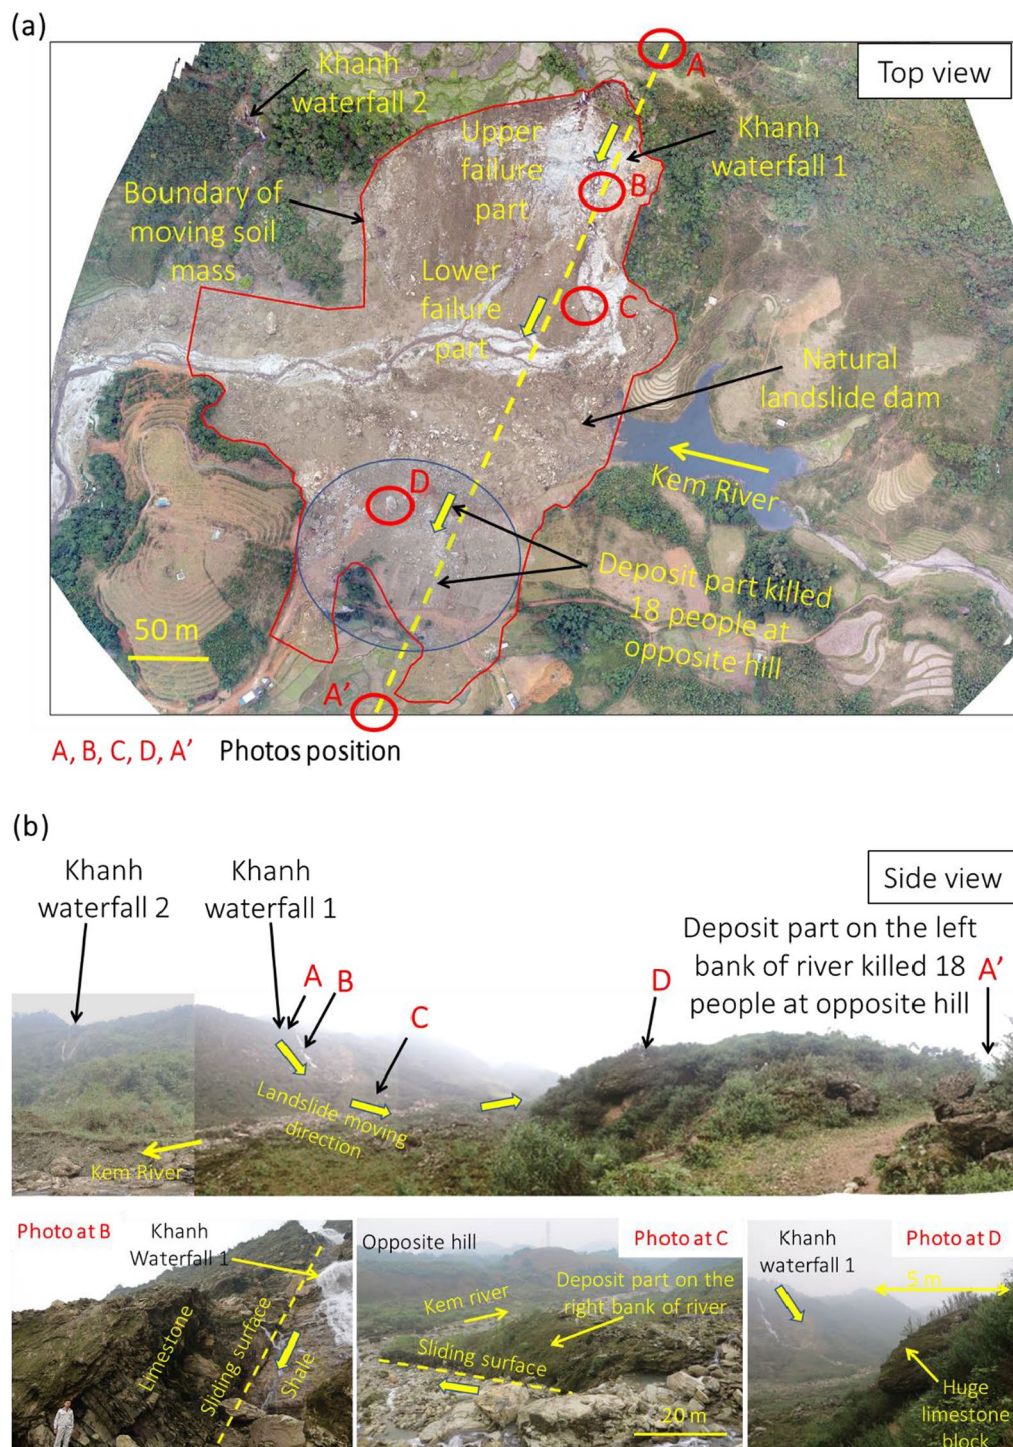
River, passed over the top of the 30 m high hill on the opposite riverbank, and reached the paddy field. The deposit part at opposite hill killed 18 people living there (Fig. 5).

Fig. 5 Photos of Khanh waterfall along the line A-A' of the landslide moving direction: **a** top view, **b** side view

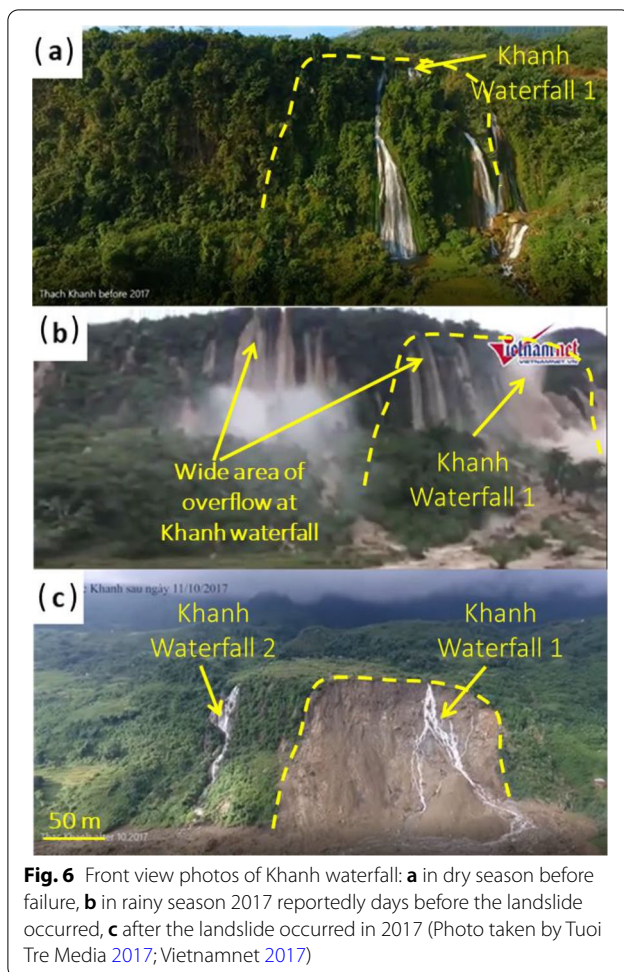
Figure 6 shows photos of the Khanh waterfall landslide taken at different times before and after the collapse of the waterfall. It shows the increase in the water around the waterfall during a heavy rain in 2017. The slope in

the dry season before 2017 was introduced as a beautiful waterfall destination for tourism (Fig. 6a). Figure 6b shows the situation of the slope in the rainy season of 2017, days before the landslide occurred. A large amount of brown water flowing from the entire slope included the waterfall as well as water ejected from the middle of the slope. Figure 6c shows the landscape after the slope area around the waterfall mostly collapsed. The moving mass containing boulders reached the opposite hill on the left bank of the river.

From the above calculation results, the amount of water collected around the waterfall during the peak rainfall on October 11 is about 181.5 m^3/s . While the allowable flow is about 3.55 m^3/s , which is about 51 times smaller than peak flow. That causes the water to overflow at Khanh waterfall. This is consistent with the situation around the waterfall before the landslide in Fig. 6b.

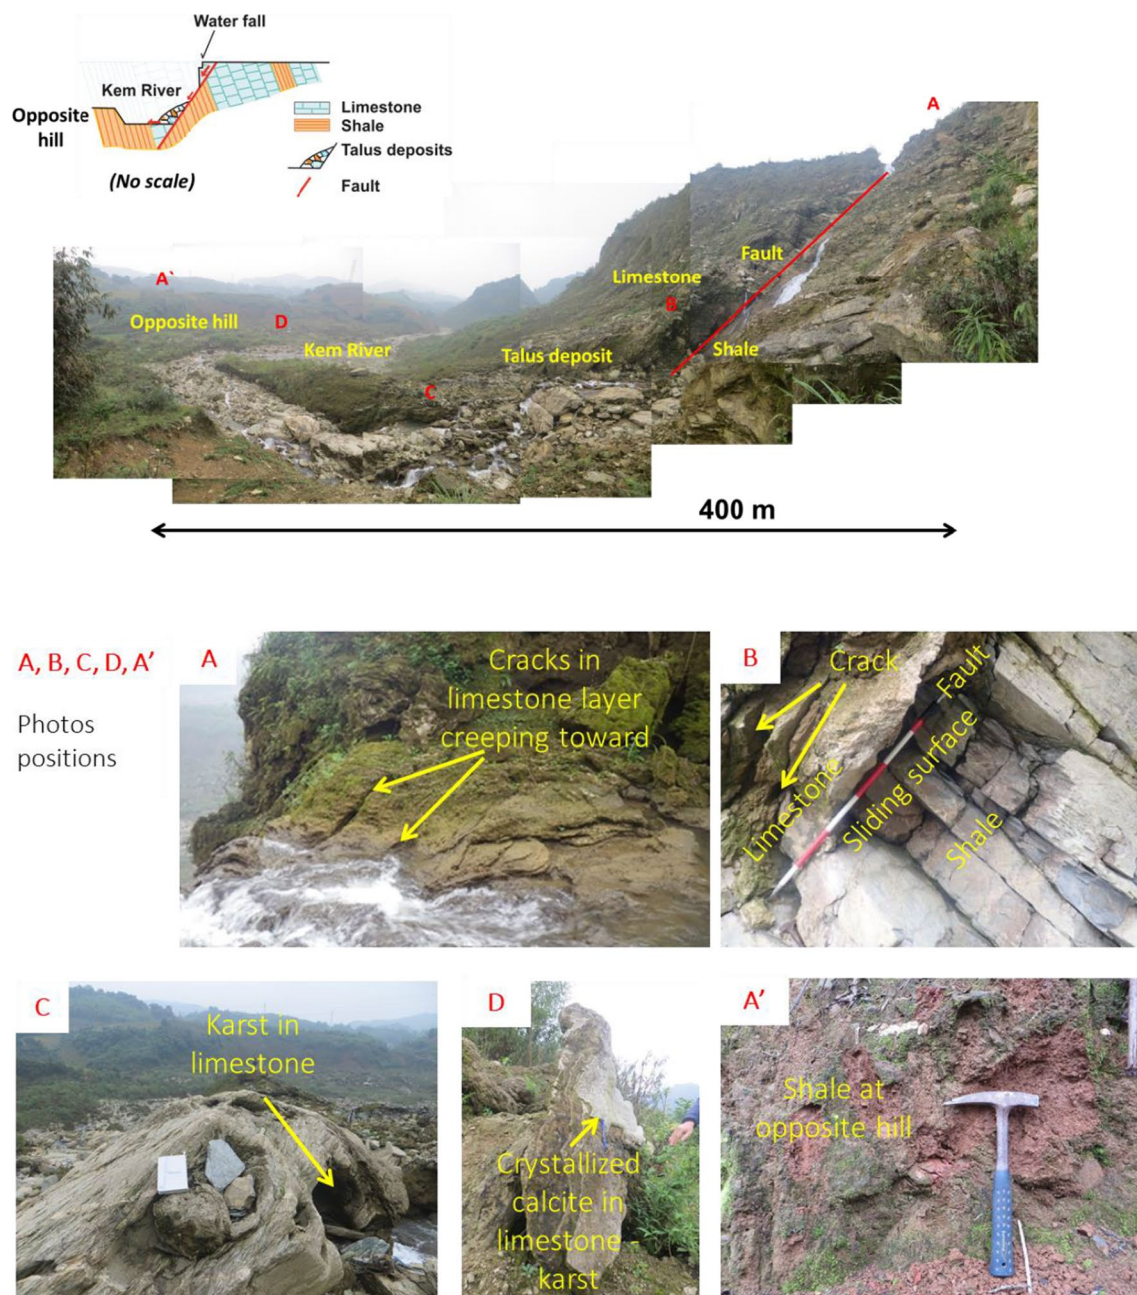
Figure 17 shows the side view and photos at different points along line A–A'. At the top of Khanh waterfall, the limestone layer had many cracks and creeping toward (Fig. 17A). At the middle of the slope, the sliding surface was found at the fault between the limestone layer and the shale layer (Fig. 17B). Limestone containing stalactite that formed the waterfall collapsed along the boundary with the shale, slipped together with the talus deposit at the bottom of the slope, and moved across the river to the opposite hill. Along the line A–A' along the landslide moving direction, many limestones were found at the toe of the slope and at the opposite hill (Fig. 17C, D). From the field survey at the site, the geological cross-section of Khanh waterfall slope was drawn in Fig. 18.

Overflow water on the top of Khanh waterfall flowed into the cracks and underground caves of the limestone layer (Fig. 17A, B). The water in cracks and underground caves increased the uplift water force and driving water force (Fig. 13). The increasing of destabilizing forces caused the slope to fail. The collapsed surface was the fault between the limestone layer and the shale layer (Fig. 18). The limestone blocks at the top of slope moved together with the talus deposit at the toe of slope. This mixture crossed the river and passed over the opposite hill. The large and fast moving mass destroyed five houses and killed eighteen people at the opposite hill. The collapse process was simulated based on Coulomb mixture theory (Denlinger and Iverson 2001). This method assumes that grain-fluid flows behave as mixtures limestone layer at the top and the talus deposit at the toe of slope. The simulation results show that the range of moving mass is similar to the actual phenomena at Khanh waterfall landslide.

Fig. 17 Cracks, karsts and crystallized calcite in limestone along the line A–A'. Shale at failure surface at point B and at opposite hill at point A'

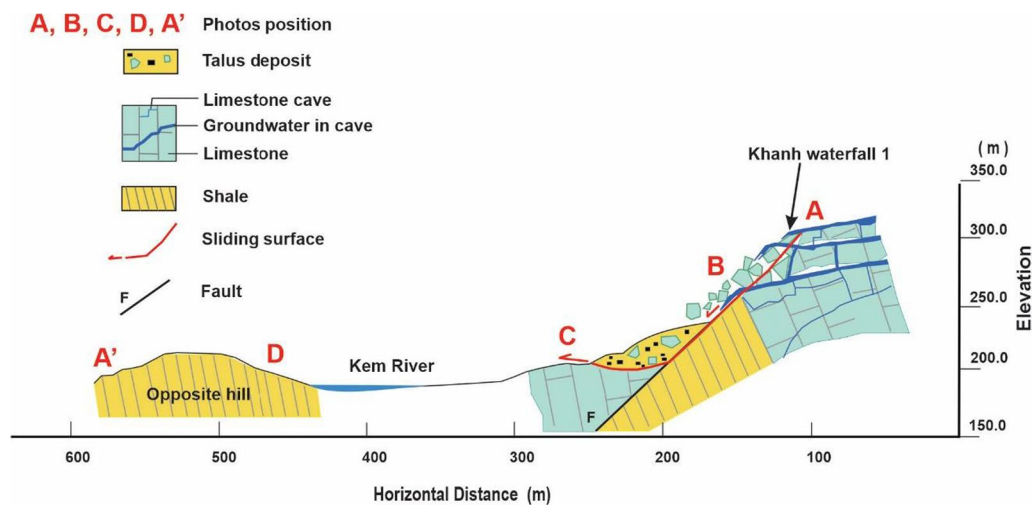
Fig. 18 Geology along line A–A' (center line A–A' in Fig. 5) of Khanh waterfall landslide—Outcrop of shale and limestone at the right bank of the Kem River after collapse

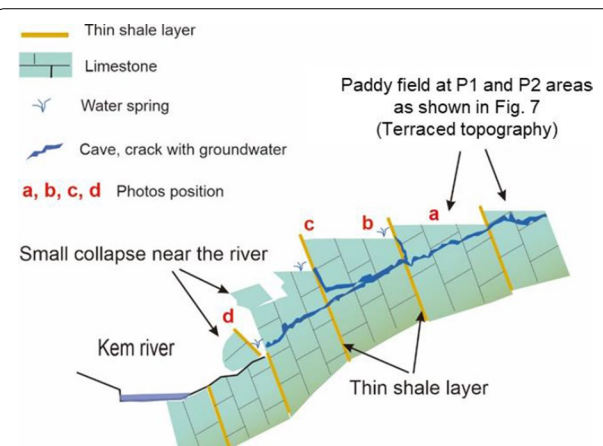
Downstream of Kem river, the geological cross-section of P1 and P2 areas were drawn in Fig. 19. Both points P1 and P2 had a concave topography which was divided by the ridgeline into the northeast-southwest direction. They show a terraced topography with steps of various heights of 2 m to 5 m at the Kem River direction below the slope (Fig. 20a). A lot of spring water was observed in the whole area (Fig. 20b). A shale with a thickness of 30 cm to 2 m was projected on the slope at a nearly vertical angle in a plate shape and parallel to the slope (Fig. 20c).

The protruding plate-shaped shale is arranged parallel on the strike of the stratum, and the geology surrounding the shale is limestone. The shale layer sandwiched between the limestone layers can be seen in the karst topography left behind by the differential erosion. There was a small-scale collapse topography with a width of 20 m to 30 m that occurred recently at the end of the slope of area P1 (Fig. 20d). However, a main scarp in the entire area P1 and P2 was not recognized.

Another nearby areas are P1 and P2 areas on the right bank downstream of Khanh waterfall. Since the topography of the P1 and P2 areas is similar to the old landslide site, it was feared that landslides would continue to occur in the future. However, the survey results show that the geology at areas P1 and P2 is different from the geology at Khanh waterfall (Fig. 19). The geology at areas P1 and

P2 is mainly limestone interspersed with a thin shale layer. In addition, the surface and groundwater in areas P1 and P2 and the Khanh waterfall landslide area are considered to have different water supply channels due to differences in water quality. It suggests that areas P1 and P2 may have a different phenomena compared with Khanh waterfall landslide.

Fig. 19 Geology at P1 and P2 areas as shown in Fig. 7

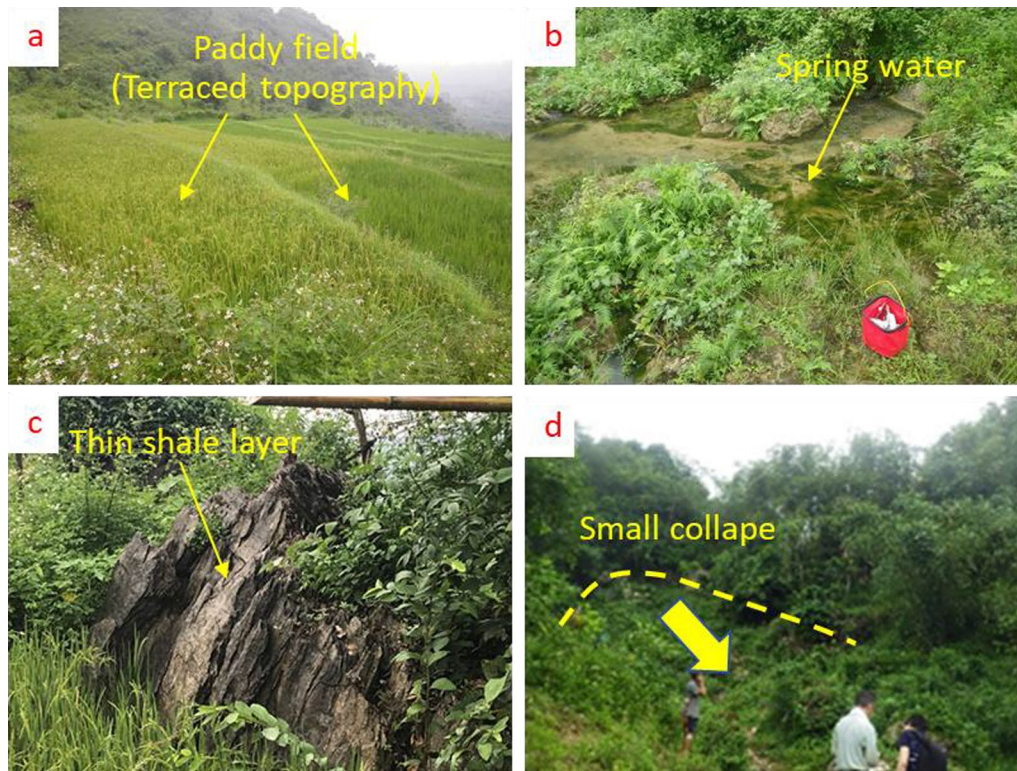
Fig. 20 Photos of a, b, c, d position in Fig. 18, **a**: terraced topography, **b**: spring water, **c**: thin shale layer, **d**: small collapse area near the river

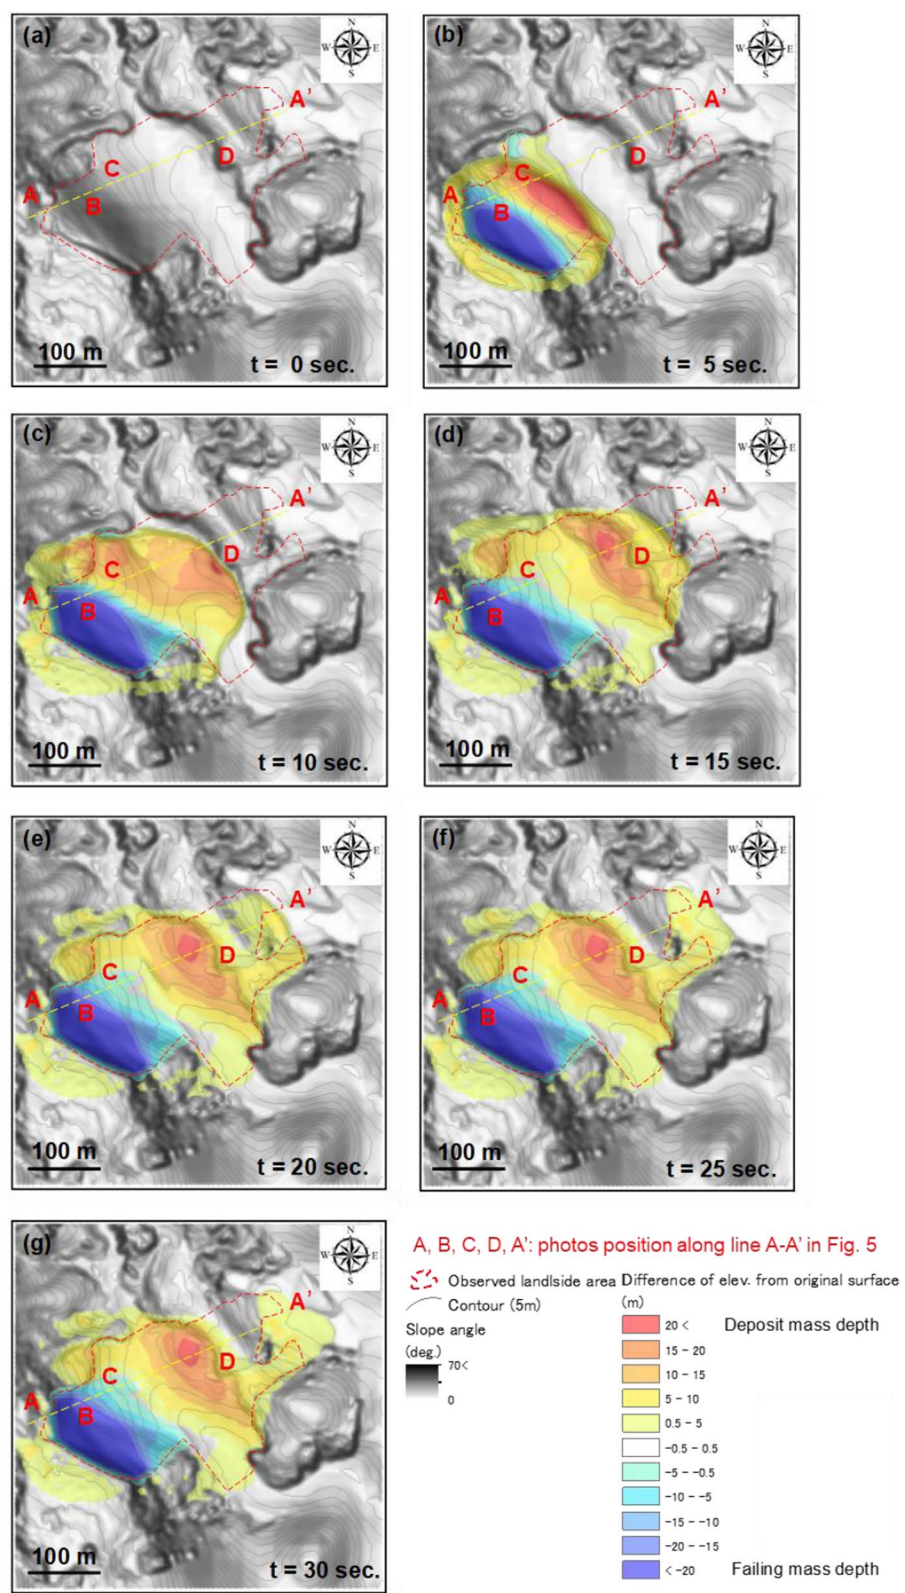
The numerical simulation result of Khanh waterfall landslide is presented in Fig. 23. The simulation result is shown with a 5-s from the initial condition ($t=0$ s) to the end of moving ($t=30$ s). The red line is a boundary of the mass moving area estimated based on the information provided by local residents and by UAV photo. The horizontal force was increased and failure started from the upper part of the slope at points A and B. The talus deposit part at point C moved together with the limestone from points A and B to points D and A'. After 15 s, the moving mass crossed the river and the opposite hill at point D. Finally, after 30 s, the mass was deposited at point A' behind the hill. However, most of the moving mass was deposited in front of the hill. Based on the boundary of mass moving area estimated by the information of local residents and by UAV photo, the simulation result is similar to the actual phenomena.

Fig. 23 Simulation result of Khanh waterfall landslide with a 5-s interval from initial condition to the end of moving: **a** at initial condition, **b** at 5 s, **c** at 10 s, **d** at 15 s, **e** at 20 s, **f** at 25 s, **g** at the end 30 s
