# Effect of climate change on earthworks of infrastructure: statistical evaluation of the cause of dike pavement cracks

Zsombor Illés<sup>1,2\*</sup> and László Nagy<sup>1</sup>

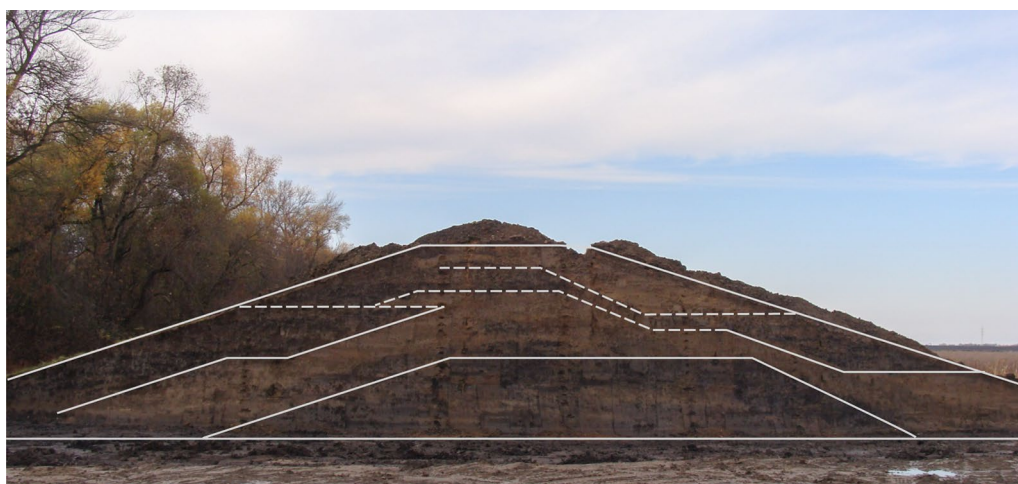
**Fig. 1** Onion shell structure discovered during the relocation of a dike near, Fokorú-puszta (Tisza right bank, north of Szolnok) (authors illustration)

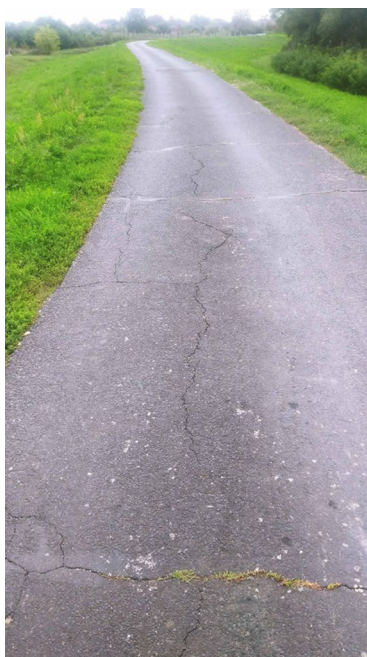
Tisza, left bank, 0+690

**i) Thin (Hairline)**

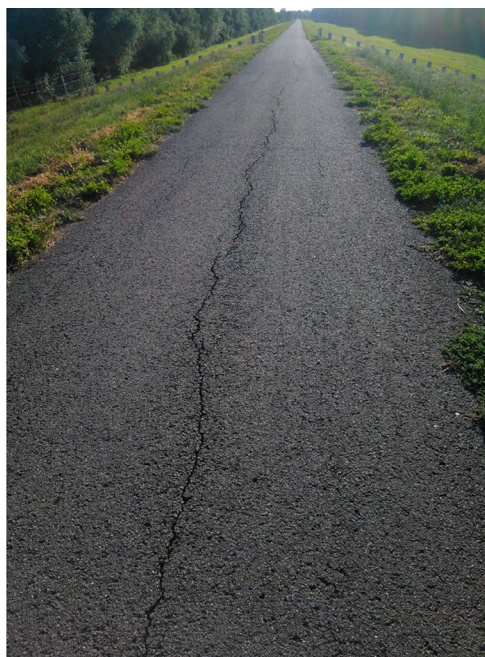
Tisza, right bank, 7+230

**ii) Medium**

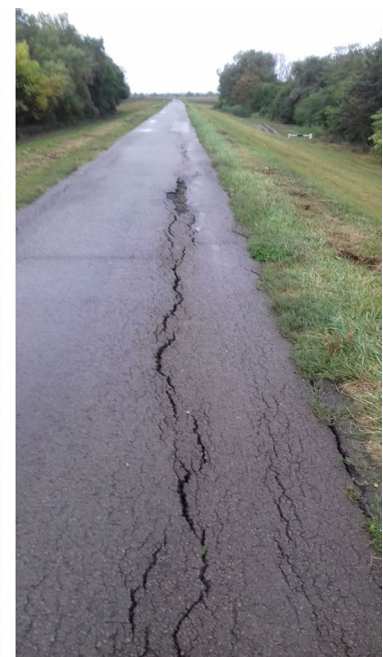
Tisza, right bank, 126+260

**iii) Thick (sturdy)**

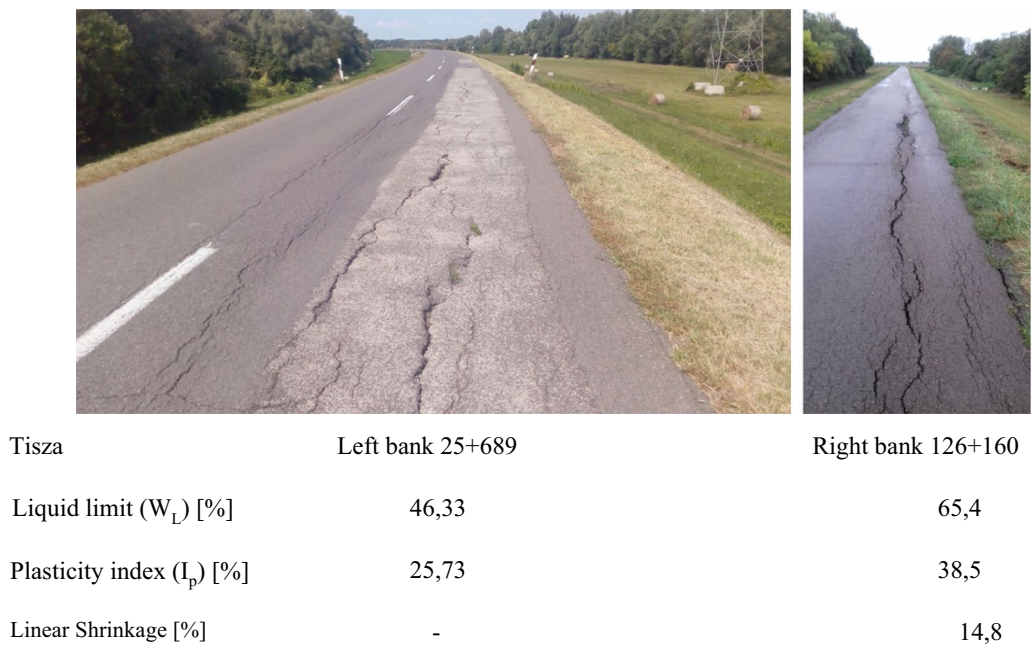
The two selected sites were the following: the Tisza left bank 25+689 and right bank 126+160. In the first site, the dike serves as the earthwork for a secondary road; in the second case, many soil mechanical investigations were carried out in the section. The cracks are parallel to the road's axis, a bit winding, and there is a height difference between the cracks' sides. They are examples of desiccation cracks.

**Fig. 12** Pavement fissures caused by shrinkage and swelling
