# Preliminary report of field reconnaissance on the 6 February 2023 Kahramanmaras Earthquakes in Türkiye

**Keywords** Field investigation, Kahramanmaras earthquakes, Seismic damage, Liquefaction, Ground failure

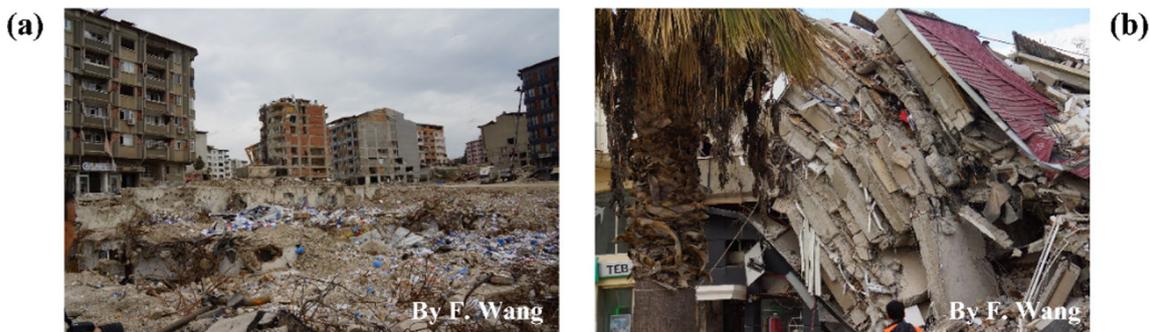
According to the preliminary field reconnaissance, the massive damage of buildings due to strong motion and high intense shaking occurred at the city centre of Antakya as shown in Fig. 3a, but not in Kahramanmaras where only several buildings were destroyed by the earthquakes in its old downtown areas as shown in Fig. 3b. In

the Antakya, most of the buildings were destroyed and removed when the reconnaissance team arrived about 50 days later. Major city functions were entirely paralyzed, including transportation, water and electricity supply.

**Fig. 3** Strong-motion-induced building damage in downtown Antakya (a) and Kahramanmaras (b)

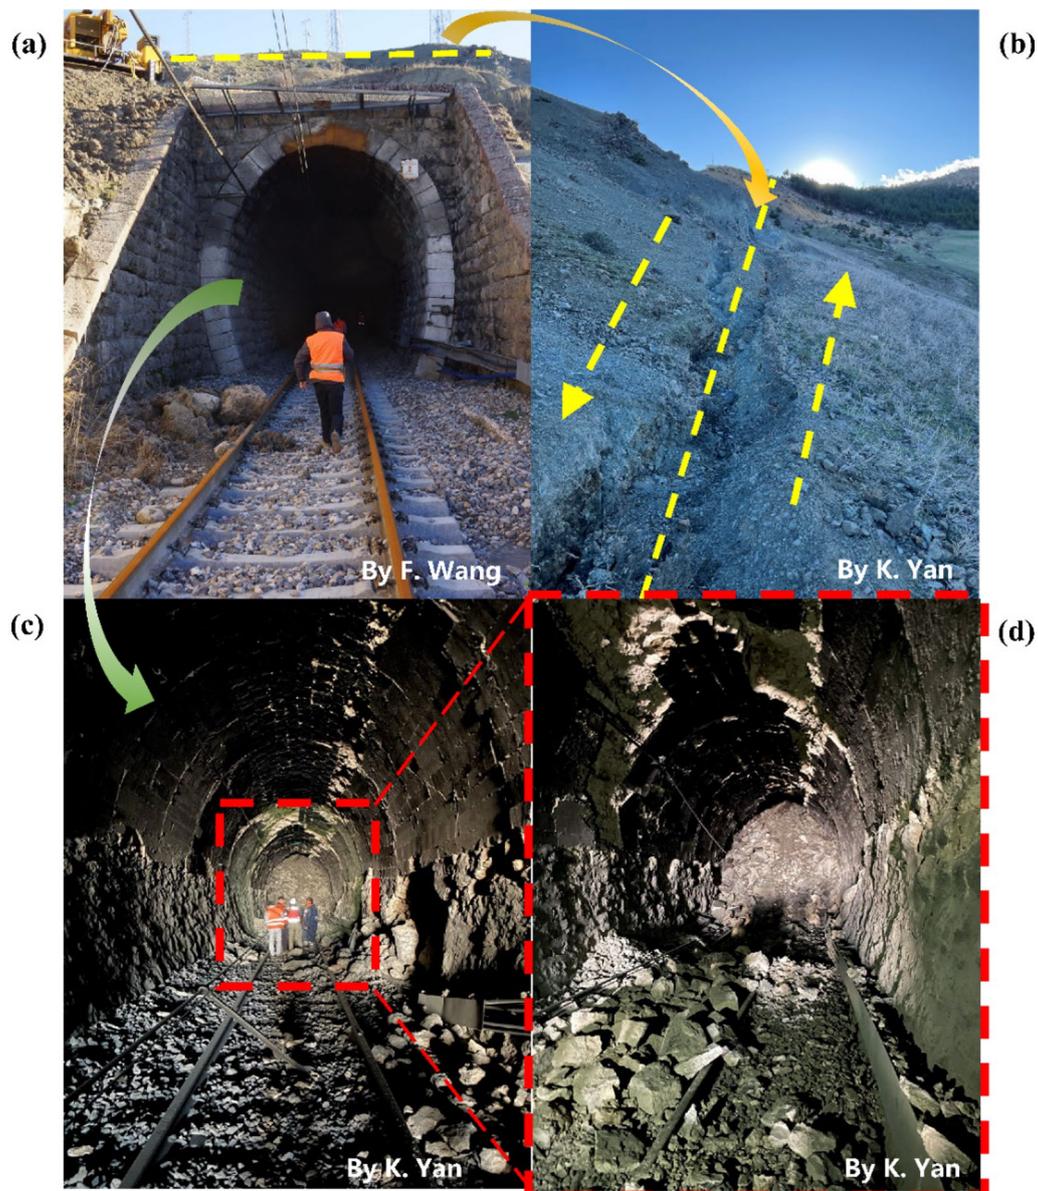
**Fig. 4** A railway tunnel (a) was cut by the left-lateral strike-slip fault (b) in Ozan, causing the tunnel collapsed (c) and the railway line interrupted (d). The railway was still in use before the earthquake

The most severely damaged tunnel was a railway tunnel at Ozan in Golbasi, Adiyaman Province, Turkiye (Fig. 4a). The tunnel was cut by the Erkenek fault segment (Fig. 4b) and was entirely blocked by a rupture-induced collapse inside the tunnel (Fig. 4c, d). The railway tunnel had been still available before the earthquakes. Moreover, there were three explosion sites of natural gas pipeline crossing the fault and cut by the ground rupture, two of the cases occurred in Turkoglu,

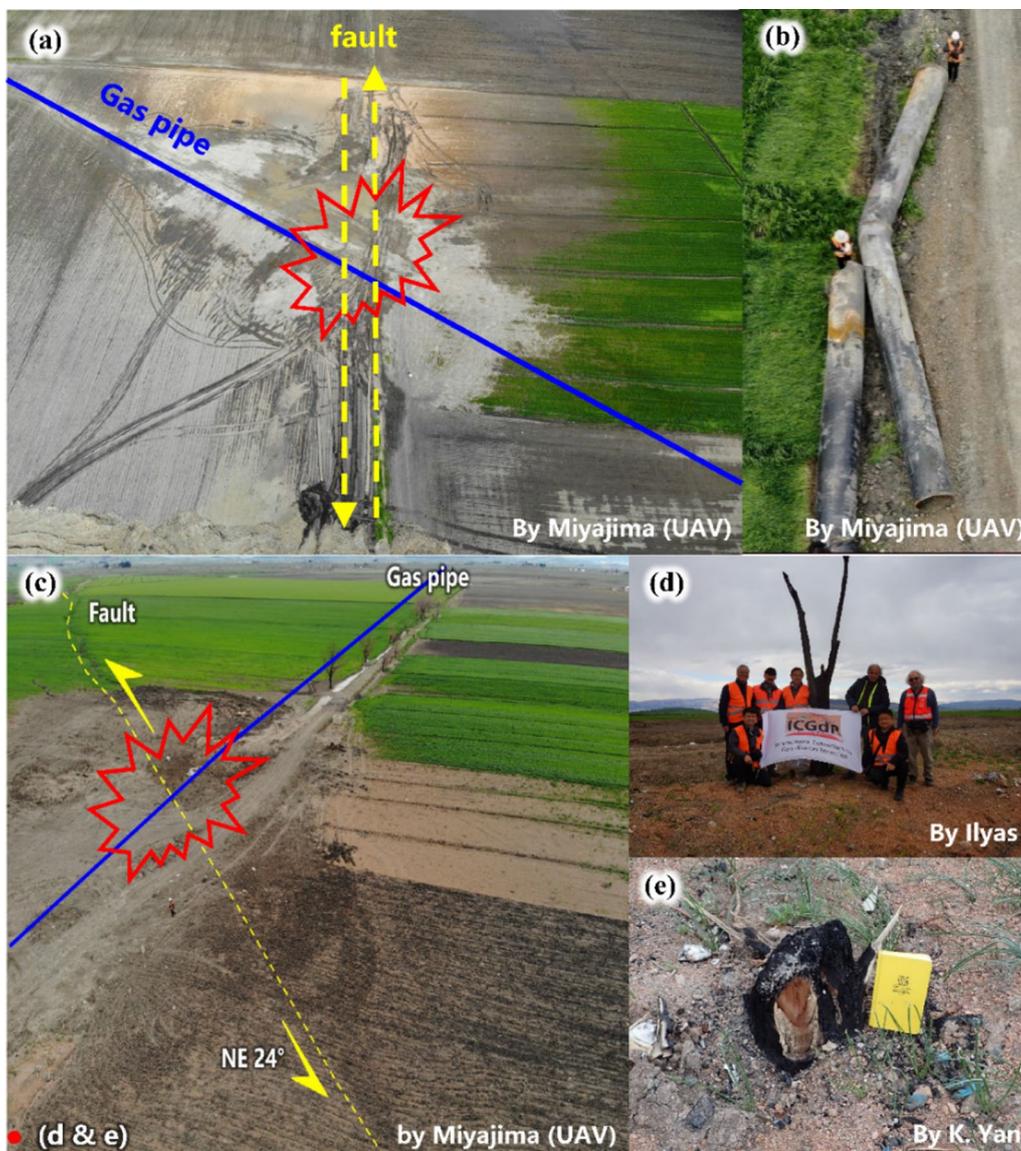
Kahramanmaras were shown in Fig. 5 as examples. According to the field investigation, the explosion diameters of the two explosions were estimated to be about 200 m. The two buckled pipelines at Ceceli had a diameter of 1 m and a pipe thickness of 15 mm. The buckling angle was measured to be 30° and 18° respectively, as shown in Fig. 5b. In addition to underground structures, such as tunnels and pipelines, various buildings were also severely damaged as shown in Figs. 6, 7.

**Fig. 5** Explosions caused by damages of natural gas pipeline crossing the faults in Turkoglu, Kahramanmaraş. **a** Gas pipeline damages at Ceceli and **b** curved steel pipe with an outer diameter of 1 m and a thickness of 15 mm; **c** gas pipeline damages at Golluhuyuk with **d** burnt tree trunks and **e** stumps

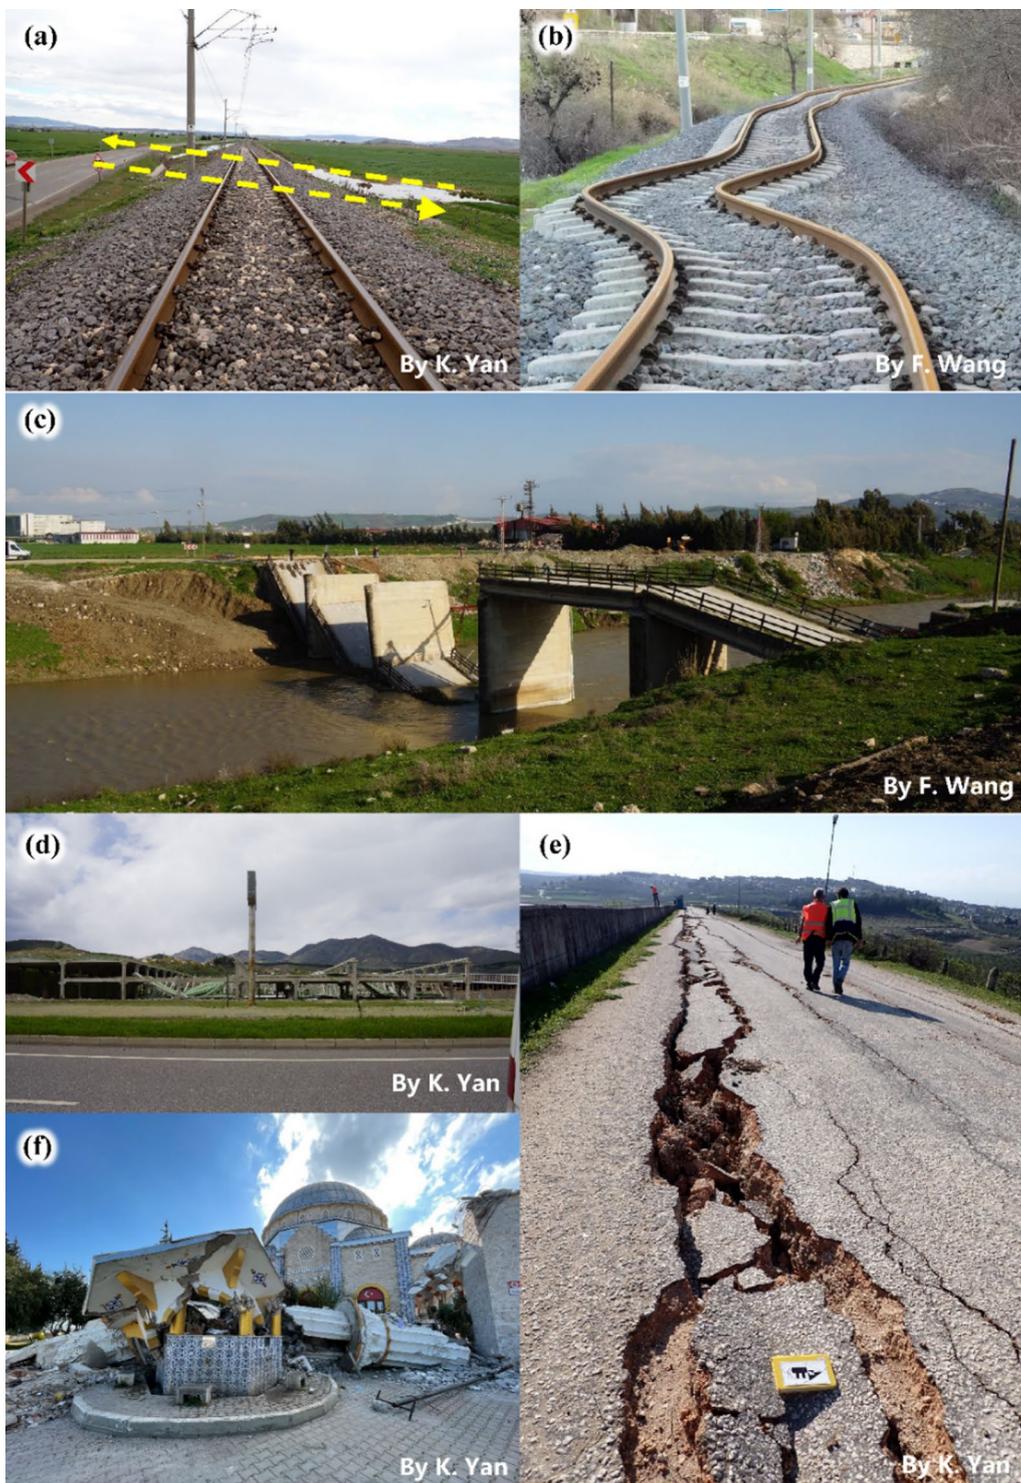
**Fig. 6** Seismic damages of major infrastructures, including **a** & **b** railways, **c** bridge, **d** factory, **e** Yarseli dam and **f** mosques

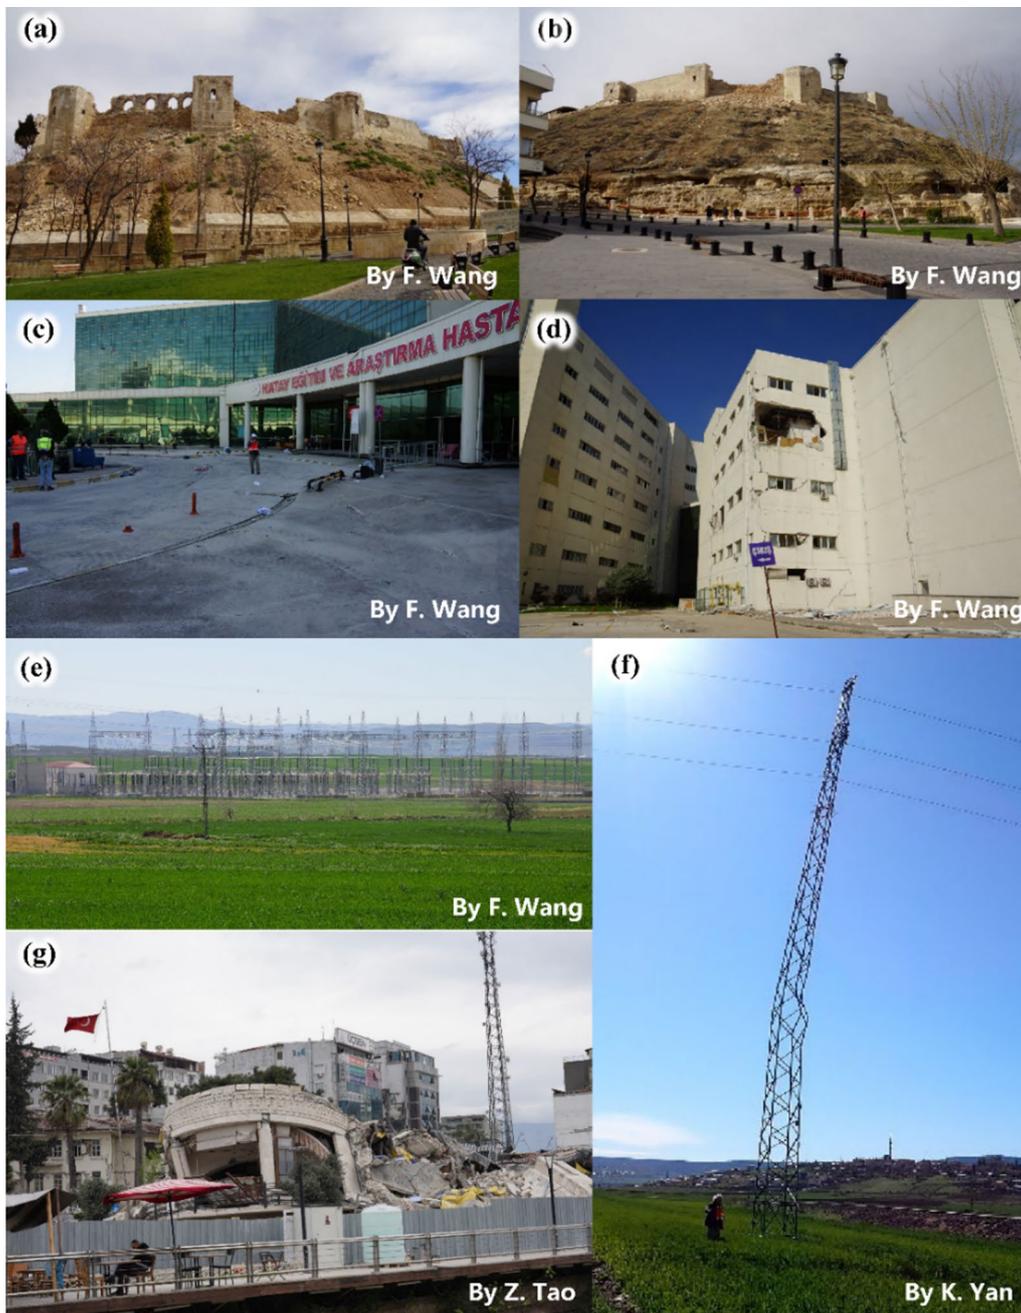
**Fig. 7** Seismic damages of major infrastructures, including **a** & **b** Gaziantep castle, **c** & **d** Hatay Hospital, **e** power plants and **f** substations and **g** provincial council building of Hatay (about 100 years old)

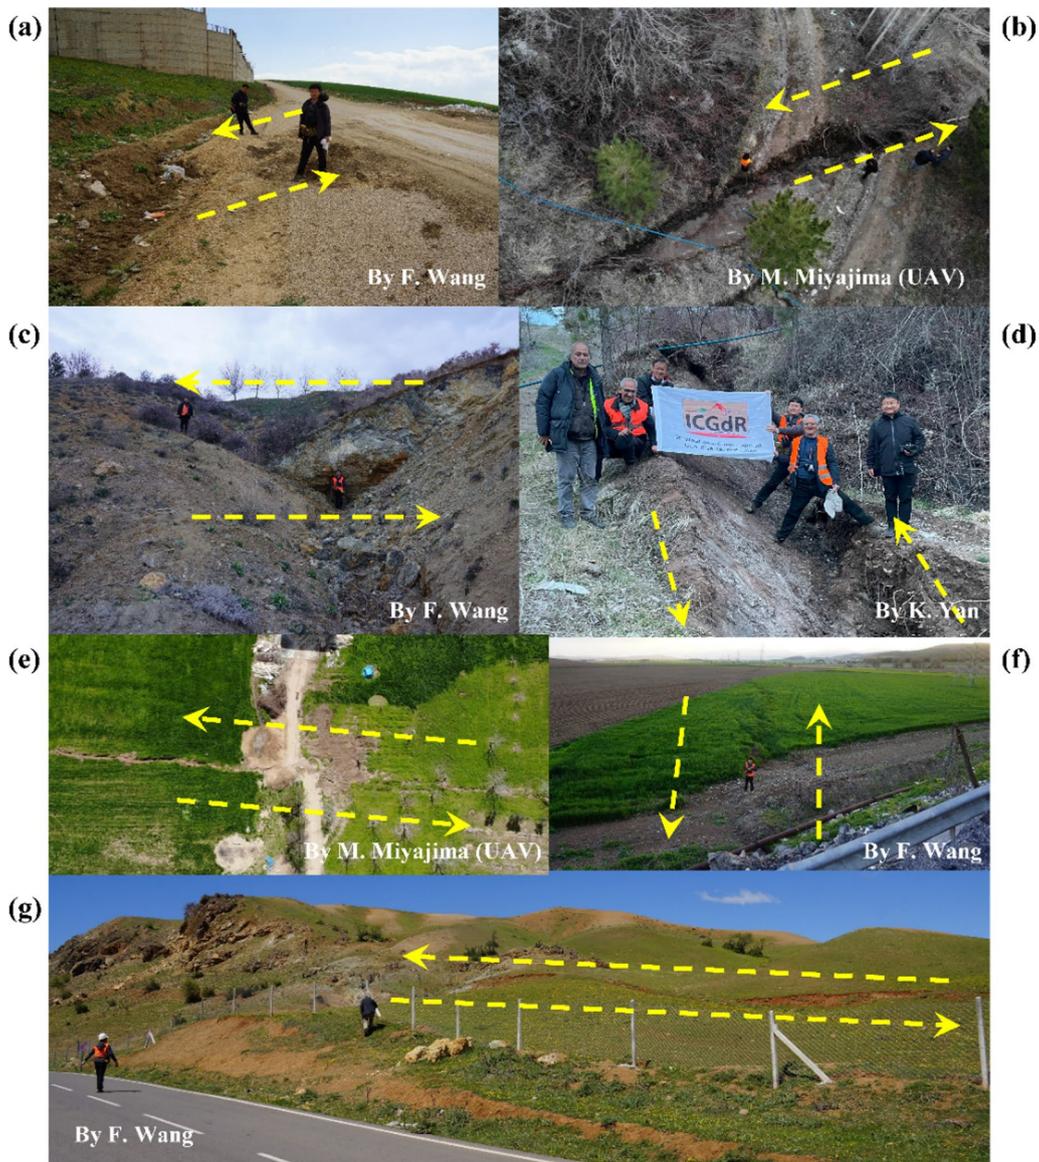
In addition to the collapses of buildings, strong seismic effects were illustrated by massive ground surface ruptures caused by fault movement, as shown in Fig. 8. The obvious ground surface rupture first occurred at the north end of Antakya (Fig. 8a) and disappeared at the west end of the second failed fault (Fig. 8b–d). Moreover, massive ruptures crossed through farmland and villages,

triggered subduction and transport line interrupted as shown in Fig. 8e–g.

**Fig. 8** Ground ruptures along the investigated faults at **a** Kirikhan (36°28'44.7"N, 36°20'01.3"E), **b & d** Findik (38°03'53.9"N, 36°44'12.4"E), **c** İcmeler (38°01'47.6"N, 37°10'08.1"E), **e** Balkar (37°43'48.8"N, 37°33'30.3"E), **f** Güzelyurt (37°28'47.6"N, 37°02'31.7"E) and **g** Tevekkelli (37°27'13.4"N, 36°59'15.8"E)

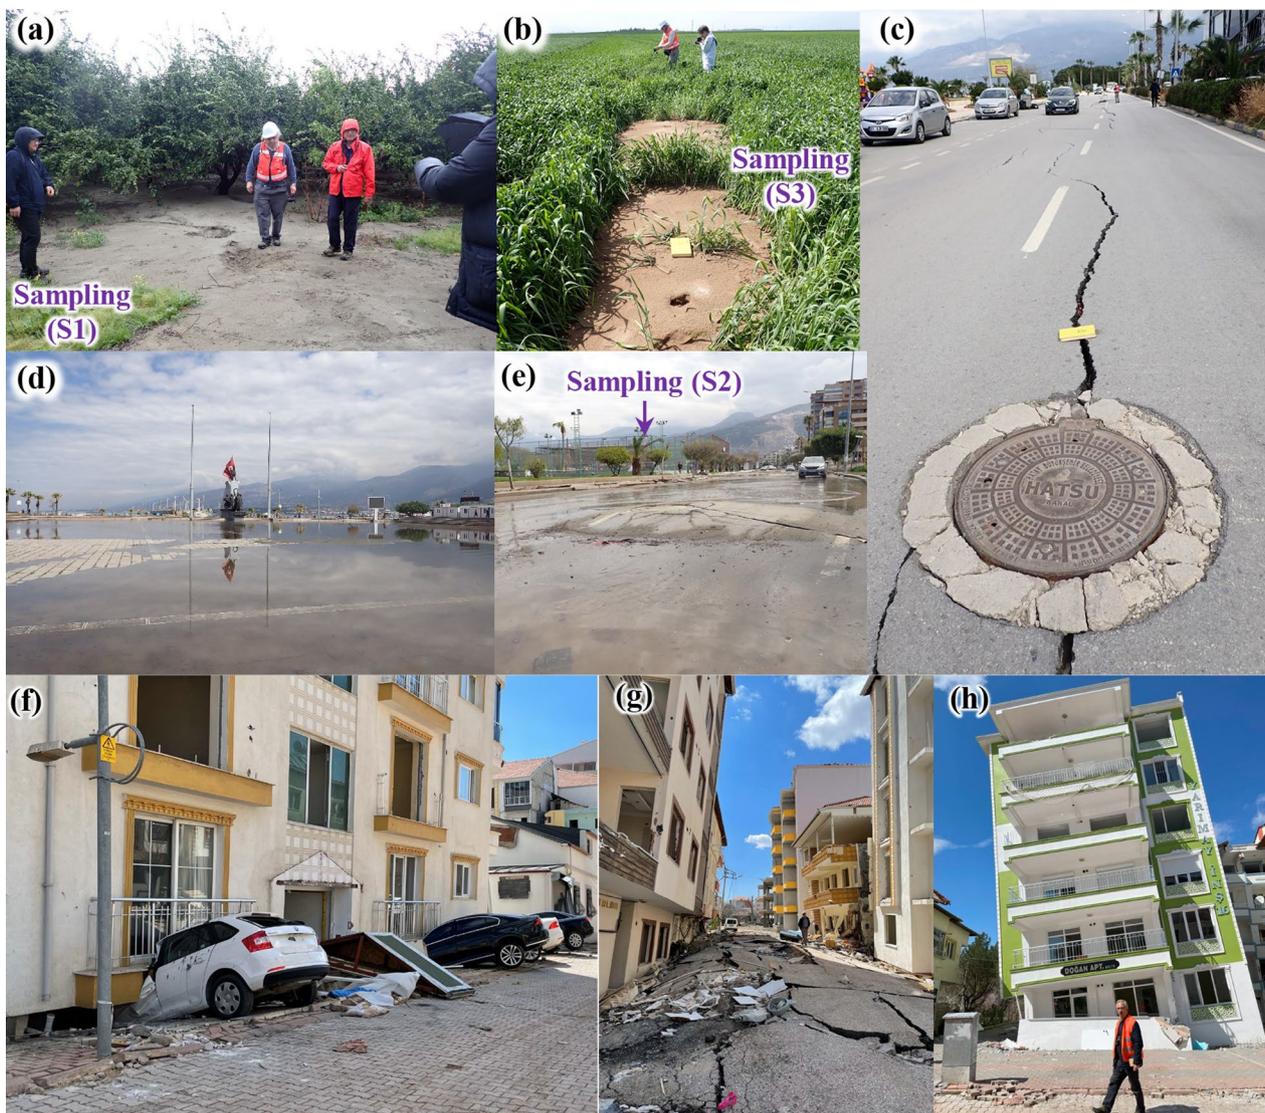
The major characteristics and damage of liquefaction include sandboiling in farmland and wheat field (Fig. 10a, b), ground cracks on road (Fig. 10c), subduction (Fig. 10d, f), floating upward of sewer manhole (Fig. 10e), uneven deformation (Fig. 10g, h) and massive lateral spreading along rivers (Figs. 11, 12) and lakeshore

(Fig. 13). Figure 10a illustrates an orchard of oranges at the coastal region in Samandag was covered by massive sandboiling, while a sandboiling belt was also observed along a long ground rupture at a wheat field in Kumlu as shown in Fig. 10b. The erupted sands were collected as S1 and S3 whose gradation curves were illustrated in Fig. 15 with detailed gradation parameters in Table 1. The S3 was poorly graded compared to S1 although they

had similar median diameter ( $d_{50}$ ). Similarly, massive liquefaction and its secondary damage were investigated at coastal regions surrounding the Lunapark in Iskenderun. In addition to the similar sandboiling as Fig. 10a, massive liquefaction-induced damage on infrastructure (like road, port) and collapse of high-story resident buildings, causing enormous fatality and economic loss. The same liquefaction-induced damages (Fig. 10f–h) occurred

**Fig. 10** Sandboiling and subduction triggered by liquefaction. **a–e** are liquefaction sites at coastal areas at Samandag and Iskenderun Lunapark, while **f–h** are the lakeside area at downtown Golbasi (Photos were taken by K. Yan)

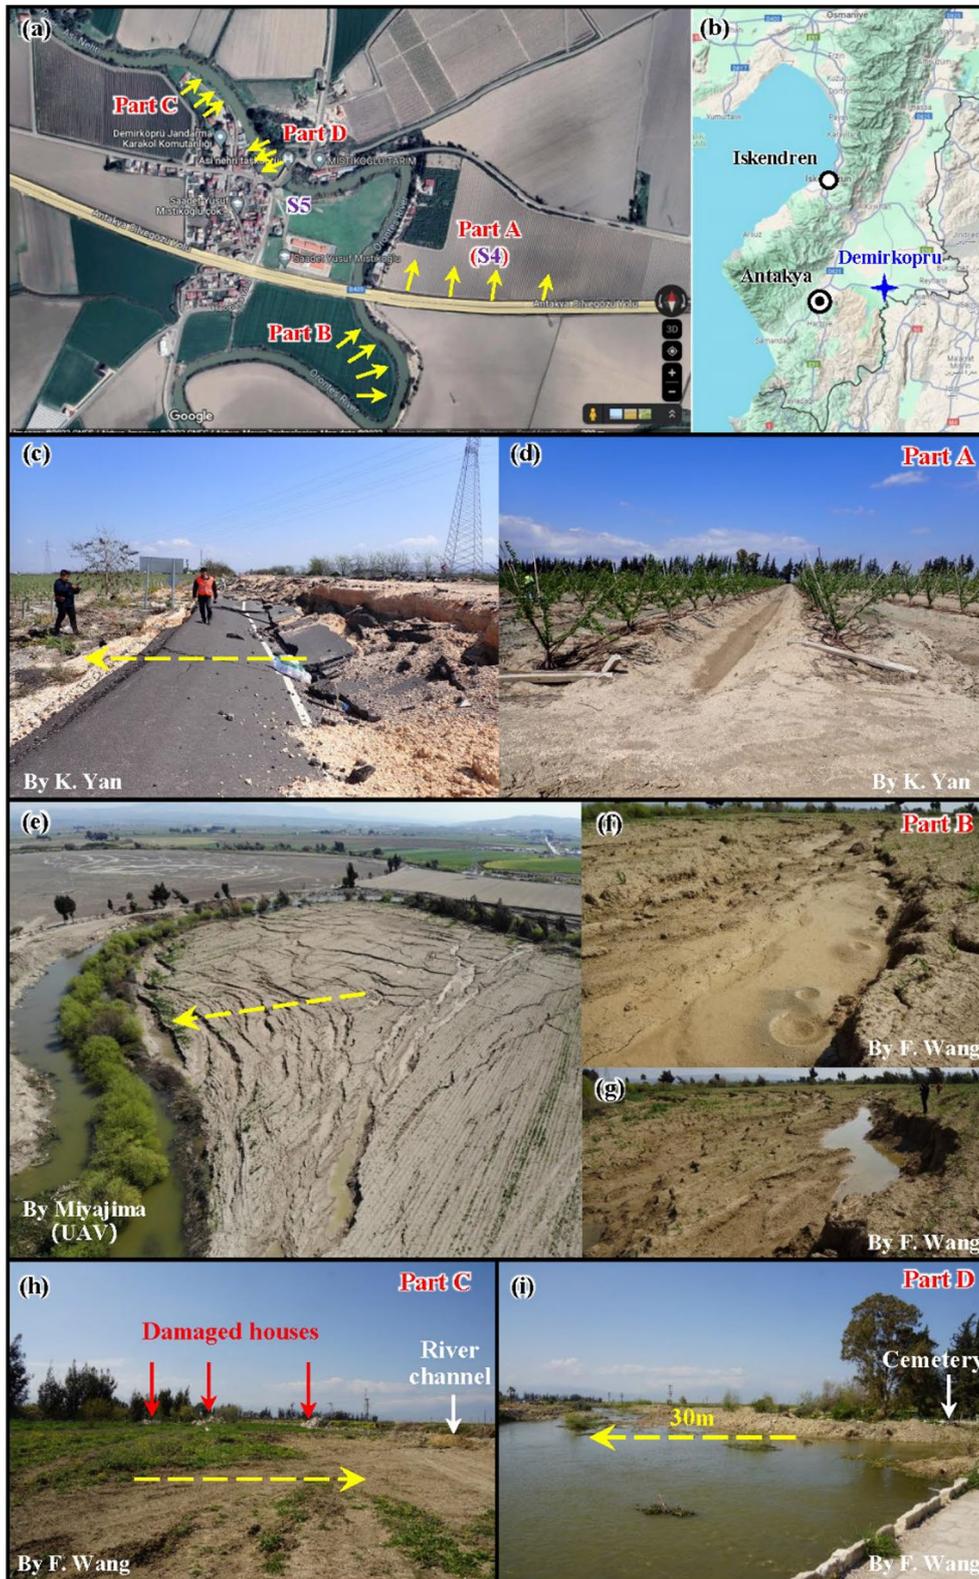
Different from the above liquefaction damage, the lateral spreading usually occurred at topographically uneven regions, like riverside and lakeshore regions as shown in Figs. 11, 12, 13. A riverside region at Demirkopru was investigated with four parts of liquefaction-induced lateral spreading as shown in Fig. 11. In Part A, a lateral

spreading to an orchard field (Fig. 11d) caused a severe broken over 1 km of the Antakya Cilvegözü Yolu which is a significant transport way in Hatay as shown in Fig. 11c. On the opposite side of the road, a large area of farmland was destroyed by the lateral spreading (Fig. 11e) with enormous explosive sand volcanoes at ground cracks (Fig. 11f, g). Moreover, the lateral spreading at Parts C and D destroyed a primary school, several resident buildings and a cemetery as shown in Fig. 11h, i. In this liquefaction site, two kinds of samples were collected at the roadside orchard (S4) and opposite side of the cemetery (S5). The S4 has similar size distribution features compared to the S1, S3 and S6, but different from S5. The S5

**Fig. 11** Liquefaction-induced lateral spreading (a) at Demirköprü (b) in Hatay. The Part A damaged the road (c) by the lateral spreading to a roadside wheat field (d); The Part B laterally moved to the river (e) with massive sand volcanoes (f) and ground cracks (g) in the riverside farmland; The Part C and Part D damaged a primary school with several resident buildings (h) and a cemetery (i)

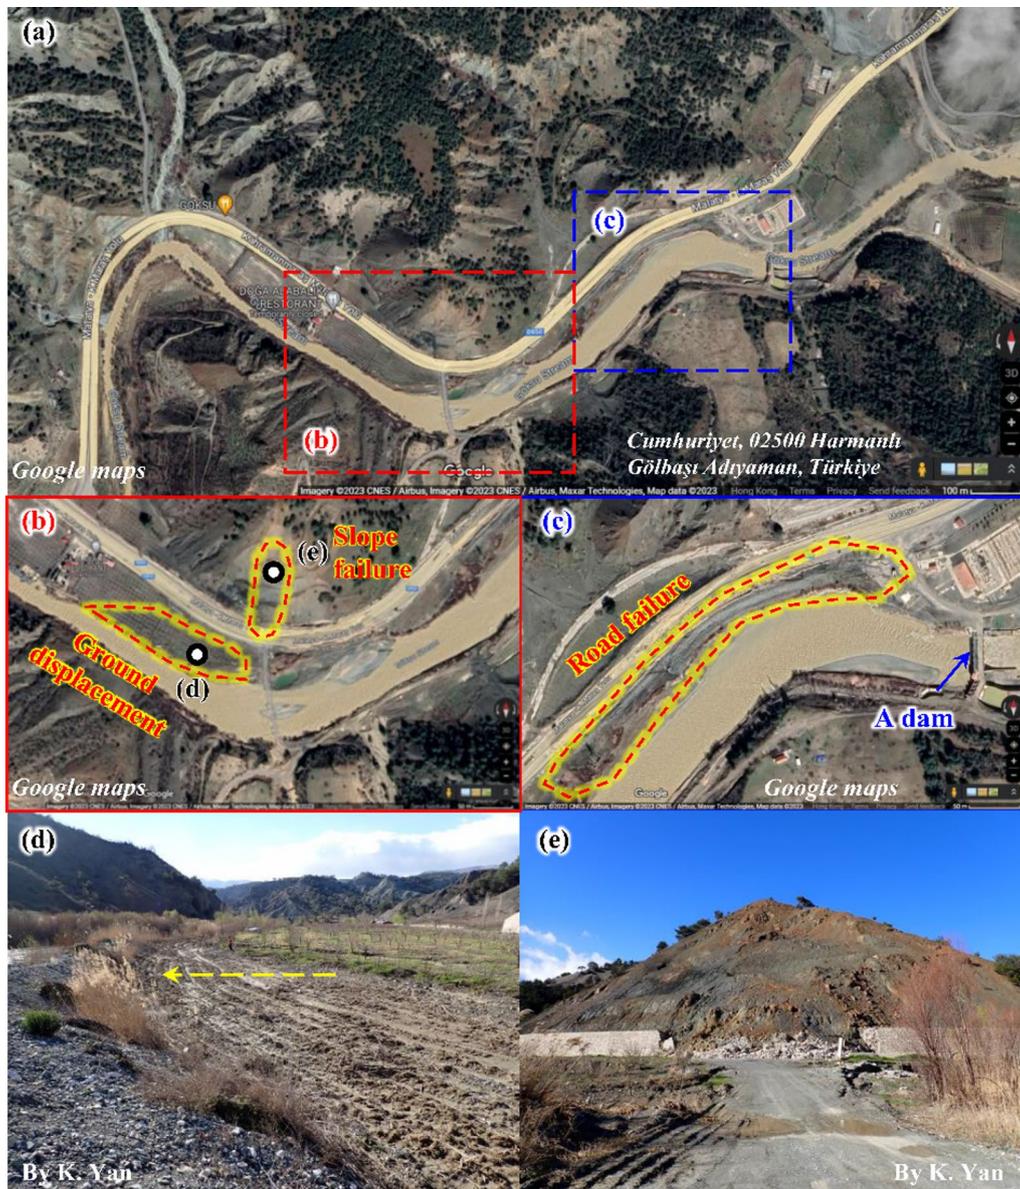
was much finer ( $d_{50}=0.07$  mm) compared to the other samples but well graded with a large uniformity coefficient of 7.38 ( $>5.0$ ) and a coefficient of curvature of 2.08 (ranging in 1.0–3.0), which represents it might be difficultly liquefied compare to the other poorly-graded sands. In this case, the liquefaction of S5 might represent the strong capacity of the Kahramanmaraş earthquakes on liquefaction in this region. Moreover, similar lateral spreading at riverside regions triggered slope failure, ground displacement and road collapse at a riverside

area close to a small dam at Cumhuriyet in Adryaman (Fig. 12).

**Fig. 12** Liquefaction-induced lateral spreading at Cumhuriyet in Adyaman (a), causing a riverside ground displacement (b & d) with a slope failure (b & e) and a road failure (c) along the river

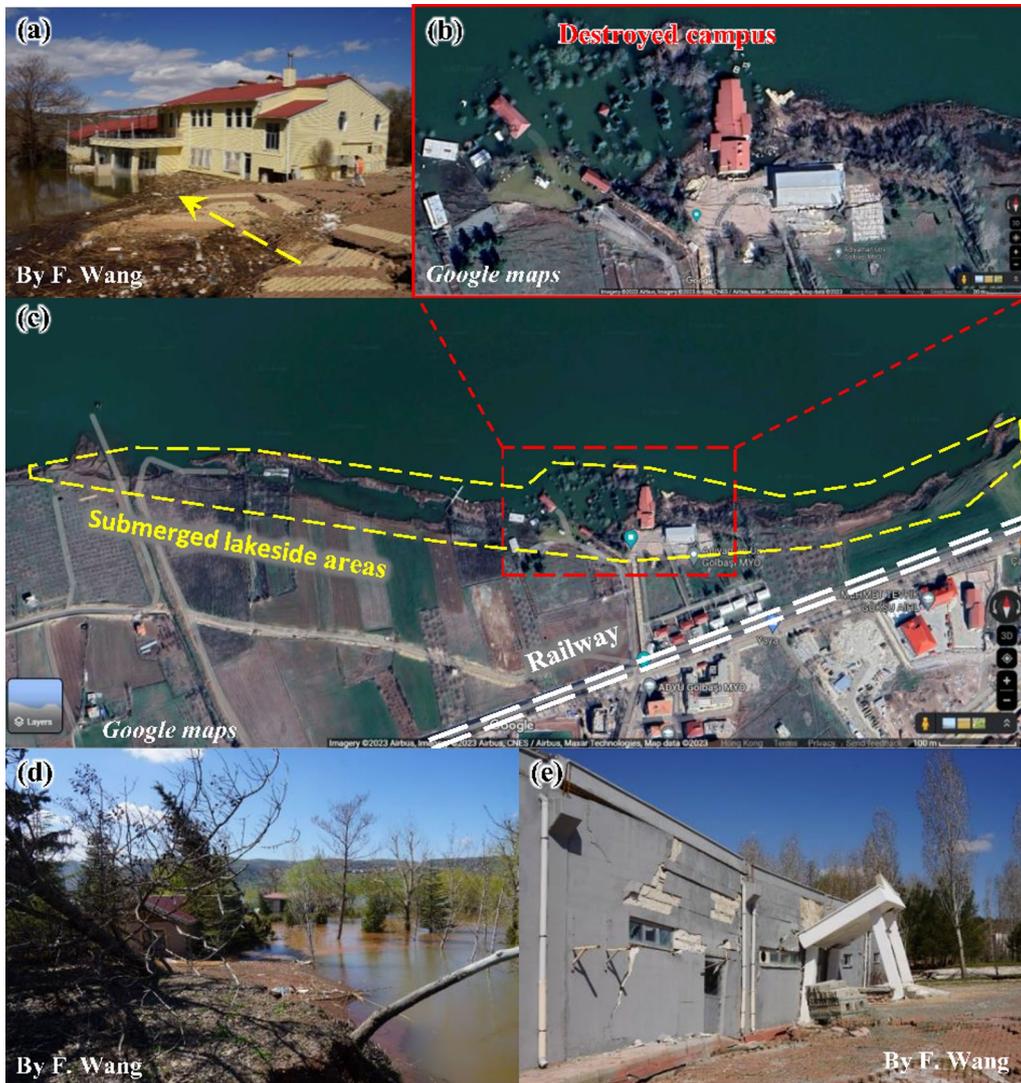
In the severely liquefied downtown of Golbasi, a lake-shore campus of the Adiyaman Üniversitesi Gölbaşı Meslek Yüksek Okulu located close to the Golbasi Lake was destroyed by the liquefaction-induced lateral spreading as shown in Fig. 13. In the campus, a large area of land with several buildings slid to the Golbasi Lake and caused the buildings submerged (Fig. 13a, d) and collapsed (Fig. 13e).

**Fig. 13** Liquefaction-induced lateral spreading at the lakeside area (c) of the Golbasi Lake, causing several buildings submerged (a, b & d) by the lake and damaged (e) by uneven subduction

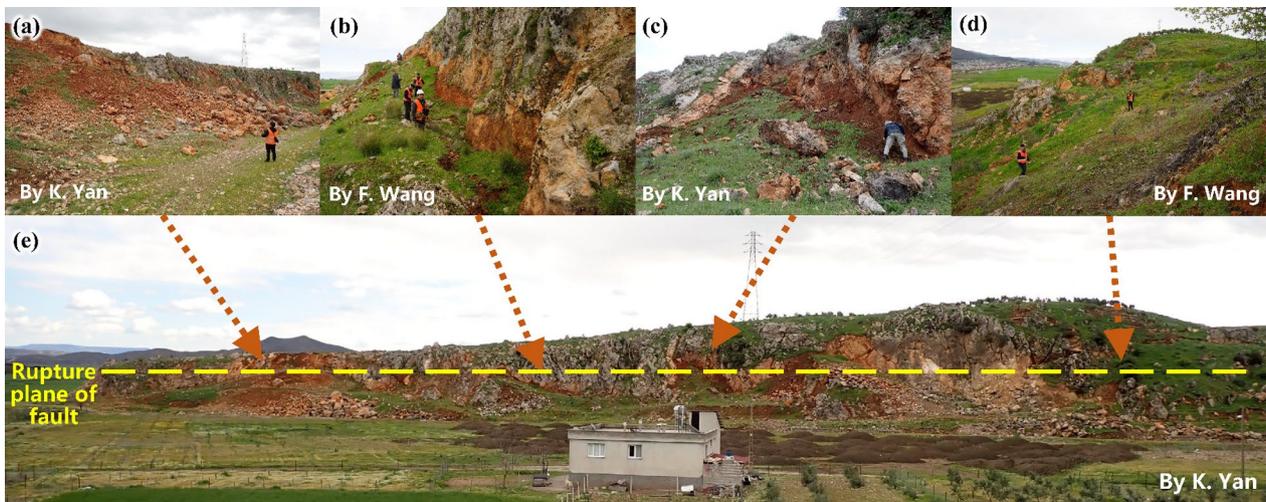
and identified in this field reconnaissance, as shown in Figs. 16 and 17. In particular, a group of slope failures occurred along the rupture zone of the fault at Yeni, Şekeroba, Türkoğlu in Kahramanmaraş Province, as shown in Fig. 16. Moreover, there were massive slope failures nearby the faults, including the Islahiye Landslide (Fig. 18) and Tepehan Landslide (Fig. 24). The Islahiye landslide was located in a formation consisting of dolomite and dolomitic limestone and was close to two fault segments. The Tepehan Landslide was due to a planar sliding of mudstone formation dipping with a gentle

**Fig. 16** Fault-triggered slope failures and collapses. **a-d** illustrate major features along the rupture plane **e** of fault

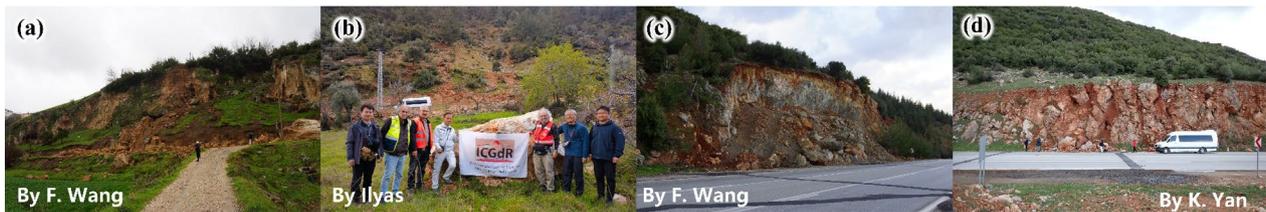
**Fig. 17** Slope collapses and rockfalls along the road at **a** Sakçagözü (37°10'35.6"N, 36°55'54.5"E), **b** Tiyek (36°48'20.9"N, 36°29'27.5"E), **c** & **d** Olucak (37°10'44.9"N, 36°42'36.3"E)

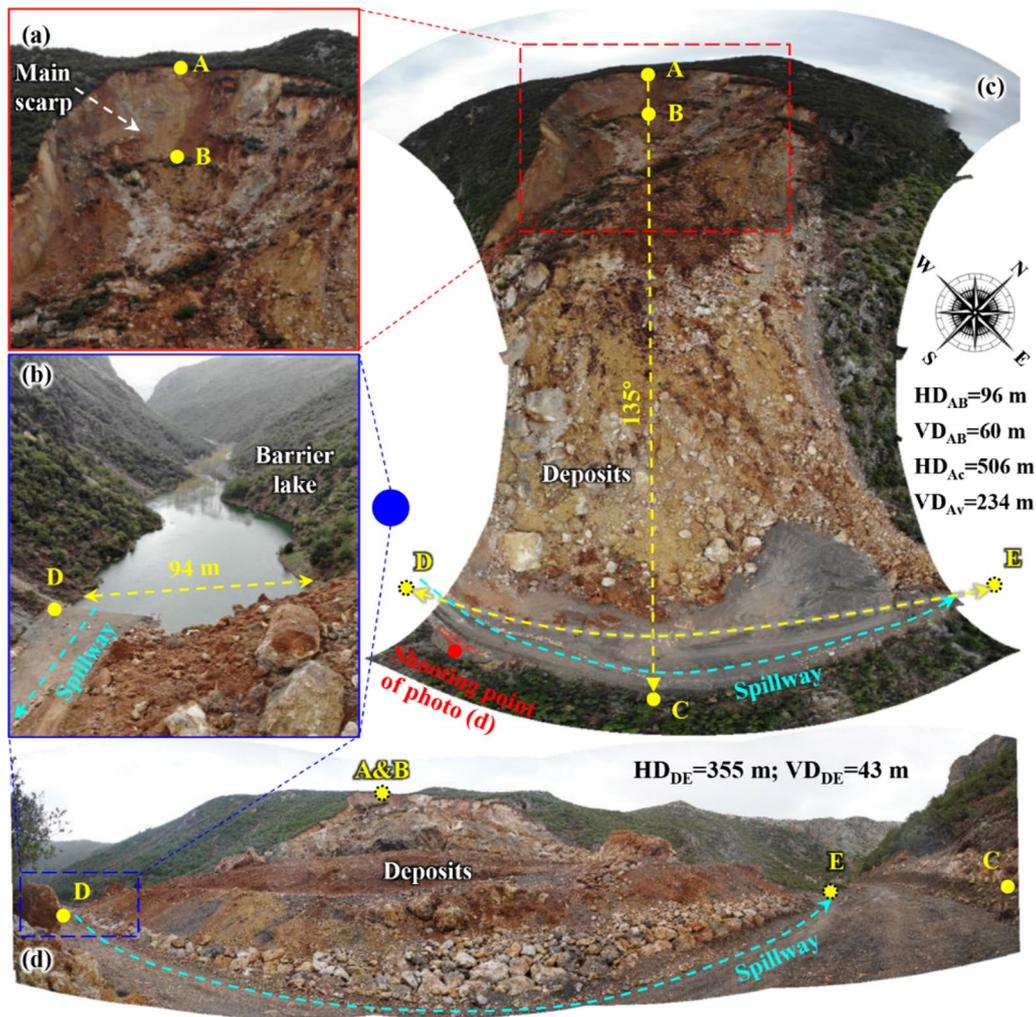
The Islahiye landslide, directing to 135° with an estimated slope of 35° as shown in Fig. 18, had a maximum horizontal runout of 506 m and a vertical drop of 234 m from scarp top (Point A) to the deposit front (Point C), forming a fan-shaped deposition with a maximum width of 355 m (D-E). The landslide, with an exposed main scarp of about 100 m high, occurred in a valley (Fig. 19) and formed a 94-m-wide barrier lake (Fig. 18b), interrupting the road from Idilli to Degirmencik. At toe of the debris deposition, a spillway of the barrier lake was constructed at about 20 m above the lake bottom (Fig. 18b, d).

**Fig. 18** Overview of the Islahiye landslide (based on UAV images by Miyajima). The main scarp (a) and barrier lake (b) are illustrated on the panoramas (c & d) of the landslide

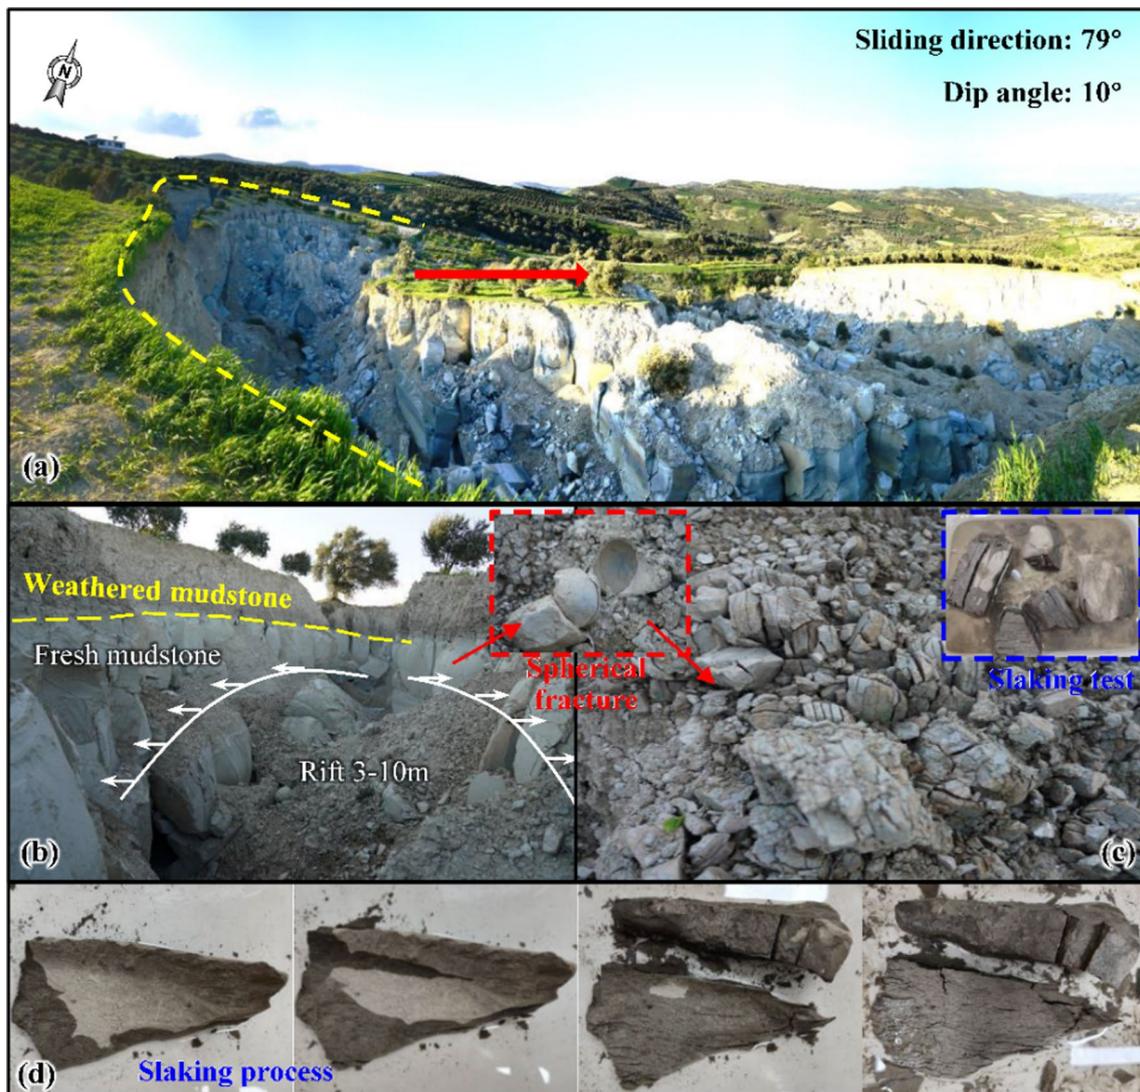
dip angle of 10°, as illustrated in Fig. 24. A field investigation in the source area (Fig. 24a, b) revealed that the sliding mass primarily consists of layered fresh mudstone and overlying soils. The mudstone easily disintegrated in the presence of water, as depicted in in-situ image (Fig. 24c) and a simplified slake test in Fig. 24d. In this instance,

**Fig. 24** Overview of source area (a) and main scarp (b) of the Tepehan Landslide and slaking progress (c & d) of the mudstone
