A successful case of emergency landslide response - the Sept. 2, 2014, Shanshucao landslide, Three Gorges Reservoir, China

Bolin Huang^{1*}, Wangjun Zheng², Zuzhan Yu² and Guangning Liu¹

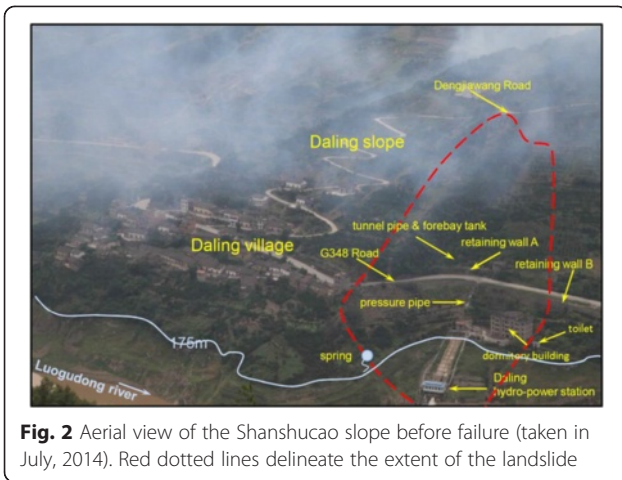
As shown in Fig. 2, National Road G348 passes the slope area. This is the nearest traffic artery connecting Yichang City to Shazhenxi Town and Badong County. More importantly, a small hydropower station named the Daling Hydropower Station was situated within the slope area. The Daling Hydropower Station was a diversion hydropower station with an installed capacity of 1,000 KW, and was built in 2008. The main buildings of the hydropower station lay the slope, along with a 5-storey dormitory, a 300 m² workshop, pressure pipes, and an impounding forebay. More than 20 people were resident at the hydropower station. Water used by the hydropower station was sourced from an upstream gully, and was derived from the Luogudong River. The water was delivered by tunnel pipelines, and flowed through the Daling slope before reaching the impounding forebay on the Shanshucao

Fig. 2 Aerial view of the Shanshucao slope before failure (taken in July, 2014). Red dotted lines delineate the extent of the landslide

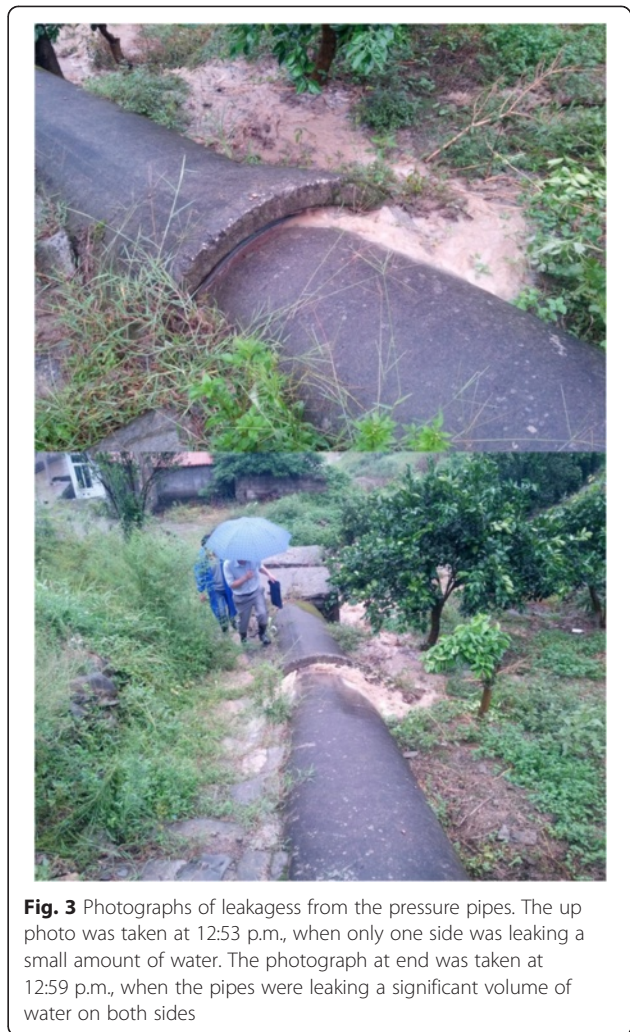
The forebay channels in the Daling Hydropower Station started to seep at about 9:00 a.m. on Sep. 2, 2014, and the pressure pipes cracked and leaked. However, no deformation was observed on the ground nearby at that time. The head of the hydropower station immediately contacted the chief engineer (one of the authors of this paper) of geological hazards in the Land and Resources Bureau of Zigui County to seek professional assistance, hoping the cause of the leakage could be established. At around 12:30 a.m., the chief engineer carried out an initial investigation of the channel seepage and pipe leakage, accompanied by officials from the Shazhenxi Government. During this investigation, the leakage increased abruptly, changing from seeping to jetting (Fig. 3). This change suggested that the pressure pipes had deformed more seriously, resulting in larger cracks. Meanwhile, a considerable volume of underground water flowed out in the upstream reaches, at an elevation of 180 m a.s.l. (the spring shown in Fig. 2), with a flow diameter of 12 cm, and a high flow rate. At this stage, no

Fig. 3 Photographs of leakages from the pressure pipes. The up photo was taken at 12:53 p.m., when only one side was leaking a small amount of water. The photograph at end was taken at 12:59 p.m., when the pipes were leaking a significant volume of water on both sides

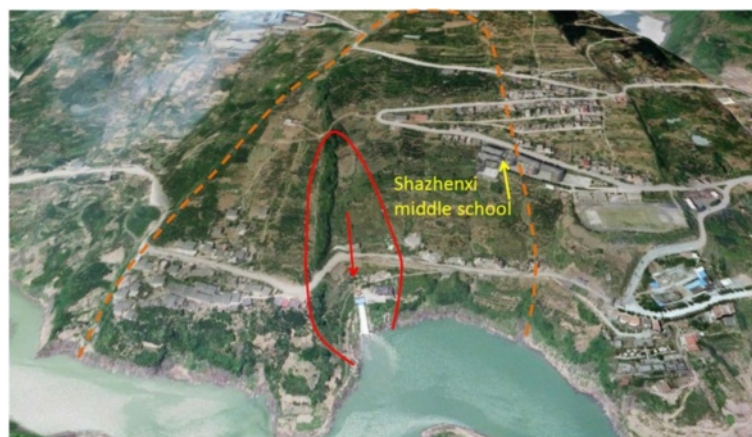
As instructed by the above emergency response plan, the Daling Hydropower Station staff, nearby residents, and the students and staff of Shazhenxi Middle School all evacuated promptly from the alert zone (Fig. 4). Thanks to the effectiveness of previous emergency evacuation drills in the case of geohazards, all 524 students and staff from the school had evacuated within 5 min. A total of over 950 persons had evacuated the classified alert zone within 15 min of the evacuation instruction being issued.

Fig. 4 Alert zones defined in the emergency response. The red lines delineate the actual extent of the landslide range, and the dotted orange lines delineate the alert zones before the collapse. No residents live on the opposite bank of the Luogudong River, and that hence that area is excluded from the alert zone

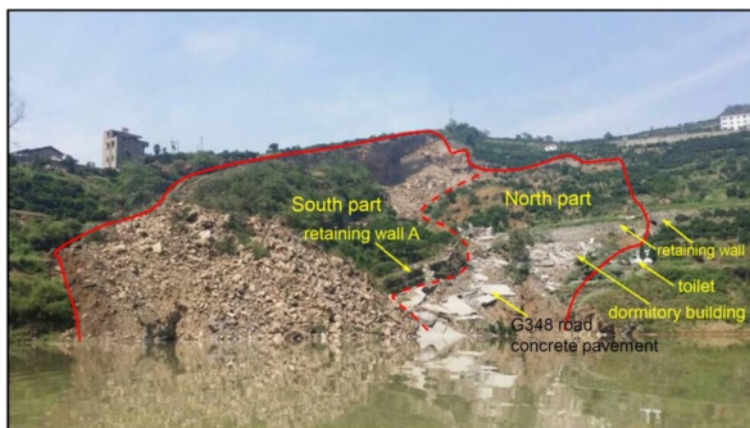
Figure 5 shows a panoramic view of the Shanshucao slope after the collapse. The landslide had destroyed the entire Daling Hydropower Station, including three buildings and workshops, along with various pipelines. The forebay, powerhouse, and the transmission and supply equipment were all destroyed or buried. National Road G348 was cut, and a 200 m long segment destroyed, along with a 450 m length of village and town roads. A 20 *hectares* citrus orchard was damaged to varying extent, of which 4.05 *hectares* were completely destroyed. The supply lines of 3 power supply sub-stations were damaged, 27 utility poles were destroyed, and some

Fig. 5 Panoramic view of the Shanshucao slope after failure (taken on Sept. 4). No remnants of the hydropower station can be seen in the ruins

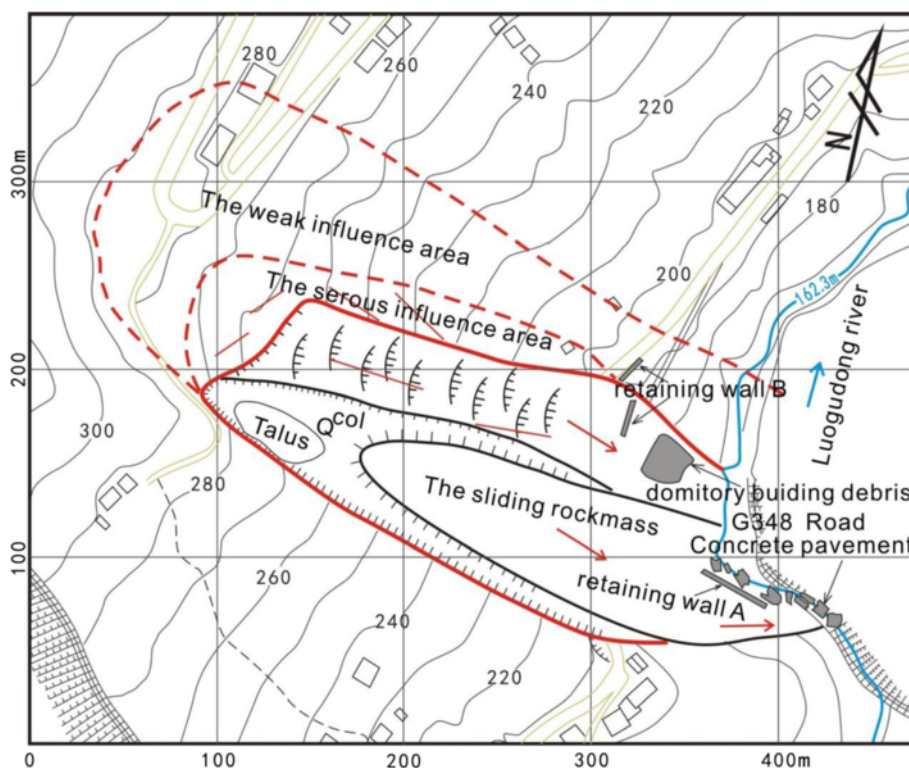
into the Luogudong River. The elevation of the water level on the day of the landslide was 162.3 m a.s.l. The area of the bedrock slide zone was 15,500 m², and that of the soil mass slide zone 9,300 m², giving a total area of the landslide of almost 25,000 m². The form of the landslide was tongue-shaped, with a length of about 350 m and width of 80–120 m (Fig. 6). The soil mass slide zone had a thickness of 1–10 m, averaging 5 m. Based on the height

Fig. 6 Sketch map of the Shanshucao landslide. Toothed lines are the landslide cliff, the red lines are major cracks, and the dashed red lines are the range of the influence area

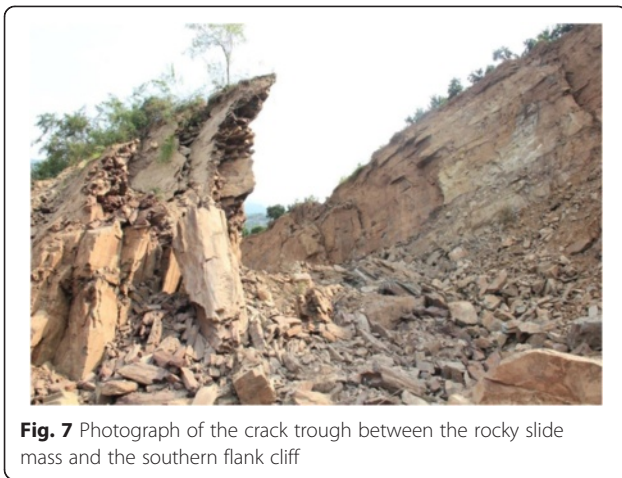
Fig. 7 Photograph of the crack trough between the rocky slide mass and the southern flank cliff

The slide of the rocky mass caused the formation of tension cracks around the rocky slide mass (Fig. 7). The width of the southern flank crack is about 12–23 m, with a length of 260 m, and is approximately U-shaped. A large number of rock blocks accumulated in its bottom part. The tension crack between the rocky slide mass and the soil mass is V-shaped, and has an average width of 1–3 m (Fig. 8). According to presence of G348 road debris and the position of the crown crack, the sliding distance of the rocky mass was about 117 m. The sliding distance of the soil mass decreases as it extends to the north. On the northern boundary of the landslide, retaining wall B was cut into two parts, with a horizontal displacement of 11.9 m, and a vertical displacement of 3.5 m (Fig. 6).

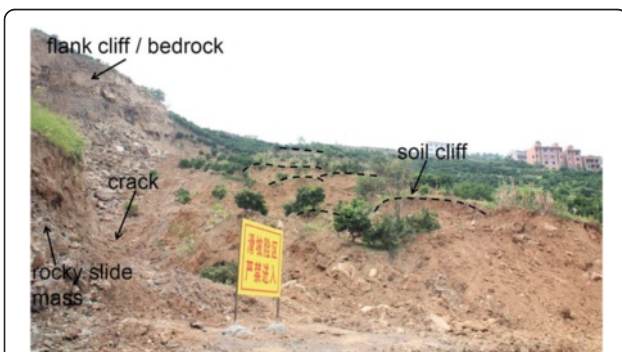
Fig. 8 Photograph of the crack trough between the rocky slide mass and the northern slide mass, and the soil slide cliff created by the soil mass slide

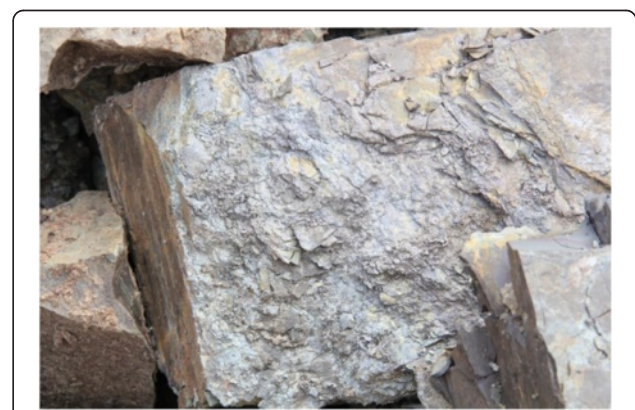
Fig. 9 Photograph of the silty mudstone of the potential slide surface

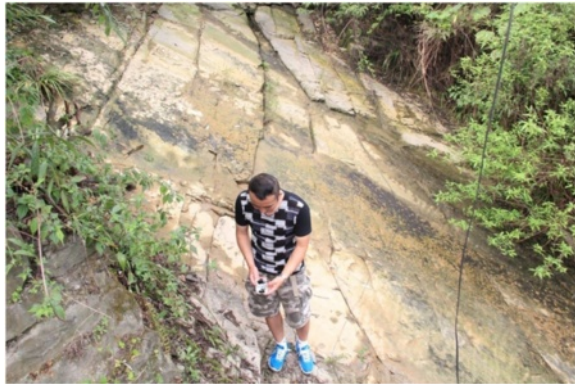
The general sliding direction of the Shanshucao landslide was about 105°. Because of the blockage of ridge, the direction of the rocky slide mass shifted from 105° to 75° around the zone of the foot (Fig. 10). According to the observed

The rocky sliding mass exhibits the representative characteristics of translational slide, such as an intact slide mass and wide tension cracks. The structure interbedded soft and hard layers is also prone to translational sliding. The soil cliff and the reduction of sliding distance in the soil mass part of the slide shows that the soil mass was drawn to slide by the lateral traction of the rocky sliding mass. The translational slide of the rocky mass led the lateral soil mass to rotationally slide on the surface of rupture. According to subsequent detailed surveys, the lithology of the rocky sliding zone was brittle and thinly-bedded silty mudstone, which is also very smooth to the touch (Fig. 9). The surface of the rupture of the soil mass is sandstone, which also crops out immediately adjacent to the landslide (Fig. 10).

Fig. 10 Weathered surface of the preexisting sandstone layer, 20 m from the northern boundary of the landslide

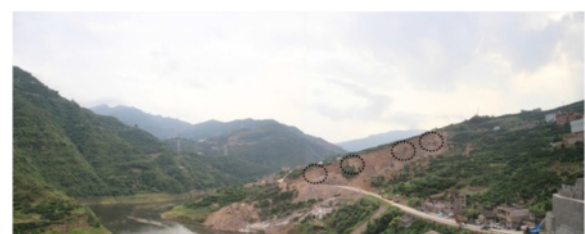
Fig. 13 Lateral view of the Shanshucaao Landslide (taken on Sep. 12, 2014). The cliff is the northern flank cliff of the landslide. Black dotted lines are damaged parts of the rock bridge (fresh exposures)
