Geotechnical damage in the 2018 Sulawesi earthquake, Indonesia

Abstract

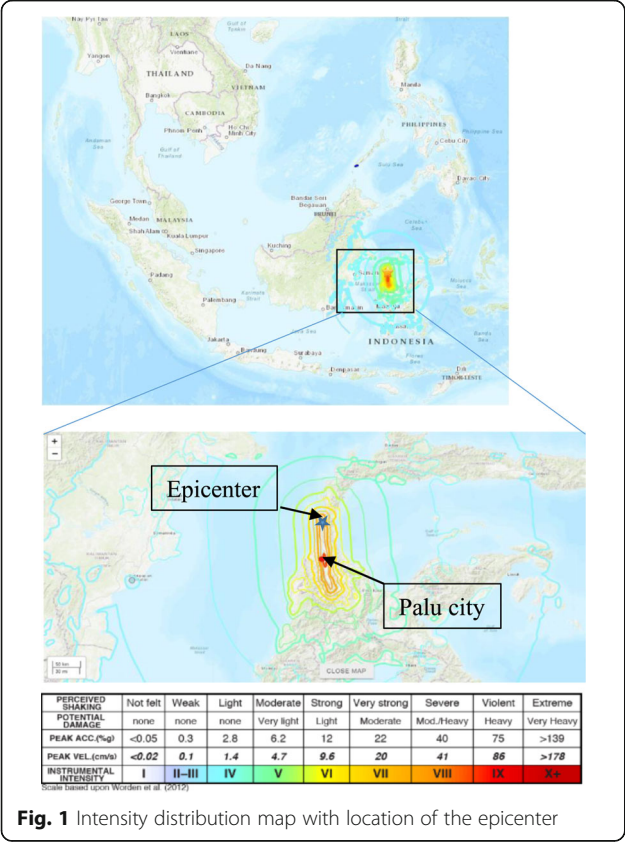
Fig. 1 Intensity distribution map with location of the epicenter

On September 28th, 2018, at 18:02 local time (10:02 UTC), a strong earthquake of magnitude $M_w = 7.5$ struck Central Sulawesi Province, Indonesia. Figure 1 shows the location of the epicenter. The epicenter was located at 0.256° south latitude and 119.846° east longitude, around 77 km from Palu city, and 20 km below the ground surface. This event was preceded by several foreshocks, the largest recorded as $M_w = 6.1$ and occurred at 14:59 local time (06:59 UTC), 3 hours earlier of the main shock. Figure 1 also shows MMI estimated by USGS. According to this figure, MMI=IX is estimated at Palu city and higher intensity is along the estimated fault line (see Fig. 3). The casualties were approximately 2256 persons, more than 1000 persons missing, and around

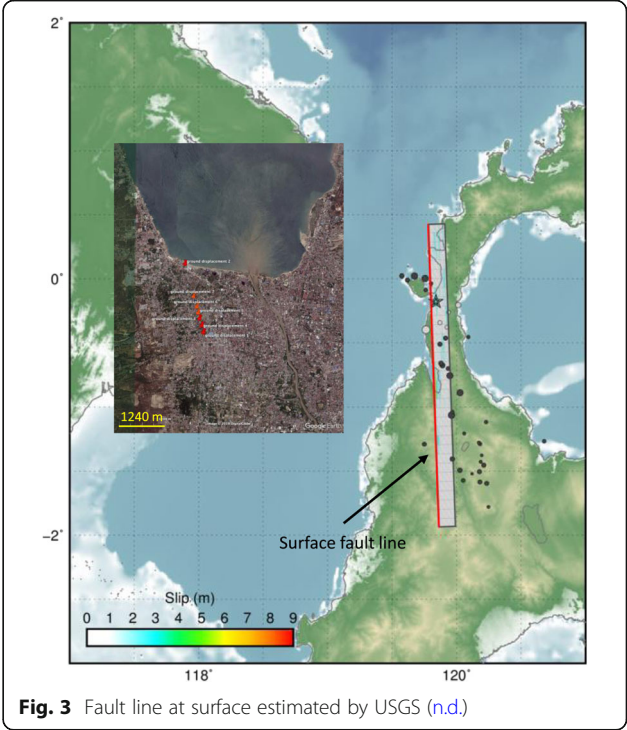
found in Palu city. These large ground displacements agree with the fault movement of left lateral slip. Figure 3 shows the fault line at surface estimated by USGS (n.d.). The epicenters of aftershocks were also indicated in this figure. The legend in this figure indicates the estimated

slip of the fault itself by USGS. According to this figure, the locations of large ground displacements appeared at surface coincide well with the estimated fault line. Therefore, the large ground displacements seem to be induced by the fault movement.

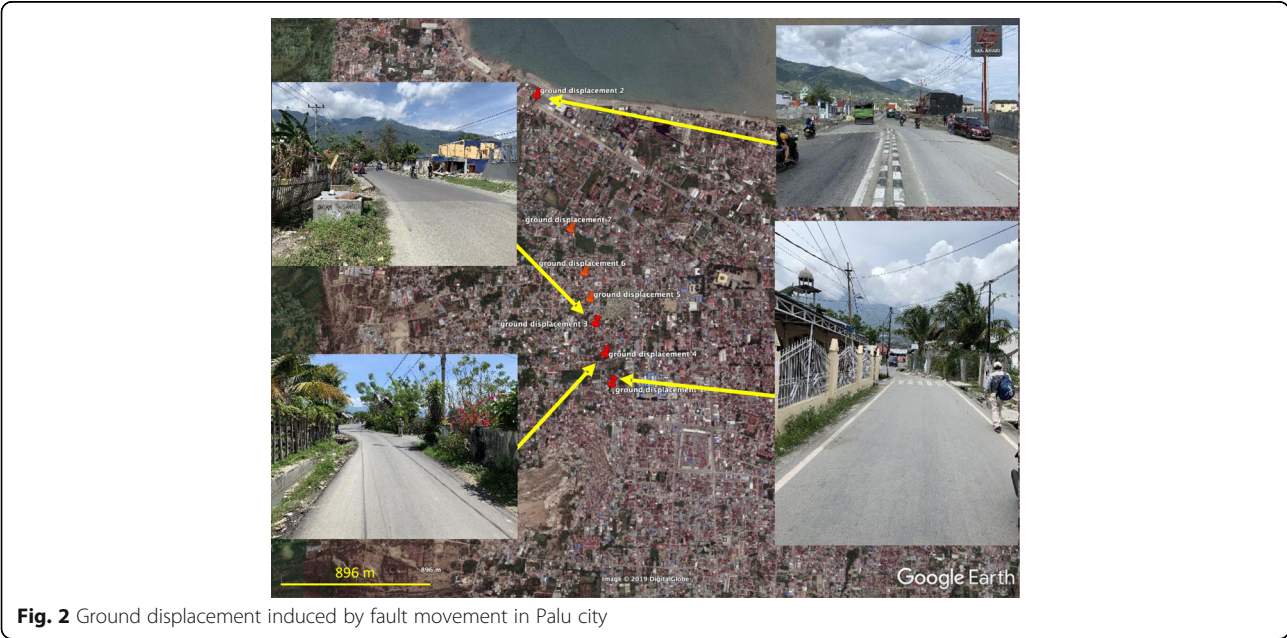
Figures 4, 5, 6 and 7 show the ground displacement triggered by the fault movement in Pangeran Diponegoro, Cemara, Kedondong and Pipa Air, streets, respectively. Before the earthquake, these four roads were

Fig. 4 Large ground displacement of 2.7m at Pangeran Diponegoro street in Palu city

straight. After the earthquake, fault movement triggered the occurrence of lateral ground displacement and bent the four roads mentioned above. The horizontal displacements of the four roads are 2.7 m of Pangeran Diponegoro street, 3.8 m of Cemara street, 4.5 m of Kedondong street and 5.0 m of Pipa Air street, respectively.

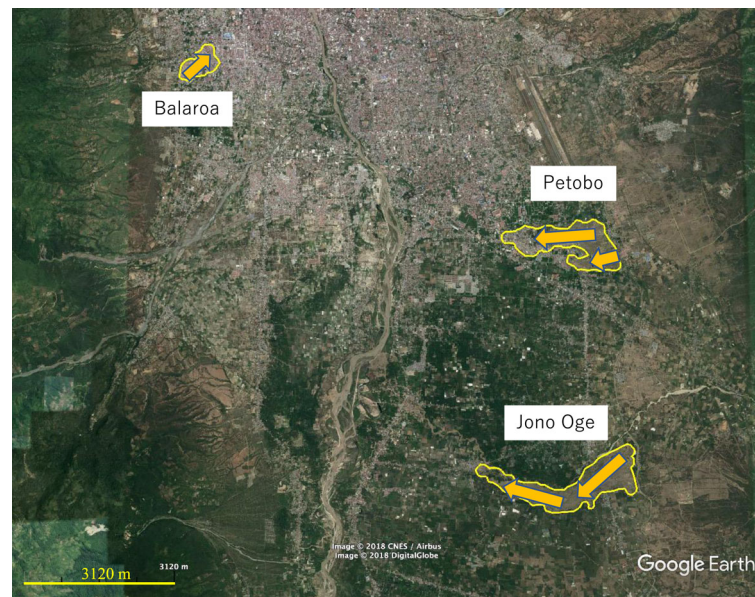
The earthquake triggered large-scale ground flow in some different sites, such as Balaroa and Petobo districts in Palu city and Jono Oge and Sibalaya Villages. The locations large ground flow of Balaroa and Petobo districts in Palu city and Jono Oge village, and the direction of the ground flow are illustrated in Fig. 8 by using Google Earth. Table 1 lists the areas and average slopes before the earthquake of each site of large ground flow estimated by using a function of Google Earth. A satellite photograph of Sibalaya village after the earthquake could not be obtained, so the area of large ground flow cannot be estimated. Average ground slope of Sibalaya village

Fig. 8 Locations of large ground flow of Balaroa and Petobo districts in Palu city and Jono Oge village and the direction of the ground flow

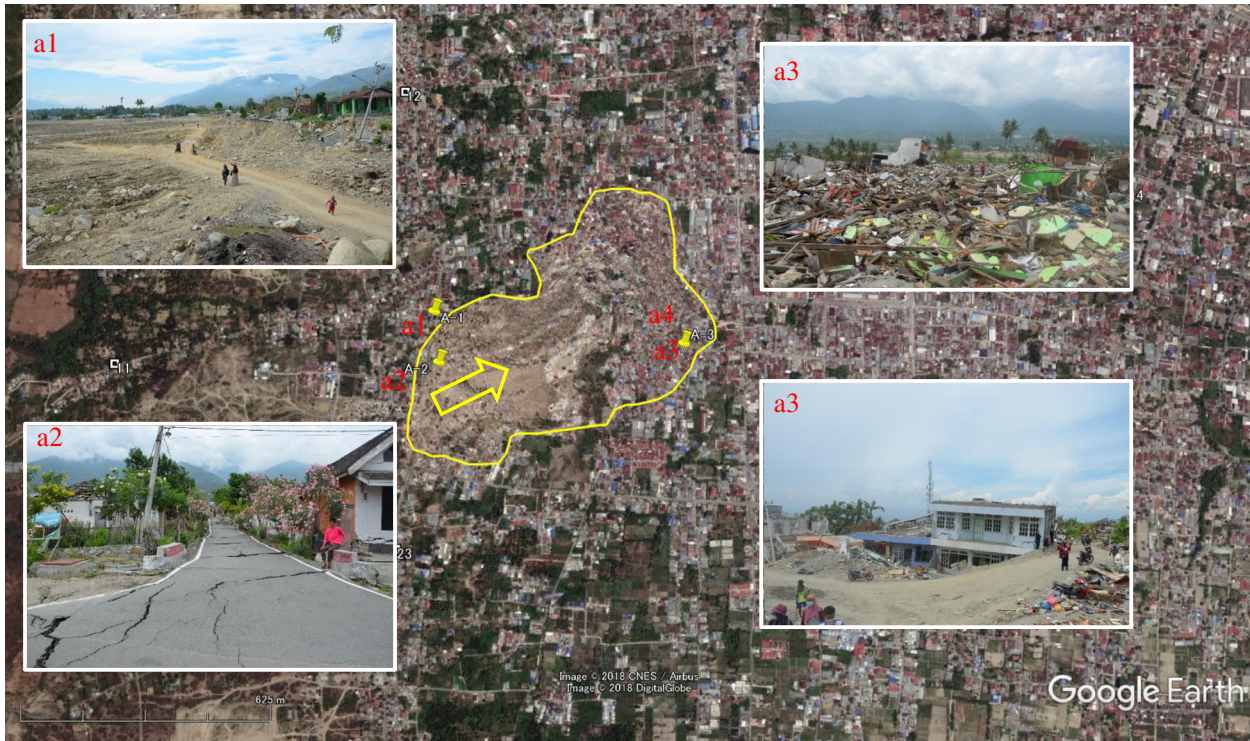
Figure 9 shows a satellite photograph by Google Earth and some photographs of damage in Balaroa district in Palu city. The direction of the large ground flow is shown by a yellow arrow in this figure. The ground flow occurred from south-west to north-east. Large ground settlements and large tension cracks appeared at the upper side of the flow and collapsed houses were piled up and many houses were buried in the flowed soil at the lower side. Balaroa district is a densely populated area. This district was reclaimed from a swamp in 1978

to 1979, then the district was used for residential houses from 1980. Therefore, the underground water level is high. Six hundred people were died of the more than 2000 inhabitants, while more are still missing. The area affected in Balaroa district was around 380,000m². Balaroa housing complex almost disappeared due to the ground flow. It is reported that around 1700 houses were buried due to lateral ground movement.

Fig. 9 Satellite photo by Google Earth and some photos of damage in Balaroa district in Palu city

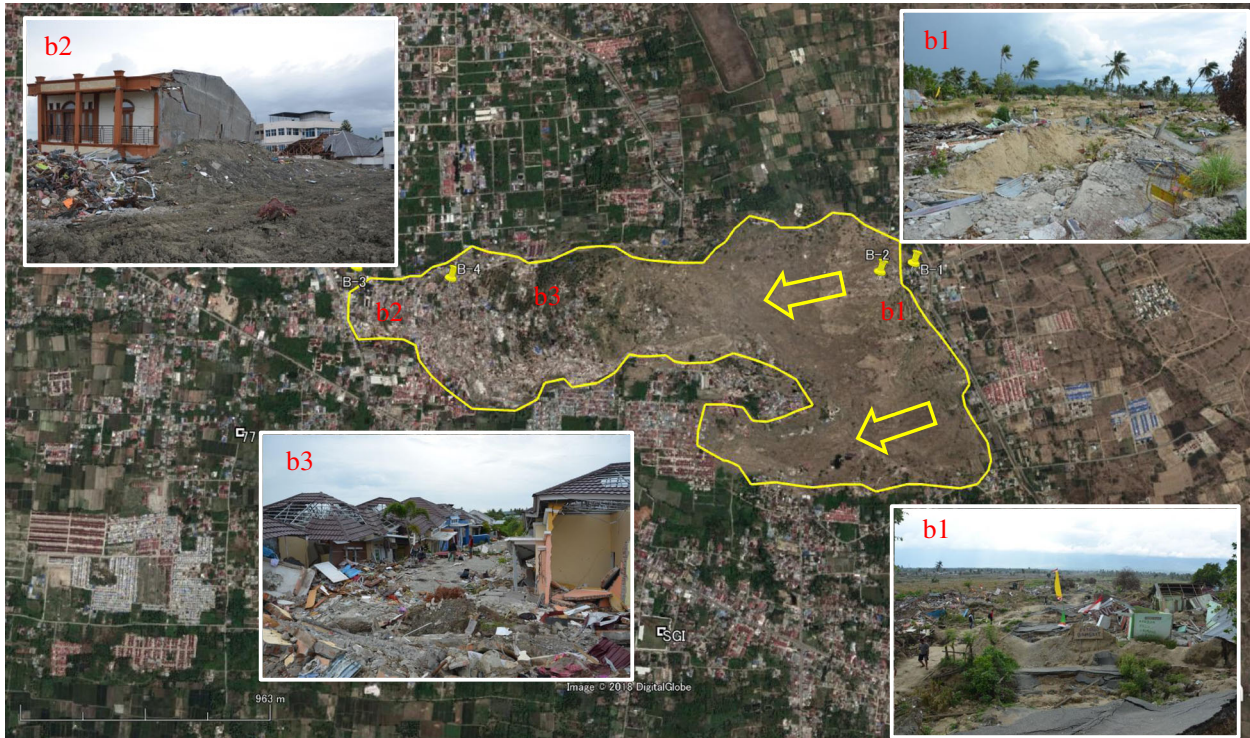
Figure 10 shows a satellite photograph by Google Earth and some photographs of damage in Petobo district in Palu city. The direction of the large scale ground flow is also shown by a yellow arrow in this figure. The ground flow occurred from east to west here. The affected area was used for residential houses before the event. Similar to Balaroa district, more than 700 houses were severely destroyed by the ground flow and hundreds of people died here. The area affected in Petobo district was much larger than Balaroa, which is around 150,000m².

Fig. 10 Satellite photo by Google Earth and some photos of damage in Petobo district in Palu city

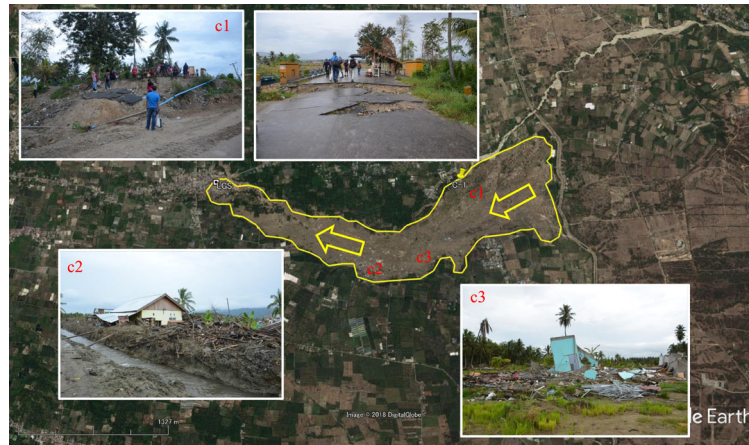
Figure 11 shows a satellite photograph by Google Earth and some photographs of damage in Jono Oge village. The direction of the large scale ground flow is also shown by a yellow arrow in this figure. The ground flow occurred from east to west. Lateral ground flow occurred as well with the affected area around 180,000m² in Jono Oge village. Most of this area was used for rice field before the event. In this area, at least 34 high school students who joined a bible camp were killed, but it is suspected that many others are dead.

Fig. 11 Satellite photo by Google Earth and some photos of damage in Jono Oge village

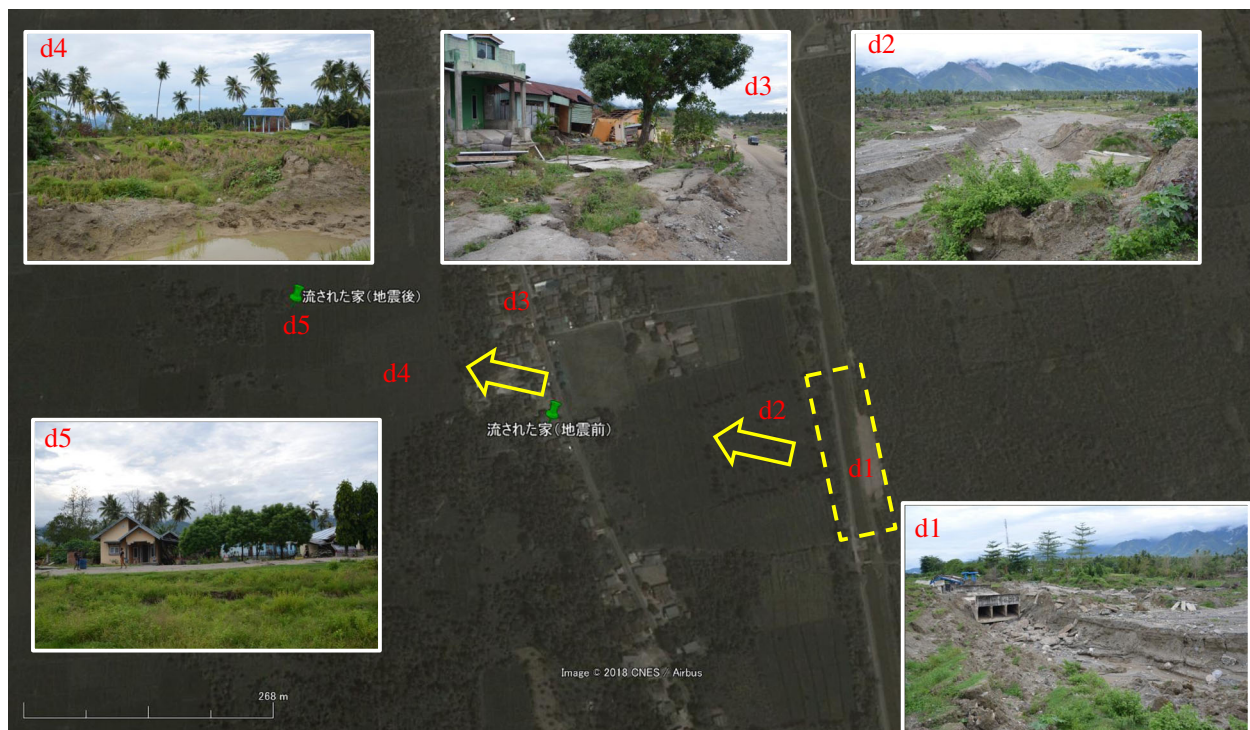
Figure 12 shows a satellite photograph by Google Earth before the earthquake and some photographs of damage in Sibalaya village. The direction of the large scale ground flow is also shown by a yellow arrow in this figure. Sibalaya village is located about 40 km south of Palu city. A satellite photograph of Sibalaya village after the earthquake could not be obtained yet. Most of this area was also used for rice field before the event. In this area, only three people were dead due to building collapse. Figure 13 shows the photograph of Sibalaya village taken by a drone after the event. The road and houses moved laterally up to about 350 m. Figure 14 shows the same house before and after the event. What made this phenomenon extraordinary is that the moving road and some houses only experienced minor damage. The mechanism of the large ground flow should be clarified in near future.

Fig. 12 Satellite photo by Google Earth and some photos of damage in Sibalaya village

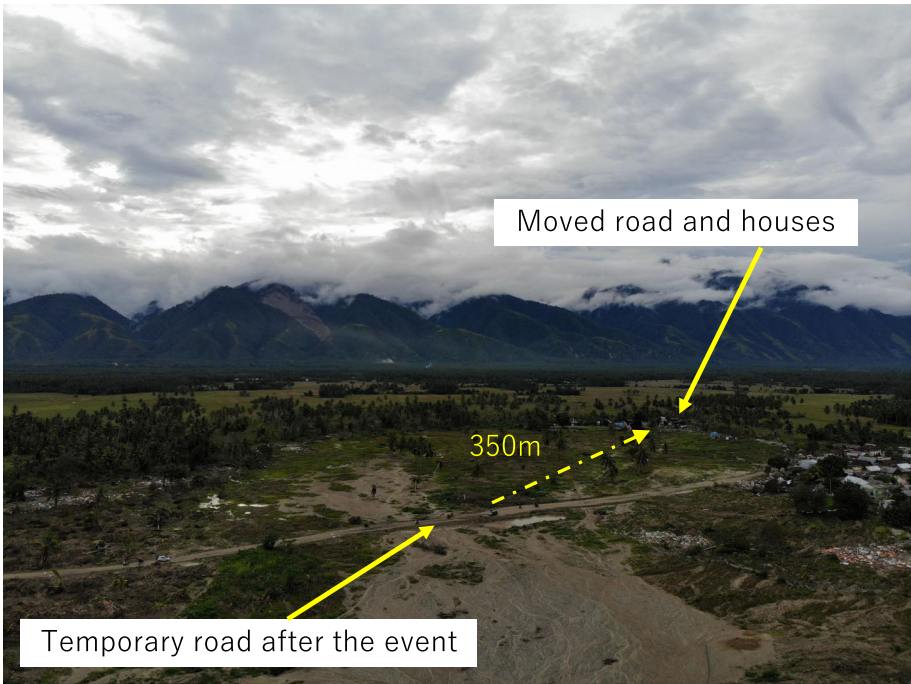
Fig. 13 Photo of Sibalaya village taken by a drone after Earthquake

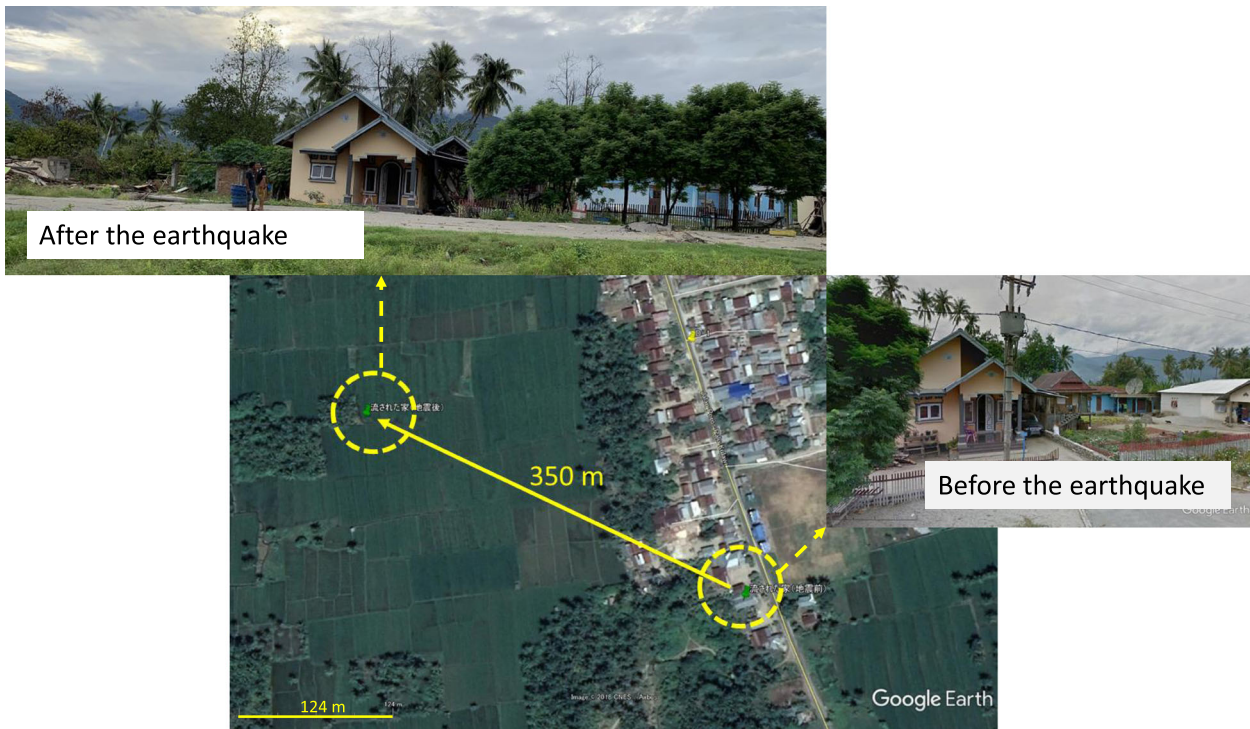
Fig. 14 Location of the moved house in Sibalaya village
