Landslide impacts and management in Nanka area, Southeast Nigeria

Abstract

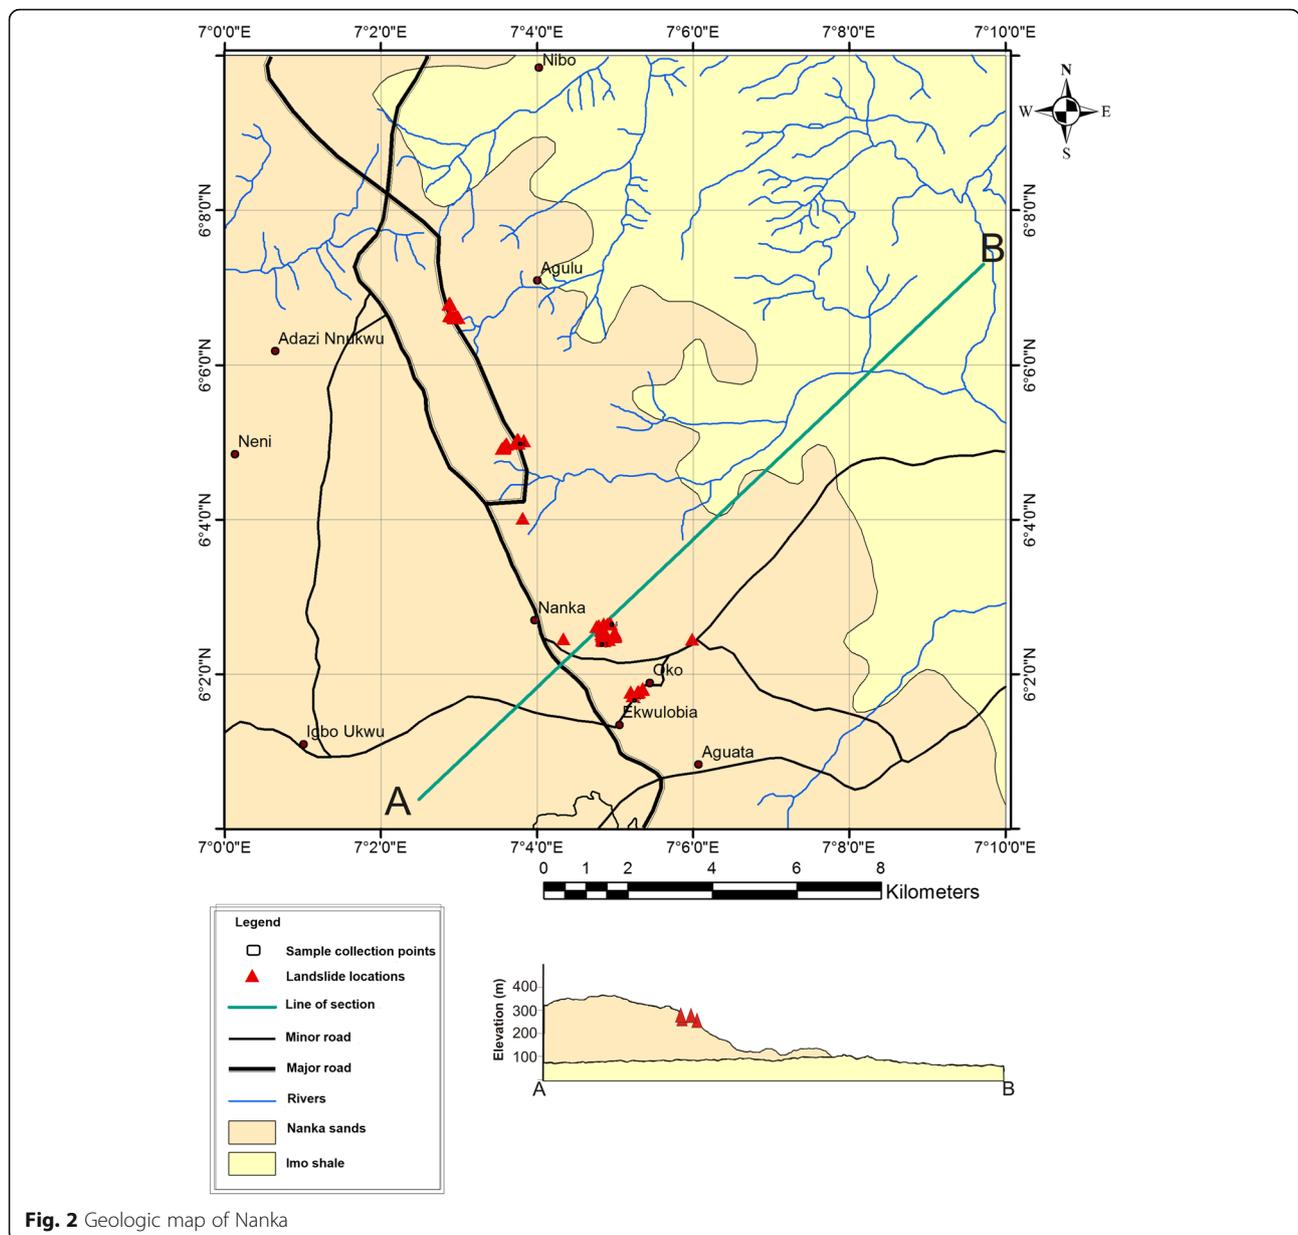
Fig. 2 Geologic map of Nanka

The study area is part of the Campanian to Eocene Anambra basin, which was formed as a result of compressive movement along the Northeast – Southwest axis of the Aptian - Santonian Abakaliki basin. This tectonic activity resulted in the folding and uplift of the Abakaliki basin into an anticlinorium and formed the Anambra basin on the Southwest and Afikpo syncline on the Southeast. This enforced the depocenter to move to the recently formed Anambra Basin and the Afikpo syncline (Murat 1972; Benkhelil 1989; Kogbe 1989; Oboh-Ikuenobe et al., 2005 and Nwachukwu et al. 2011). The Nanka Formation (Early Eocene) which is underlain by Imo Shale (Paleocene) is the main exposed Formation in the study area (Nwajide 1980).

Nanka Formation consist of unconsolidated or poorly consolidated sands with thin claystone and siltstone bands. The sand is poorly-sorted, cross-bedded and medium to coarse grained with variegated colour; yellow to brown, pink to purple to iron stained on weathered surface and white to milky white on fresh surfaces (Fig. 2). The Clay/Shale beds are dark grey to grey with specks of mica, pyrite and gypsum in some places. Sandstone consists of quartz arenites with predominantly

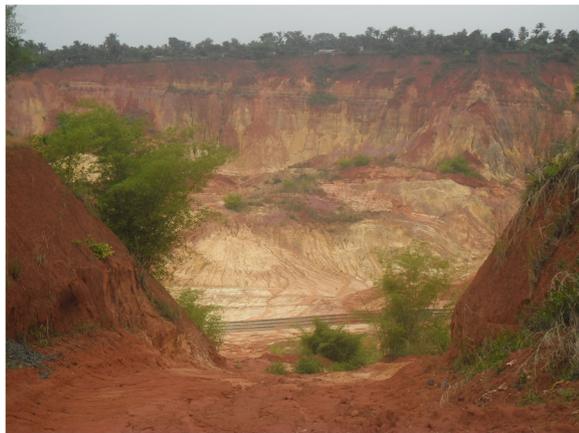
Fig. 5 Nanka complex gully erosion

Most of the landslides in Nanka are shallow translational debris slides, slumps and occasional debris topples (Fig. 5). Landslide depths in this area ranges from 0.2–1.8 m, with average depth of 0.74 m. Okagbue (1992) stated that topples (rotational falling) occasionally occur in the area. The impermeable clay beds separating the lower sand horizon acts as gliding plane for several large slumps (Ogbukagu 1976; Okagbue 1986). Many of the slumps are known to occur within the near homogeneous soil overburden (Okagbue, 1992).

Landslides have impacted Nanka area negatively in various forms and dimensions, but we will focus on the morphology of the land area, settlement region, agriculture and land cover. Generally, Nanka has an undulating topography/morphology ranging from gently sloping lowlands to slightly steep highlands. Morphologically, Nanka keeps evolving due to the effects of landslides and erosion. Gullies are widespread in Southeast Nigeria, but Nanka gully complex is the most outstanding in terms of extent and natural destruction (Okagbue 1992). The complex gullies have high slope angles ranging from 36° - 65° based on field measurements, though in some inaccessible areas, the slope angles were estimated to be between 70 ° and 80 °. The depth of the gullies are over

110 m in some places with a width of over 500 m based on field estimations. Landslides occur along the gully slopes especially during the rainy season, regular slides along the slopes persistently increase the width of the gullies and modify the morphology of the area. Yalcin (2007) reported that earth's surface is continually being modified by gravitational mass movements, particularly landslides. The surface of the earth, both on the continents and beneath the oceans is incessantly modified by internal forces and the forces of gravity (landslides). The net morphologic effect of landslides is to reduce slopes to angles at which they possess long-term stability (Schuster and Highland 2003).

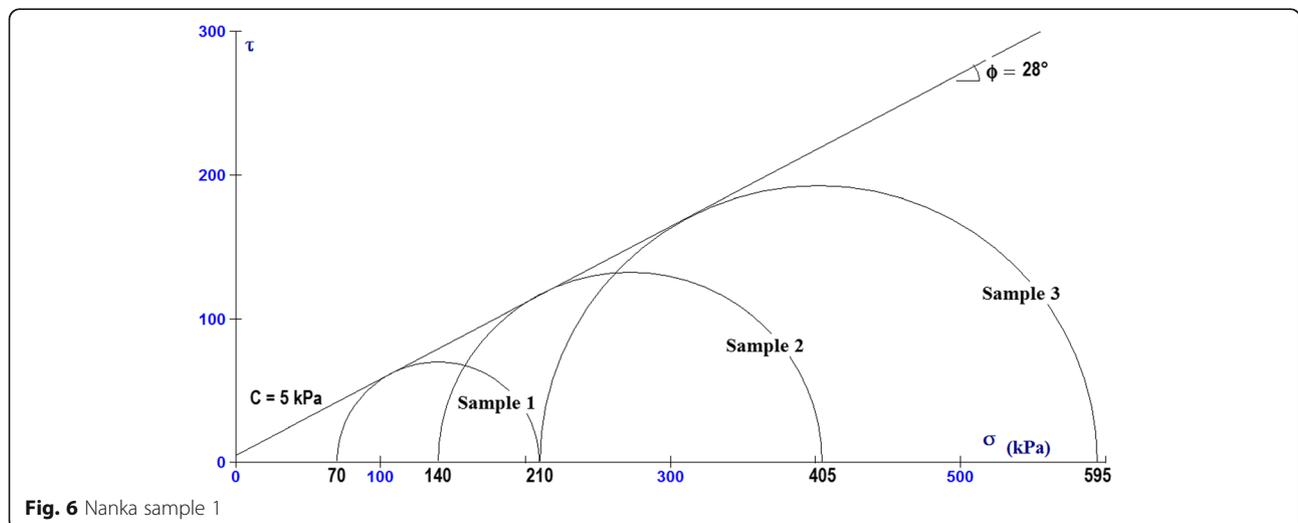
Fig. 6 Nanka sample 1

Results of geotechnical characteristics of the slope materials (Table 1) showed that samples 1, 2 and 3 are medium-fine clayey sand materials while sample 4 is greyish silty clay. The average range of coefficient of permeability of samples 1, 2 and 3 is 1.11×10^{-6} - 1.47×10^{-6} , while sample 4 is 9.51×10^{-8} m/sec. The very low permeability to impermeable silty clay units that separates the sand units in the area have been identified to be the gliding plane for several landslides in the area (Okagbue 1992). The average range of the angle of internal friction and cohesion of samples 1, 2 and 3 are (28° - 30°) and (5 kPa - 8 kPa) respectively (Figs. 6, 7, 8), while sample 4 is 8° and 43 kPa respectively (Fig. 9). Samples 1, 2 and 3 are non-plastic, but have average liquid limits (LL) range of 23–26. Also, the liquid limits (LL), plastic limits (PL) and plasticity index (PI) of sample 4 are 75, 36 and 39 respectively. Sowers and Sowers (1970) reported that $PI > 31$ should be considered high and indicates high content of expansive clay while Bell (2007) classified clays with Liquid Limit (LL) range of 70–90 as very high plasticity. This could explain why the clays in this area serve as gliding plane to several landslides.

Sample number	Cohesion (kPa)	Angle of internal friction (°)	Coefficient of permeability (m/sec)	Liquid Limit	Plastic Limit	Plasticity Index	Grain size
Nanka Sample 1	5	28	1.11×10^{-6}	24	Np	Np	Clayey Sand
Nanka Sample 2	6	29	1.47×10^{-6}	23	Np	Np	Clayey Sand
Nanka Sample 3	8	30	1.28×10^{-6}	26	Np	Np	Clayey Sand
Nanka Sample 4	43	8	9.51×10^{-8}	75	36	39	Silty Clay

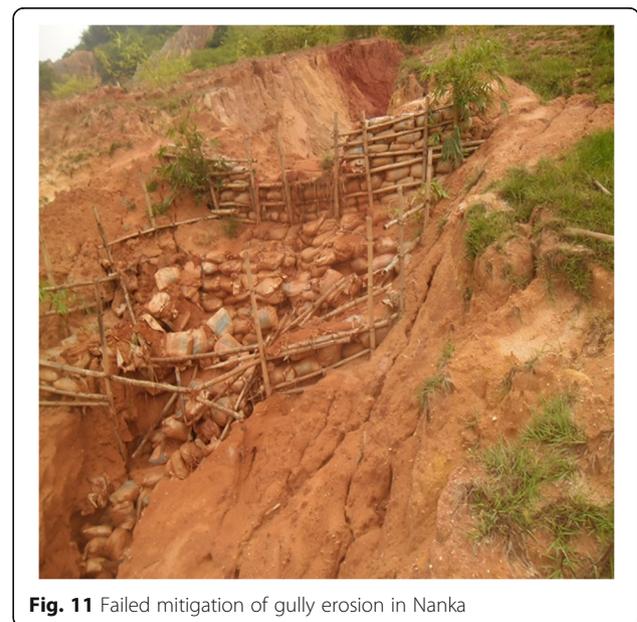
Fig. 12 Nanka simulation at slope angle of 40°

We decided to make the slope material parameters constant for the three simulations and vary the slope angles, this is to help us understand the relationship between slope angle and landslide dimensions, and to reveal the safety map of the slope with colour map and factor of safety range. The simulations revealed that as the slope angle increases, the potential slip mass volume increases (Figs. 12, 13, 14). This could be because of slope height and slope base length obtainable in this area. This means that areas with higher slope angles will possibly have more potential mass volume. Our simulations agree with our observations in the field and with two dimensional discrete element numerical simulations by Katz et al. (2014). The factor of safety ranges at different slope angles revealed slight differences. The factor of safety ranges at slope angles of 60°, 50° and 40° are 0.93–1.83, 0.95–1.85 and 0.97–1.87 respectively. This implies that areas with higher slope angles will fail before areas with smaller slope angles under similar conditions. This is in agreement that lowering of slope angles in a given area will make the slope more stable.

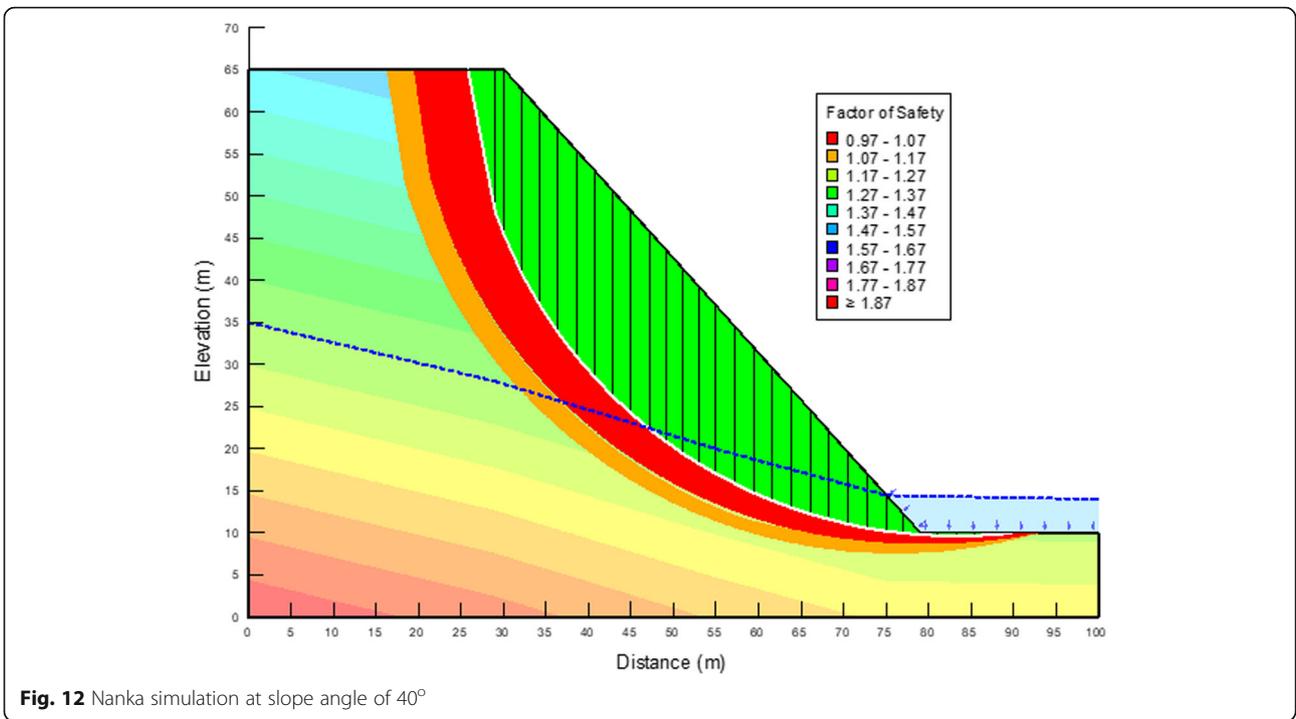
Most of the slope angles measured during the field studies ranged between 40° and 60°, therefore, our limit equilibrium simulations to model the slopes will have three representative slope angles (40°, 50° and 60°). The

slope material parameters needed for this simulation are cohesion, angle of internal friction, and unit weight based on the analysis type of the Morgenstern and Price (1965) limit equilibrium method. Morgenstern-Price is a general method of slices developed on the basis of limit equilibrium. It requires satisfying equilibrium of forces and moments acting on individual blocks.
