The distribution of soil morphological characteristics for landslide-impacted Sumbing Volcano, Central Java - Indonesia

Abstract

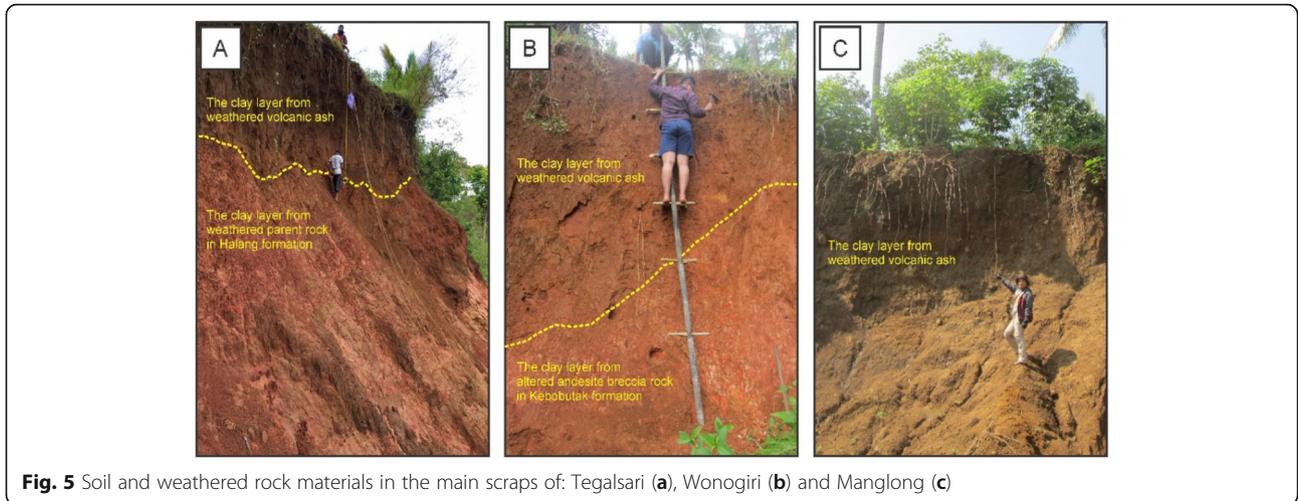
Escarpment of landslide showed soil profile and layers of soil material lying under. (Fig. 5). The term of soil profile is used to describe horizons which was formed through pedogenic process at up to 2 m depth (Schaeztl and Anderson, 2005), while layer terminology is used to describe the difference in soil material at the depth of more than 2 m (Sartohadi et al., 2018). Soil layers with high content of clay also found at the depth of more than 2 m in all landslide location under study (Table 4 column 6, S14-S16, S42, S61). The existence of soil material layers with high clay content has different origin: (1) at Tegalsari landslide location, it was formed as a result of deep

translocation of clay from layers lay over it, (2) at the Wonogiri landslide location, it came from base rocks after hydrothermal alteration in the past, (3) at the Manglong landslide location, it was formed from repeated formation process (polygenetic soil formation). Whether it is horizon Bt at less than 2 m depth or soil material layers at more than 2 m depth, both can act as landslide sliding plane in the wet conditions.

The soil horizons and soil material layers which are exposed to landslide fault escarpment describe the physical and chemical characteristics of soil particle that form them in various ways. Soil horizons are developed from parent soil of recent volcanic ash, while soil material layers are developed through different types of processes. Soil material layers in Tegalsari landslide were developed tuffaceous sandy rocks, while the one in Wonogiri was

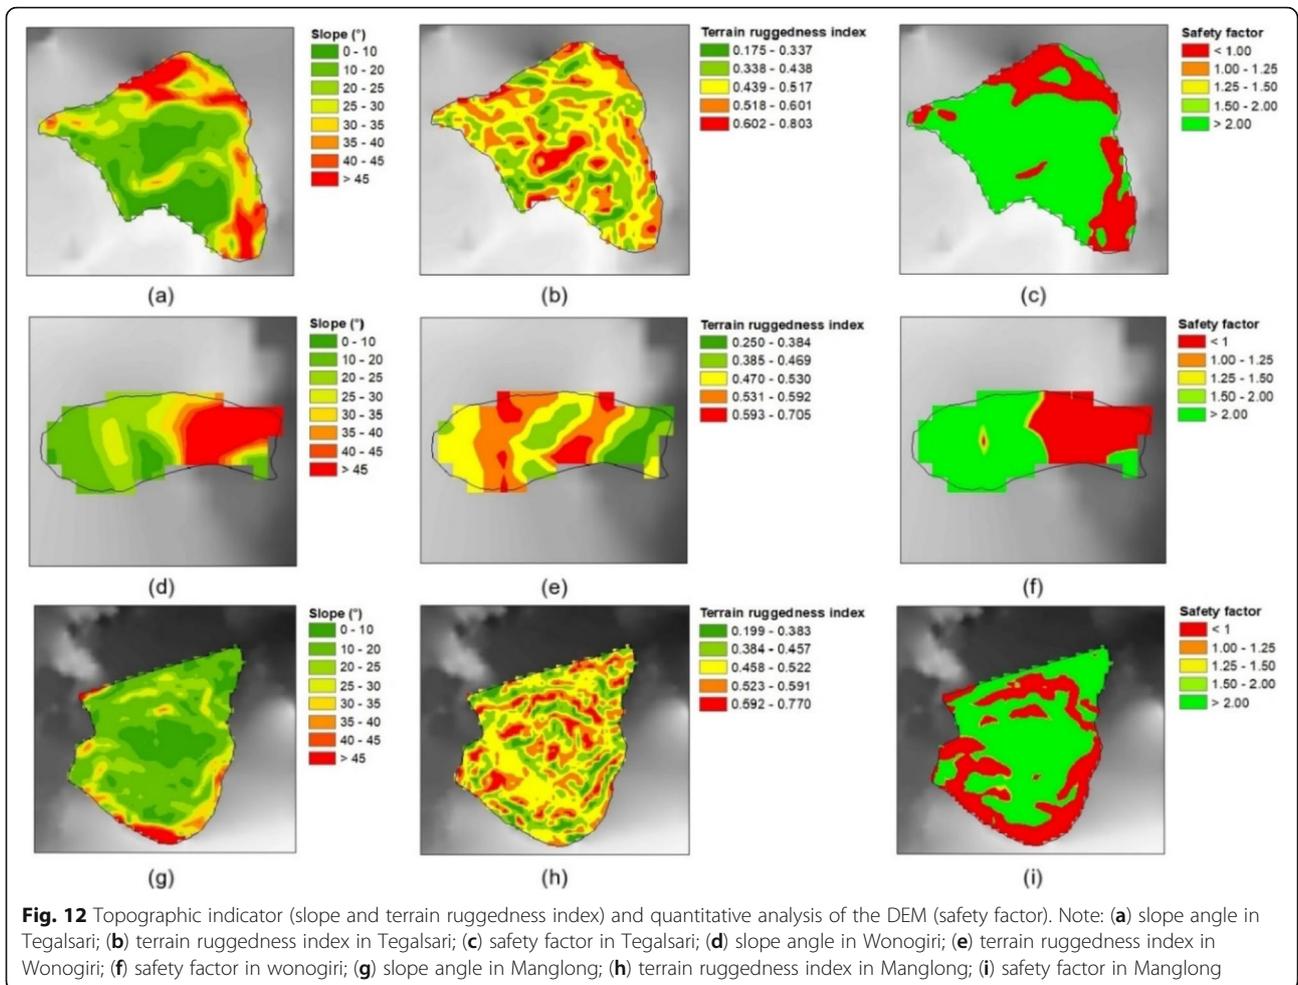
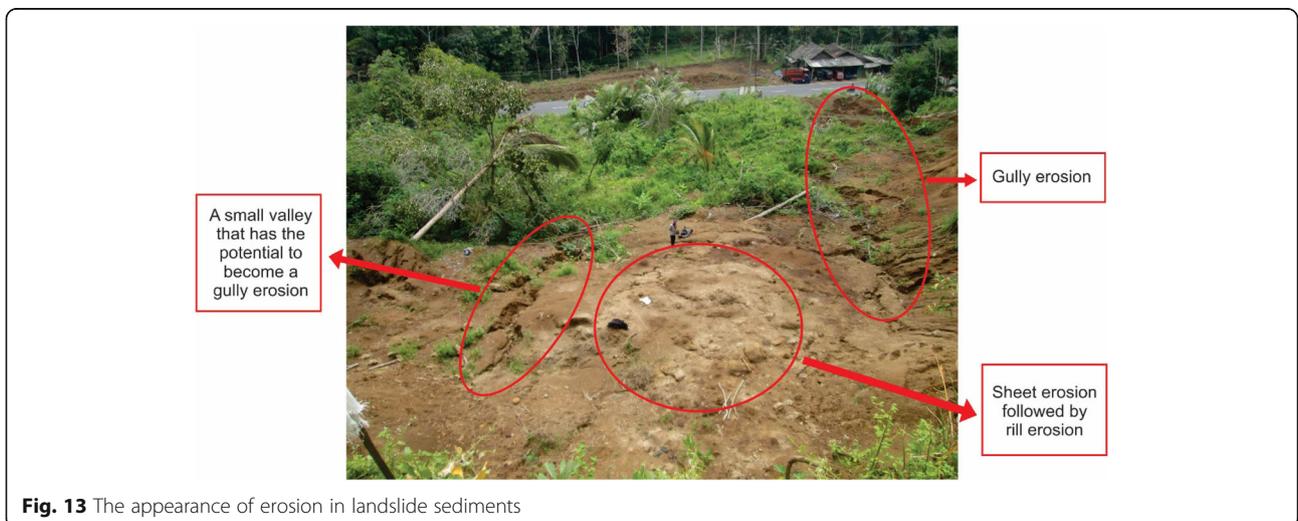
The change in soil morphology at the body of the landslide tends to form soil that sensitive towards erosion. The sensitivity is due to unstable soil structure (structure hardness degree is weak and soil penetration is less than 0.5). The change in soil surface morphology at the body of the landslide produced complex reliefs (Fig. 12b and h). There exist some parts with steep but short slope. Combination between soil morphology and soil surface morphology, added with position at escarpment and body of the landslide cause the plots formation of erosion become more intensive (Hassen and Bantider, 2020). Figure 13 shows example of the surface of the body of landslide in Manglong where many plots and trenches erosion can be seen. If it is not controlled, plots and trenches can initiate the process of landslide reactivation. It is supported by the observation of safety factor (Fig. 12c, f and i).
