Environmental and economic impact of cloudburst-triggered debris flows and flash floods in Uttarakhand Himalaya: a case study

Vishwambhar Prasad Sati* and Saurav Kumar

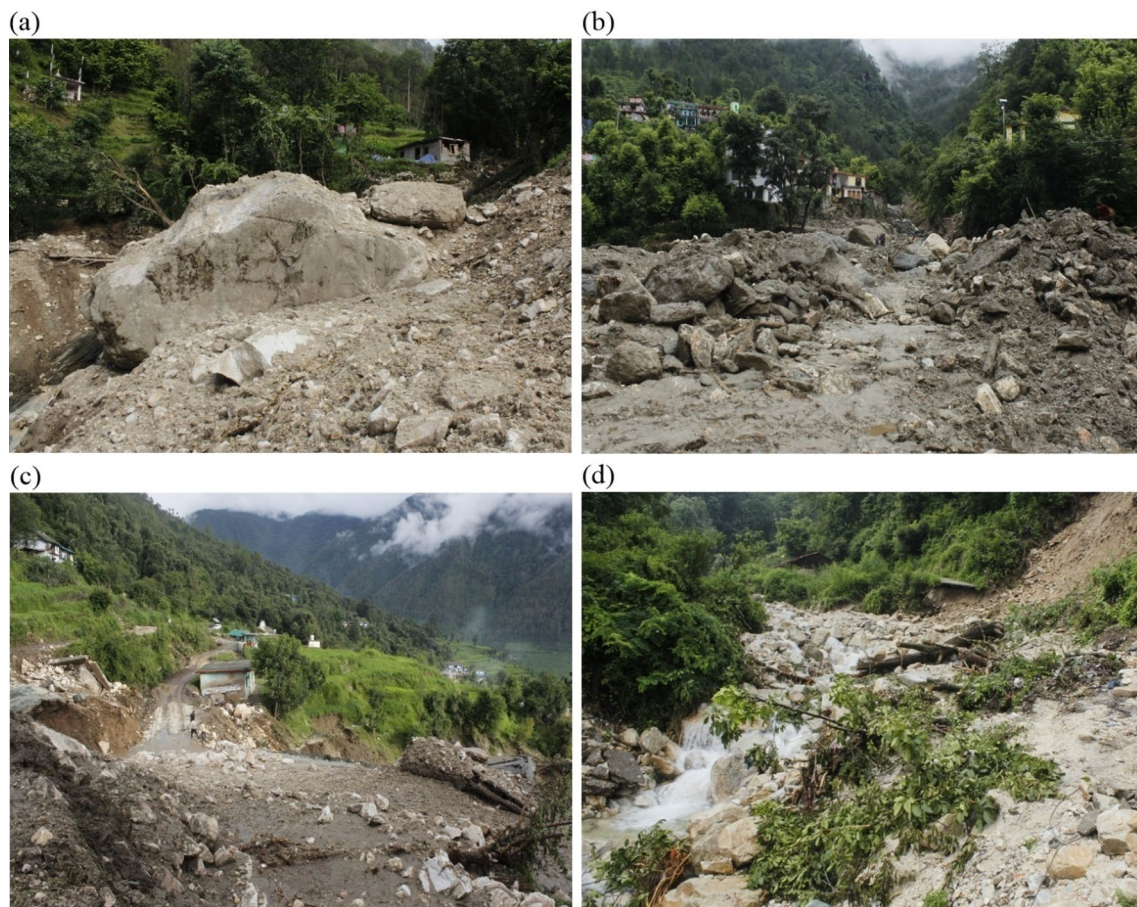
Figure 5 shows four villages—Nirakot, Mando, Kankrari, and Siror, which were severely affected by cloudburst-triggered debris flow and flash flood. The volume of debris and boulders can be seen in all the villages. These villages are surrounded by dense sub-tropical and temperate forests that vary from pine to mixed-oak and deodar. Kharif crops were growing in the arable land whereas a large cropland has been washed away.

Fig. 5 Cloudburst affected villages **a** Nirakot, **b** Mando, **c** Kankrari, **d** Siror; Photo: by authors
