A community-operated landslide early warning approach: Myanmar case study

Neil Dixon¹, Alister Smith^{1*} and Matthew Pietz²

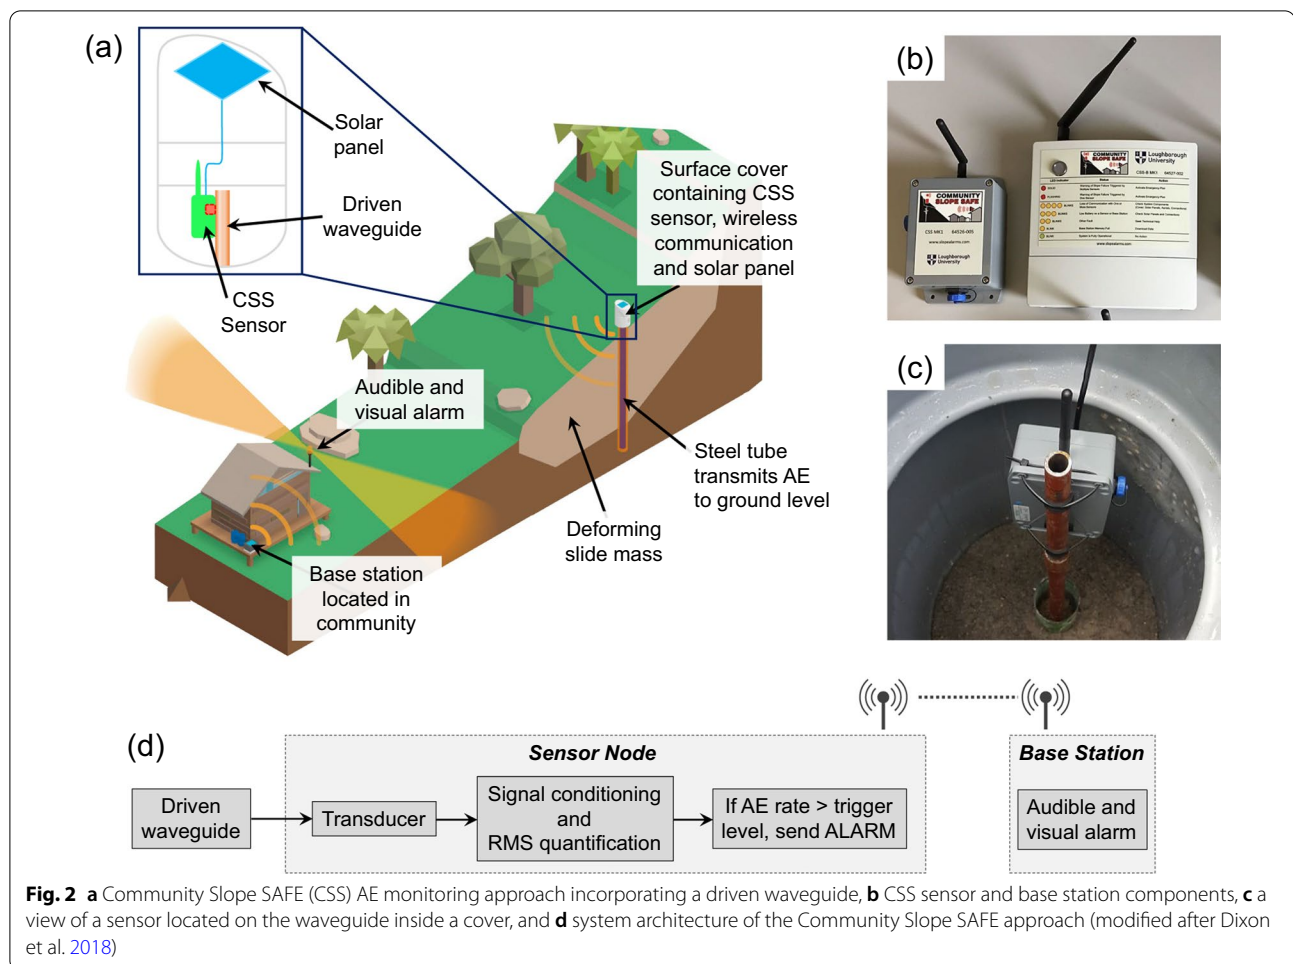
Fig. 2 **a** Community Slope SAFE (CSS) AE monitoring approach incorporating a driven waveguide, **b** CSS sensor and base station components, **c** a view of a sensor located on the waveguide inside a cover, and **d** system architecture of the Community Slope SAFE approach (modified after Dixon et al. 2018)

Figure 2 a) shows a schematic of the CSS system used in this trial, Fig. 2 d) details the main components and operating architecture, Fig. 2 b) shows photographs of the sensor and base station components and Fig. 2 c) shows the method of sensor connection on a waveguide. A full description of the CSS approach, including details of a laboratory study to validate operation of the system and interpret detected AE, is given by Dixon et al. (2018), with a summary provided below.

The AE sensor is attached to a steel tube waveguide driven into the slope (Fig. 2a, c). The waveguide both intercepts AE generated by soil deformation if the slope starts to move (it can also generate AE as the tube is

deformed as described below) and it also provides a low attenuation propagation pathway for AE produced in the slope to travel to the ground surface where they can be detected and quantified by the sensor. Use of driven waveguides simplifies the installation process by using readily available low-cost equipment (e.g., hand operated post rammers), and this also reduces costs, although the depths to which they can be driven depends on the strength and stiffness properties of the host soil. Installation of a waveguide by driving, results in the steel tube being in intimate contact with the in-situ ground forming the slope, which ensures it is sensitive to slope deformations by minimising AE transmission losses at the soil/tube boundary. ‘Noisy’ material is placed inside the waveguide as proposed by Nakajima et al. (1991) such that as the tube is deformed, straining of the infill also generate AE. Sand is an ideal material to use as the ‘noisy’ infill material as it is cheap and universally available, and it was used in this study. The CSS system comprises the following functions (Fig. 2 d):

- Conversion of AE (i.e., stress waves) propagating along the waveguide to voltages using a piezoelectric transducer
- Signal amplification and filtering to remove noise at both low (<15 kHz) and high (>40 kHz) frequencies that can be generated by the electronics and/or environment
- calculation of the signal RMS (root mean square, a measure of signal energy)

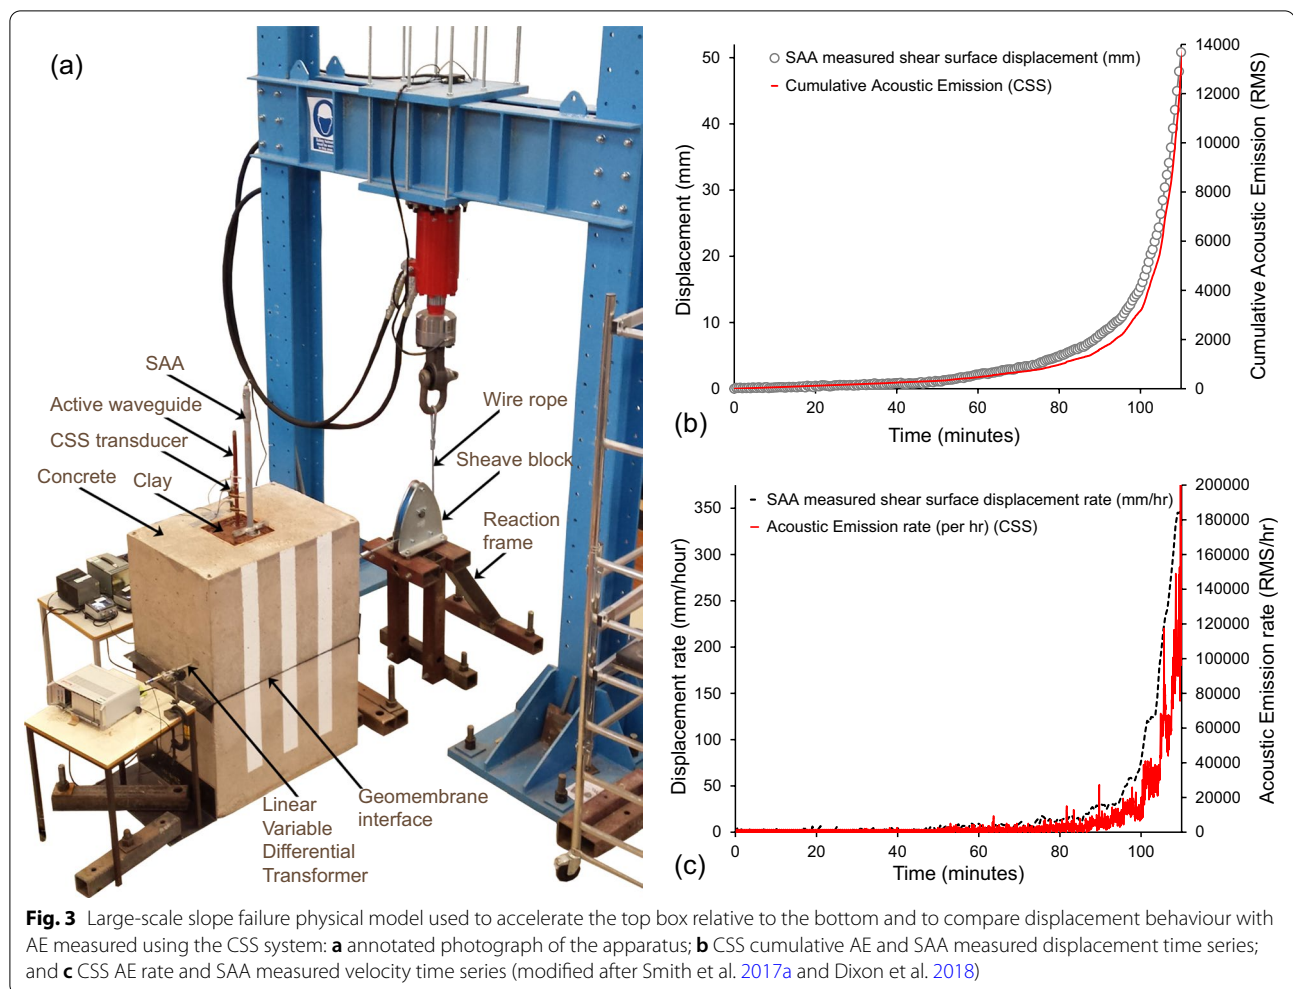
Series of physical model experiments were conducted to evaluate performance of the CSS approach by comparing applied deformation behaviour of active waveguides with the measured AE response. The waveguides were subjected to accelerating deformations to replicate known behaviour in first-time landslides, which accelerate as progressive failure occurs and post-peak strengths are mobilised. Figure 3 a) shows the experimental setup, and full details of the test procedure are reported in

Smith et al. (2017a) and Dixon et al. (2018). The large-scale direct shear device has a central column filled with stiff clay. An active waveguide and a ShapeAccelArray (SAA) in-place inclinometer were installed through the clay column. Displacement of the top block relative to the bottom block was by a pulley system controlled by a hydraulic actuator, which generated shearing in the clay column. The excellent agreement between AE and displacement trends (i.e. cumulative and rate) shown in Figs. 3 b) and c) provides conclusive evidence that AE rates are indicative of 'slope' displacement rates, and hence that AE monitoring can be used to provide information on the stability status of a slope.

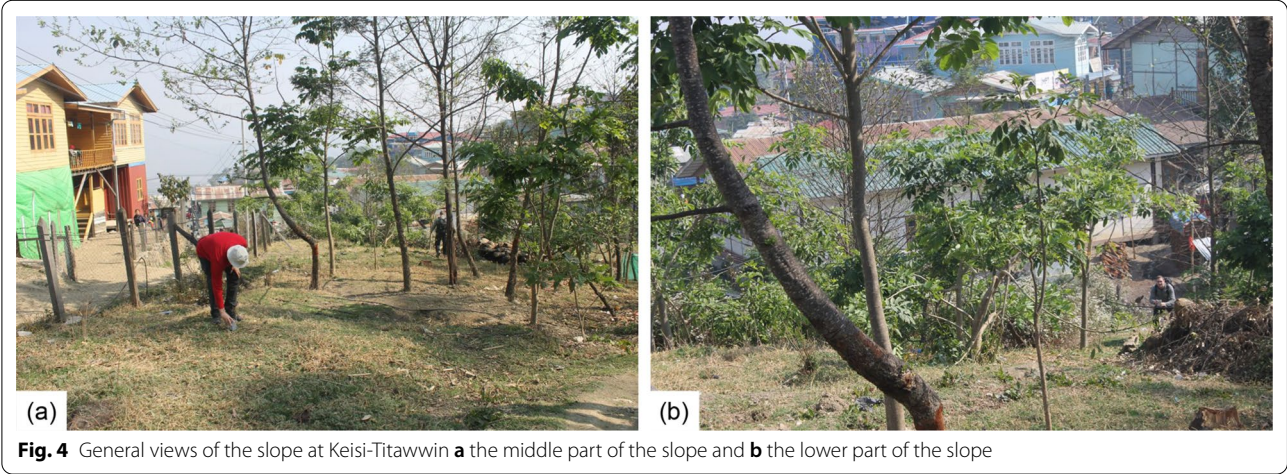
1. Site 1 Keisi-Titawwin is in the middle of a slope that comprises an area of gardens, including a plant nursery, and scrub land hosting livestock (Fig. 4), bounded by an access track at one side, and houses and workshops at the other side and at the toe. The general undulating topography and cracking on the lower part of the site indicates previous shallow slope movements, which was confirmed by discussions with locals. The concern at this location is that during periods of heavy rainfall, movements could be reactivated, impacting on the properties at the toe and damaging the communal garden area.

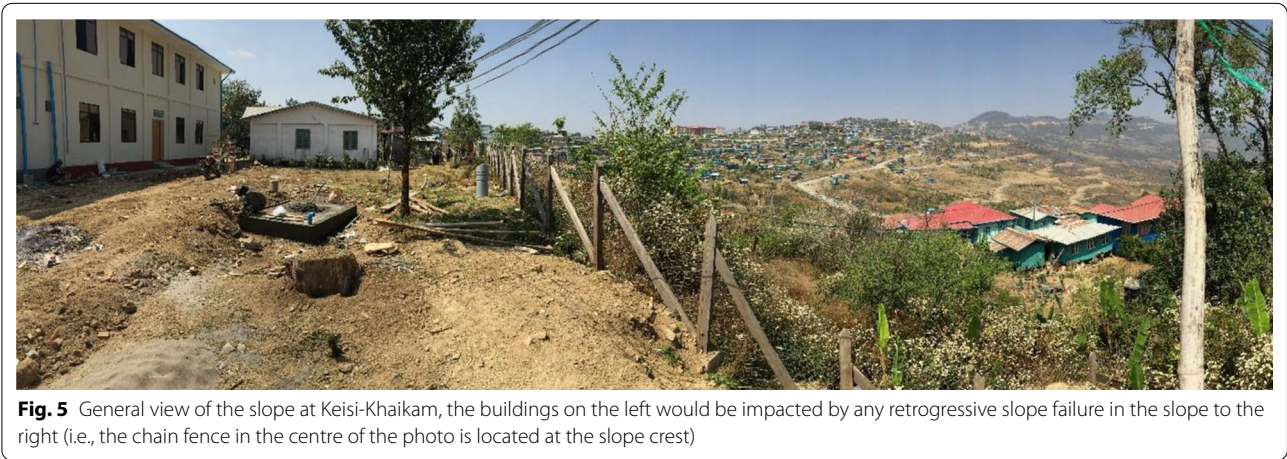
2. Site 2 Keisi-Khaikam is at the top of a steep slope that has previously experienced landslides, as evidenced by the undulating slope profile and cracking. These failures damaged properties at the slope toe. The concern at this location is that retrogressive failures in the top of the slope would damage government buildings located close to the crest (Fig. 5).

At Site 2, Keisi-Khaikam, both sensor nodes were installed behind the slope crest on horizontal ground, approximately 1.5 m from the top of the slope (Figs. 5 and 6). Sensor 3 is installed on a 5.5-m-deep waveguide and is closest to Base station 2, and Sensor 4 is installed on a waveguide 4-m-deep and is furthest away from the base station.

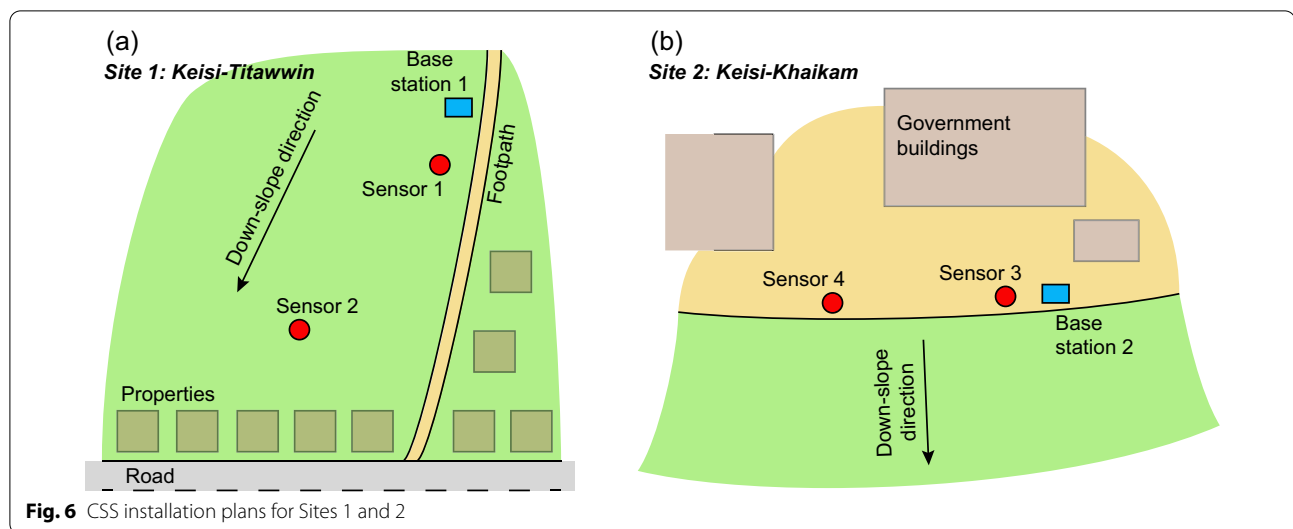
Figure 6 shows the system configurations and reference notation used at the two sites. Time and resources prohibited a detailed survey necessary to produce detailed plans or cross-sections. At Site 1, Keisi-Titawwin, Sensor 1 is in the upper part of the slope, and is closest to Base station 1, and Sensor 2 is in the lower part of the slope.

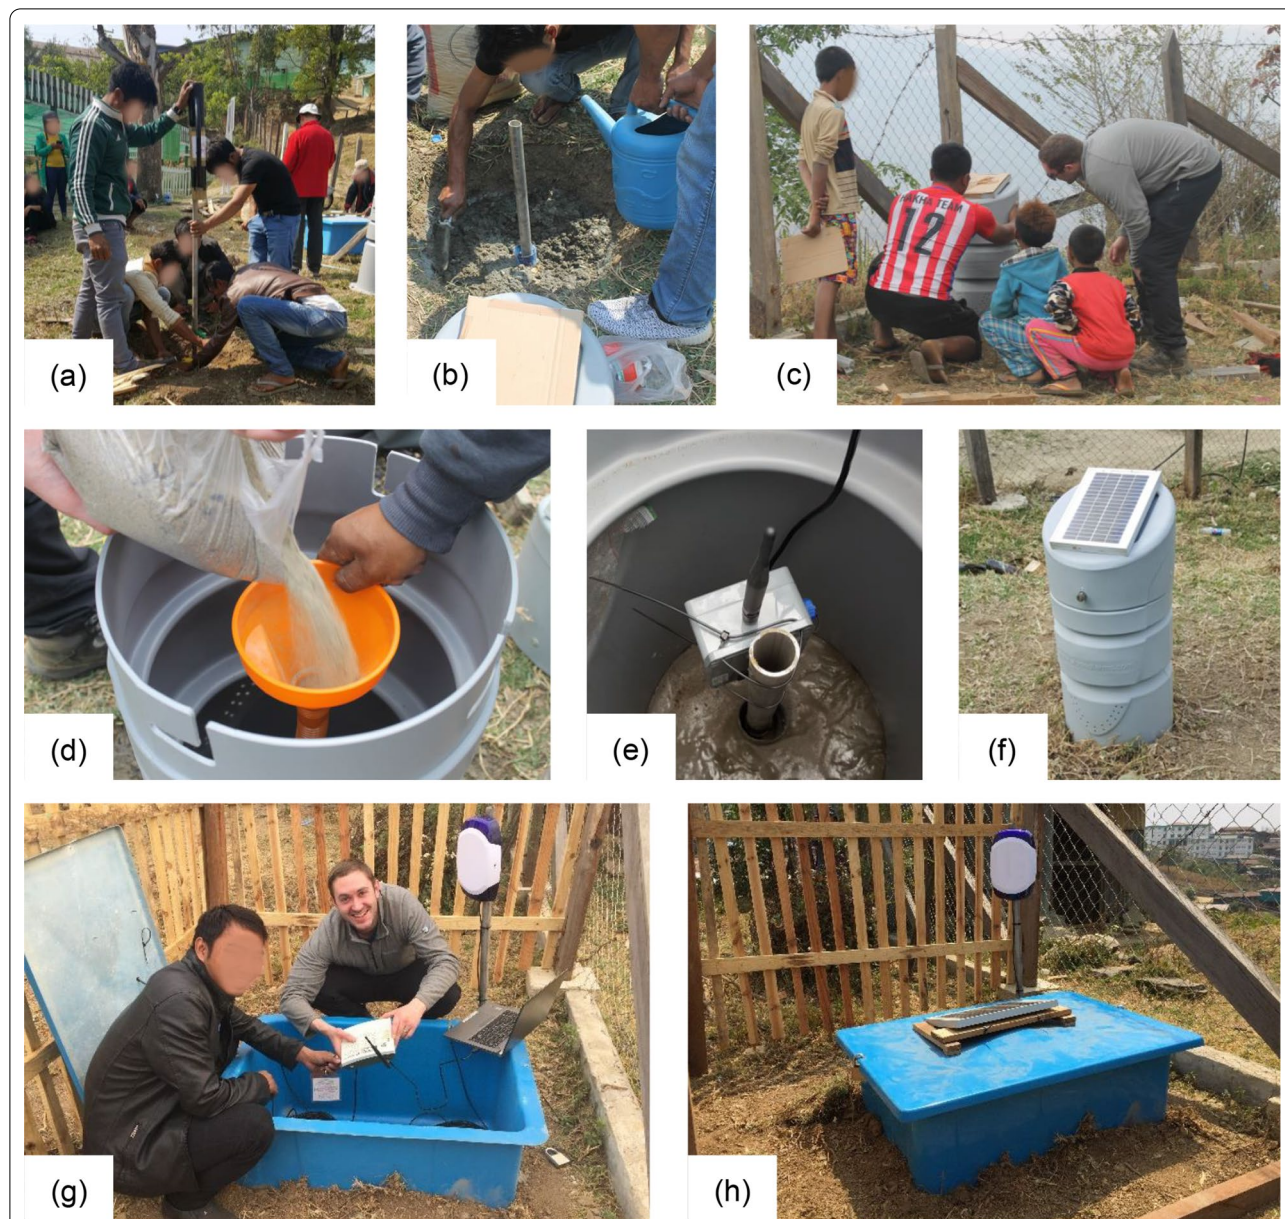
Fig. 7 Key stages of works by the authors, LRV and CCERR to install CSS at Sites 1 and 2: **a** driving the steel waveguide, **b** concreting the base for the cover, **c** placing the cover with help from interested children, **d** placing 'noisy' sand inside the steel waveguide, **e** the CSS sensor attached to the waveguide, **f** a completed sensor installation with integrated solar panel to charge the sensor battery, **g** set up of the base station and flashing light/siren alert system, **h** completed base station with solar panel to charge the battery

Waveguides at each of the two locations were installed using the post rammer to drive the steel tubes to depths of 3 m below ground level. Sand infill was placed inside the tubes to form active ‘noisy’ waveguides (“Community Slope SAFE (CSS) monitoring system” section) and purpose-designed covers with pre-mounted solar panels were concreted in place to enclose and protect the waveguide and sensor. The sensors were attached to the

waveguides using cable ties so that the piezoelectric elements were in good contact. The base station was housed in a lidded plastic container, with a solar panel positioned on top. All solar panels were orientated (i.e., rotated and tilted) to maximise solar gain. Figure 7 shows photos depicting the key stages of installation taken at the two sites.

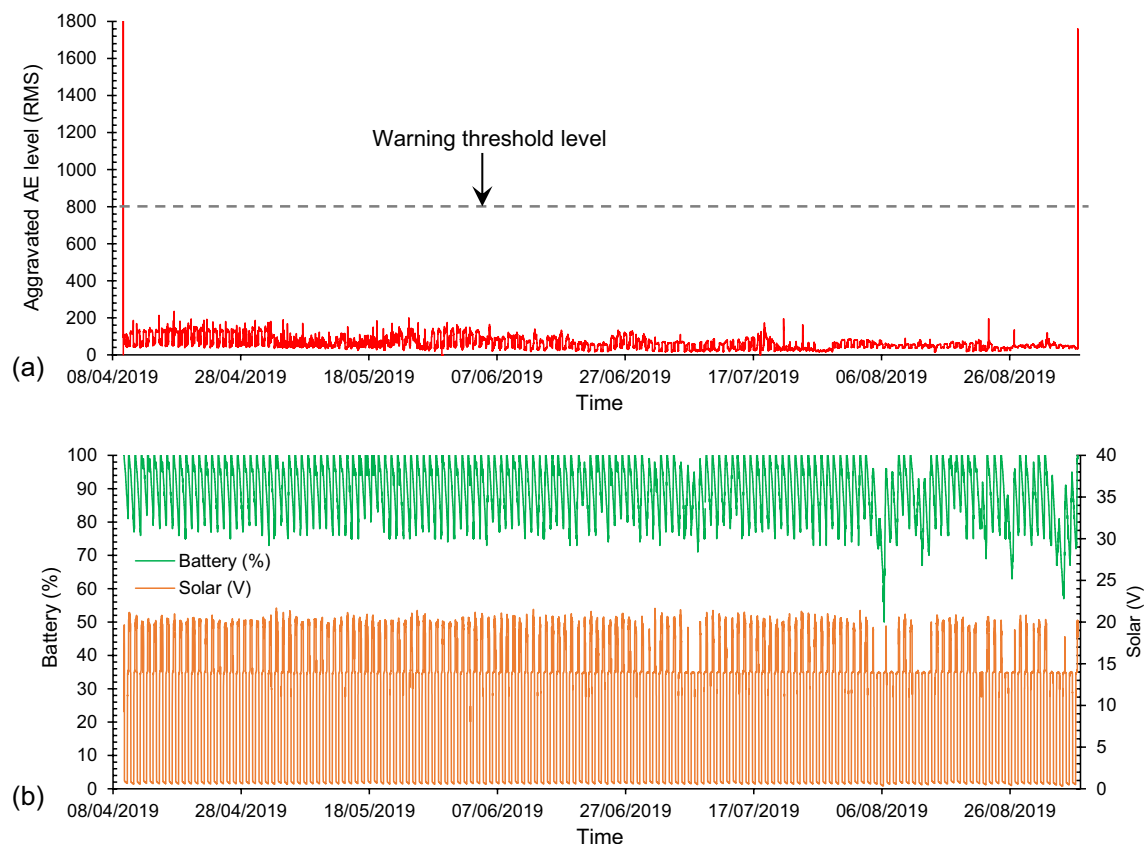
Fig. 8 Site 2, Sensor 3 **a** Example measured AE data showing low level aggregated AE RMS time series measurements indicative of stable ground. The peaks of AE at the start and end of the monitoring period were generated by CCERR/LRV visiting the site to trigger an alert and test operation of the system. **b** shows example solar (V) and battery level (%) data. (Dixon and Smith 2022)

Example measured AE data is presented in Fig. 8 a) for Site 2, Sensor 3. It shows very low levels of AE detected throughout the monitoring period. This is indicative of stable ground. The peaks in AE at the start and end were artificially generated by tests conducted during LRV visits. Because no slope instability events occurred at the sites during the trial, there was not an opportunity to detect ground movements using CSS and hence test triggering of the visual/audible alert system. However, the trial was still able to provide useful learning as discussed in “CSS performance” section. Figure 8 b) presents example data for operation of the solar panel (voltage level)

and charging of the battery (percent). This shows the system operating continuously over a period of 5 months.

The AE warning threshold level shown in Fig. 8 (i.e., the horizontal dashed line) was set such that exceedance would trigger an alert of potential movements. Based on experience from monitoring comparable slopes, an AE threshold was selected to warn of displacement rates in the order of 5 mm per minute. Laboratory calibration for the CSS system by Dixon et al. (2018) was used to define the AE RMS level indicative of this magnitude of displacement rate. Despite no slope failures occurring, the 20+ months of monitoring experience allowed the selected AE trigger level to be reviewed. It was not exceeded during normal operation and no false alerts were generated.
