RESEARCH ARTICLE

The 21 February 2005, catastrophic waste avalanche at Leuwigajah dumpsite, Bandung, Indonesia

Background: On 21 February 2005 the Leuwigajah dumpsite, Bandung (Java, Indonesia) was affected by a large slide after heavy rainfalls. Second deadliest waste slide in history, it buried 71 houses and killed 143 people. Amongst the contemporary disastrous events of this type, only a few have been documented. We explored failure preconditions, triggering mechanisms and local context that conducted to this disaster. We carried on four field investigations on the site. A series of aerial photographs were acquired and completed by topographical measures on the ground. The morphology of the slide and its trajectory were reconstructed. To constrain the movement condition, we studied the internal structure of the source area and realized surveys among stakeholders of the dumpsite and citizen.

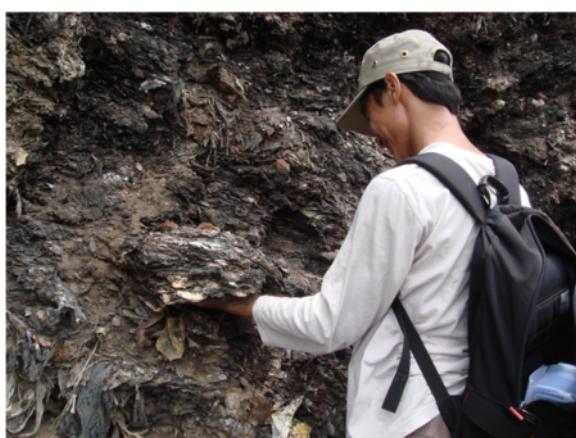
Figure 3 Sampling of the waste deposits (photo: F. Lavigne, February 2007).

transport mechanisms. Field investigation was carried out in the medial part of the deposit where the material had not been disturbed after the event, i.e. upstream from the location of the buried villages. However, heterogeneous waste composition (Figure 3), obstacles in determining waste strength parameters, and a lack of knowledge about the principles of waste mechanics result in considerable uncertainties in stability calculations. Therefore such calculations were not considered in this study.

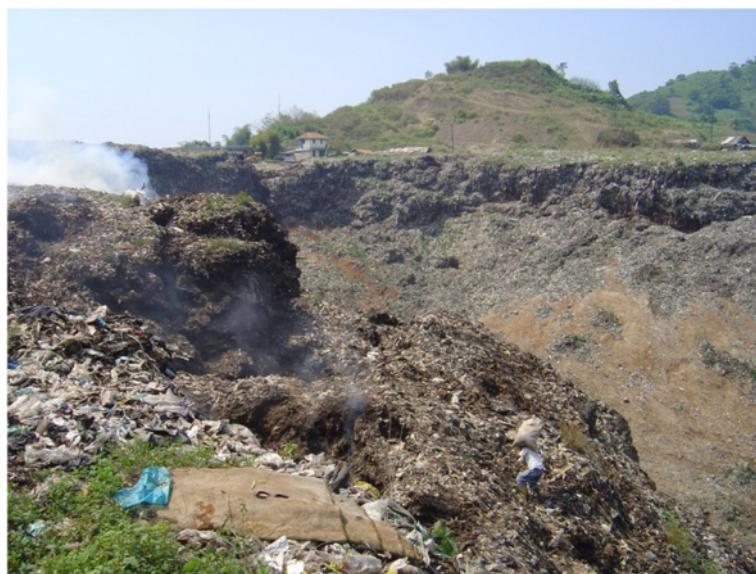
Figure 4 Scarp of the dumpsite after the February 2005 disaster. In the foreground, a scavenger carrying reusable material from the dumpsite. In the background, the steep natural slope in brown color (photo: F. Lavigne, July 2005).

Five months after the February 2005 disaster, the upstream part of the dumpsite displays a 10 m-high scarp cutting the waste accumulation (Figure 4). At the base of the scarp, the waste deposits are very thin or absent because they have been washed away during the 2005

event. The Figure 4 clearly shows that the gradient of the natural slope was very high, in the order of 45°.

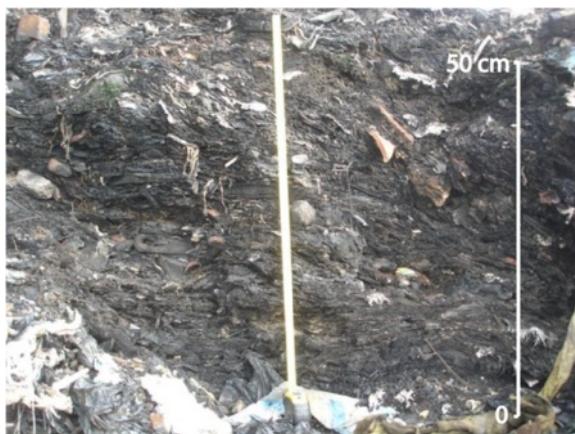
Figure 6 Internal structure of the deposit showing undulating discontinuities and foliated layers (photo: P. Wassmer, February 2007).

Below the surface, the layers comprise plastic bags remnants mixed with soil and a fine-grained matrix of decomposed organic garbage. Other materials found within the deposits were plastic pieces, stones, pieces of wood, metallic material etc. The main part of the deposit displays a finely foliated structure generally underlain by remainders of plastic bags. All the material shows a preferential fabric rather parallel to the previous topography. Outcrops conform to the displacement direction are showing undulating discontinuities that delimit 5 to 30 cm thick stratified layers (Figure 6).

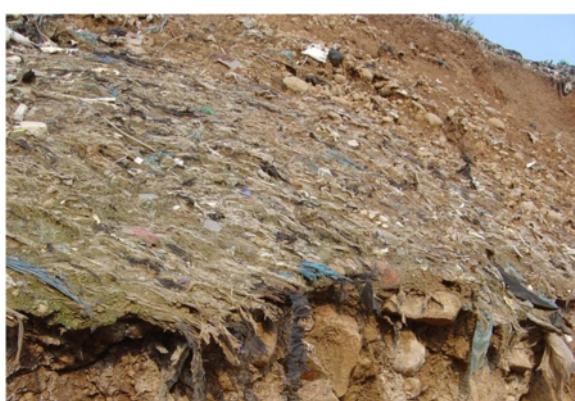
Figure 7 Pieces of plastic bags displaying horizontal orientations along the post-disaster scarp of the dump (Photo: F. Lavigne, July 2005).
