Slope mass rating-based analysis to assess rockfall hazard on Yogyakarta Southern Mountain, Indonesia

Karlina Triana^{1*} and Koko Hermawan²

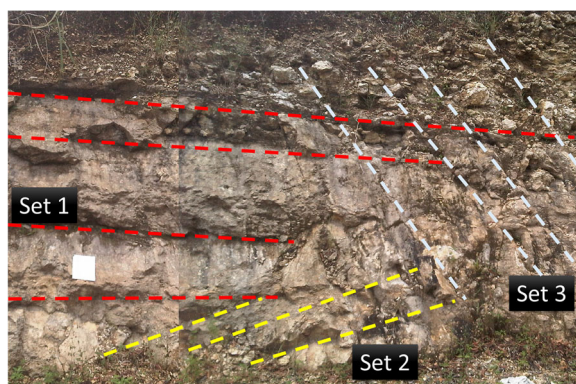
Fig. 2 Three sets of joints were measured in indirect RQD observations (without borehole). The picture was taken at Station 4 (110°20'53.25"E, 8°0'15.08"S) with an A4 paper as a scale

Indirect RQD measurements were carried out in all 17 stations because there was no borehole available. Based on the measurements, the RQD values in all stations categorized as good–very good. The 14 stations have very good RQD values, while 3 (three) other stations that are Station 1 (composed of andesite units) and Station 7 & 10 (composed of fragmental limestone units) have good

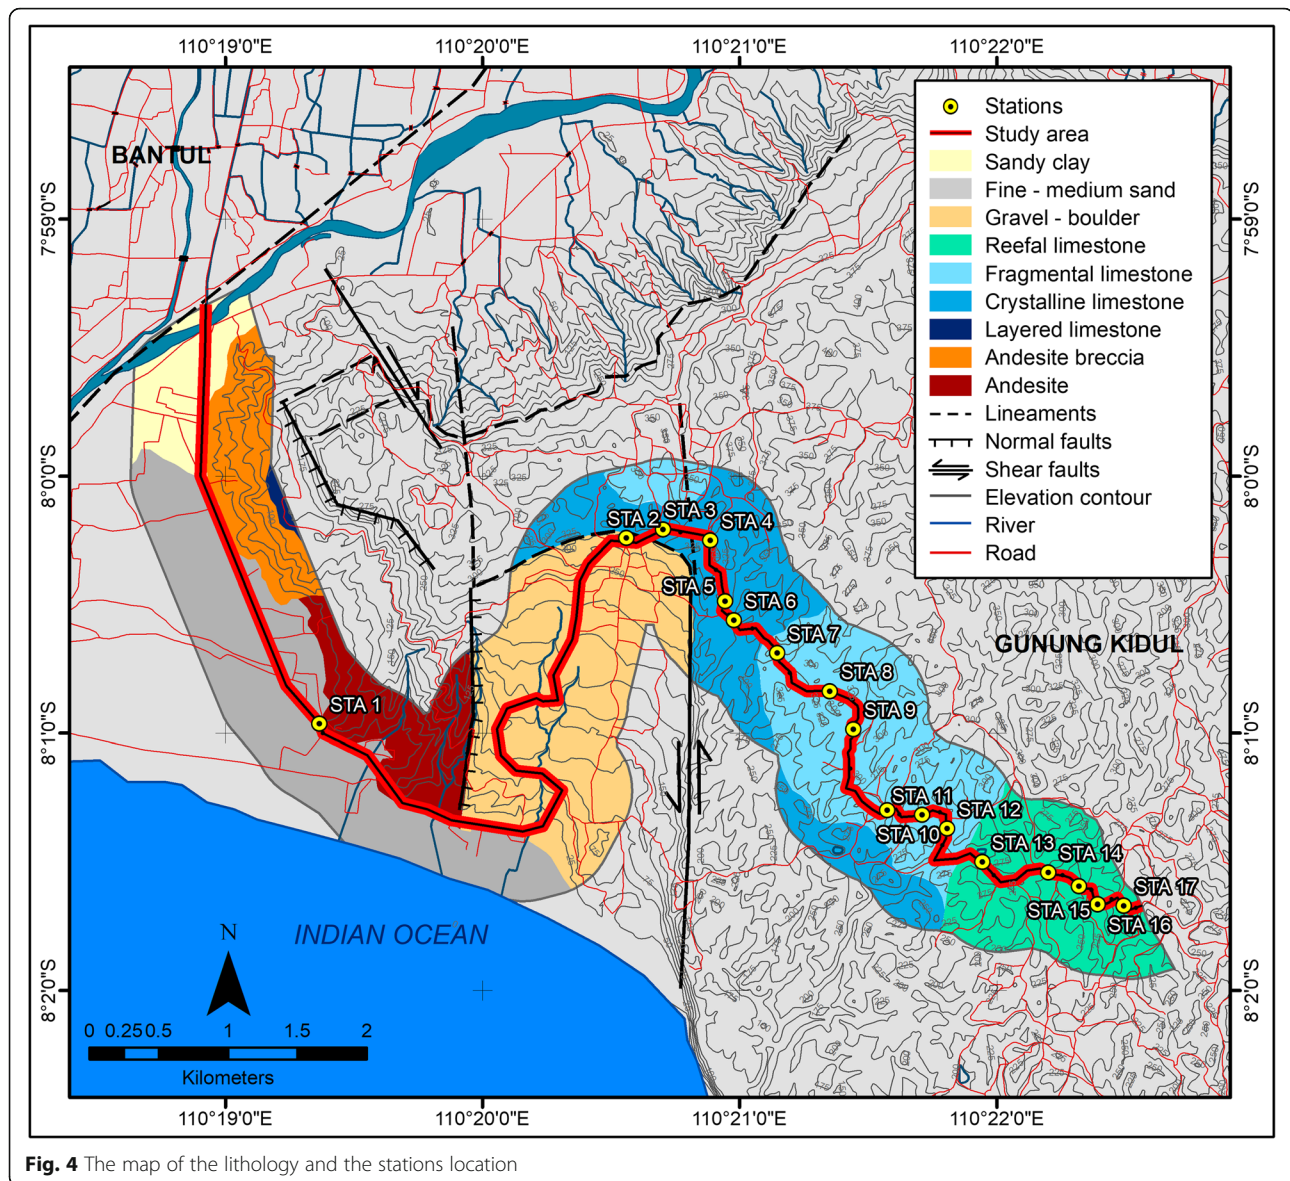
Fig. 4 The map of the lithology and the stations location

The number of slopes found on the main roadside was 17 slopes with varying height and length. Each slope becomes an observation point so that in total 17 stations were analyzed in this study. The naming of these units was based on the lithology of the rocks. There were only 4 (four) geological units found from the 17 stations in the study area (Fig. 4). These 4 (four) geological units, i.e., andesite, crystalline limestone, fragmental limestone, and reefal limestone (Rahardjo et al. 1977), used as the analysis unit in the analysis stage.

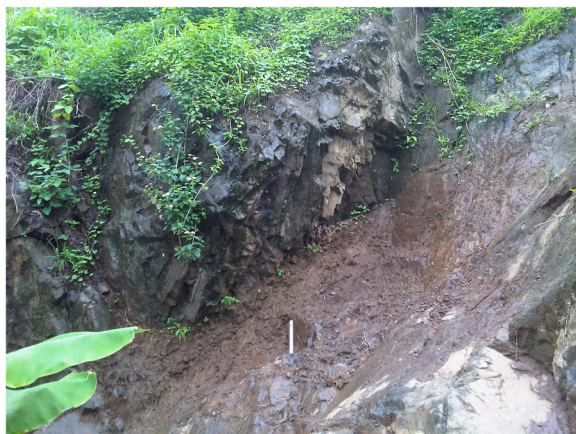
Fig. 5 The condition of groundwater flowed through joints to the surface of andesite rocks. The groundwater flows consistently and weathers the underneath rock surfaces. The photo was taken at Station 1 with a 30 cm ruler as a scale

rock surfaces, but there was 1 (one) exception station with a significantly different state. Station 1, which is composed of andesite unit, has a flowing groundwater condition (Fig. 5). Meanwhile, the other slopes composed of crystalline, fragmental, and reefal limestone have between dry and moist groundwater conditions. Table 14 shows the groundwater conditions in the study area.

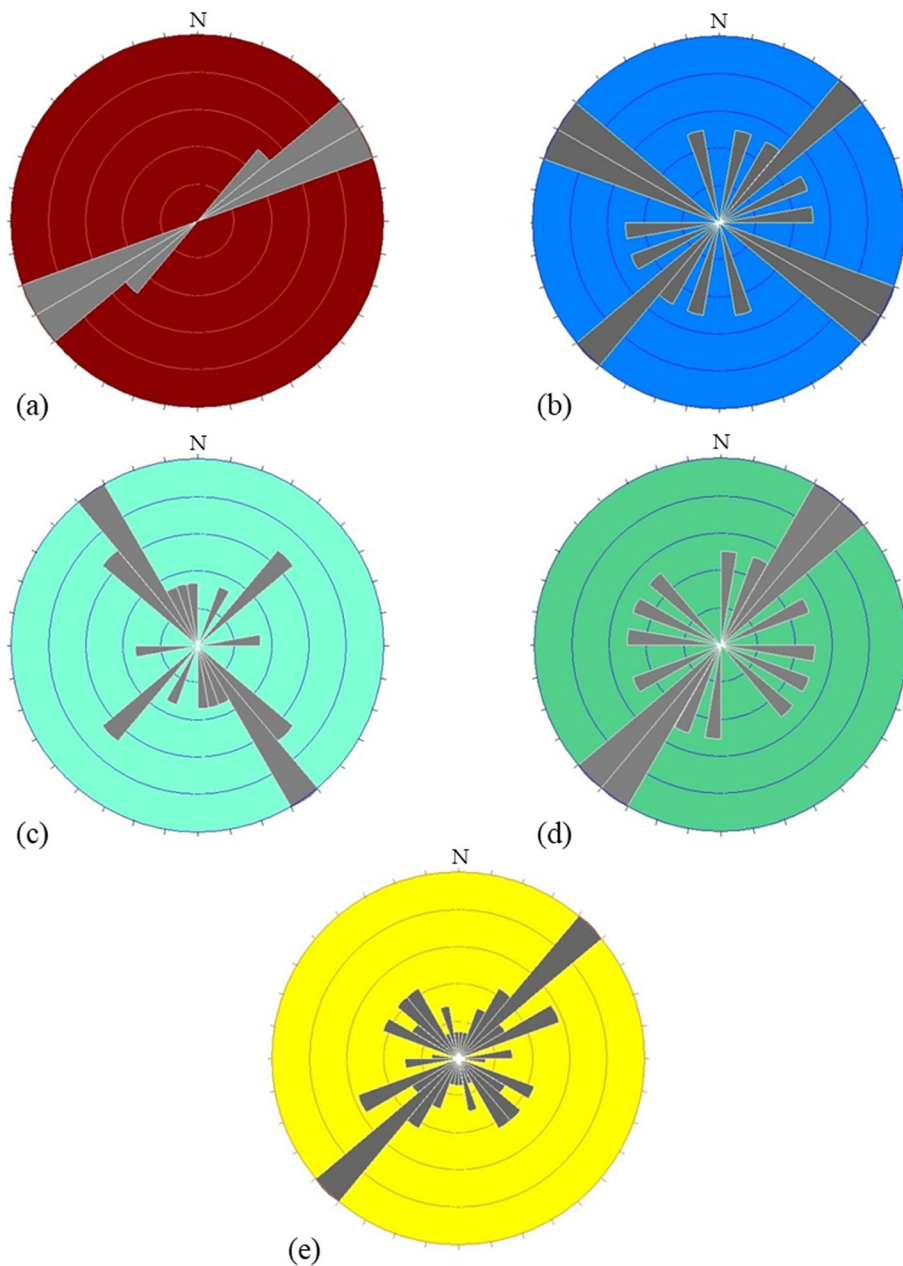
Fig. 7 Rose Diagrams of (a) Andesite unit; b Crystalline limestone unit; c Fragmental limestone unit; d Reefal limestone unit; and e all units

discontinuous plane in the slopes. The diagrams show that the dominant strike orientation of the discontinuous planes was trending northeast-southwest (N 60°E) in the andesite unit (Fig. 7a), northeast-southwest (N 45°E) in the crystalline limestone units (Fig. 7b), northwest-southeast (N 325°E) in the fragmental limestone units (Fig. 7c), and northeast-southwest (N 40°E) in the reefal limestone units (Fig. 7d). In general, the most dominant strike orientation of all discontinuous planes in the study area was trending northeast-southwest (N 45°E).

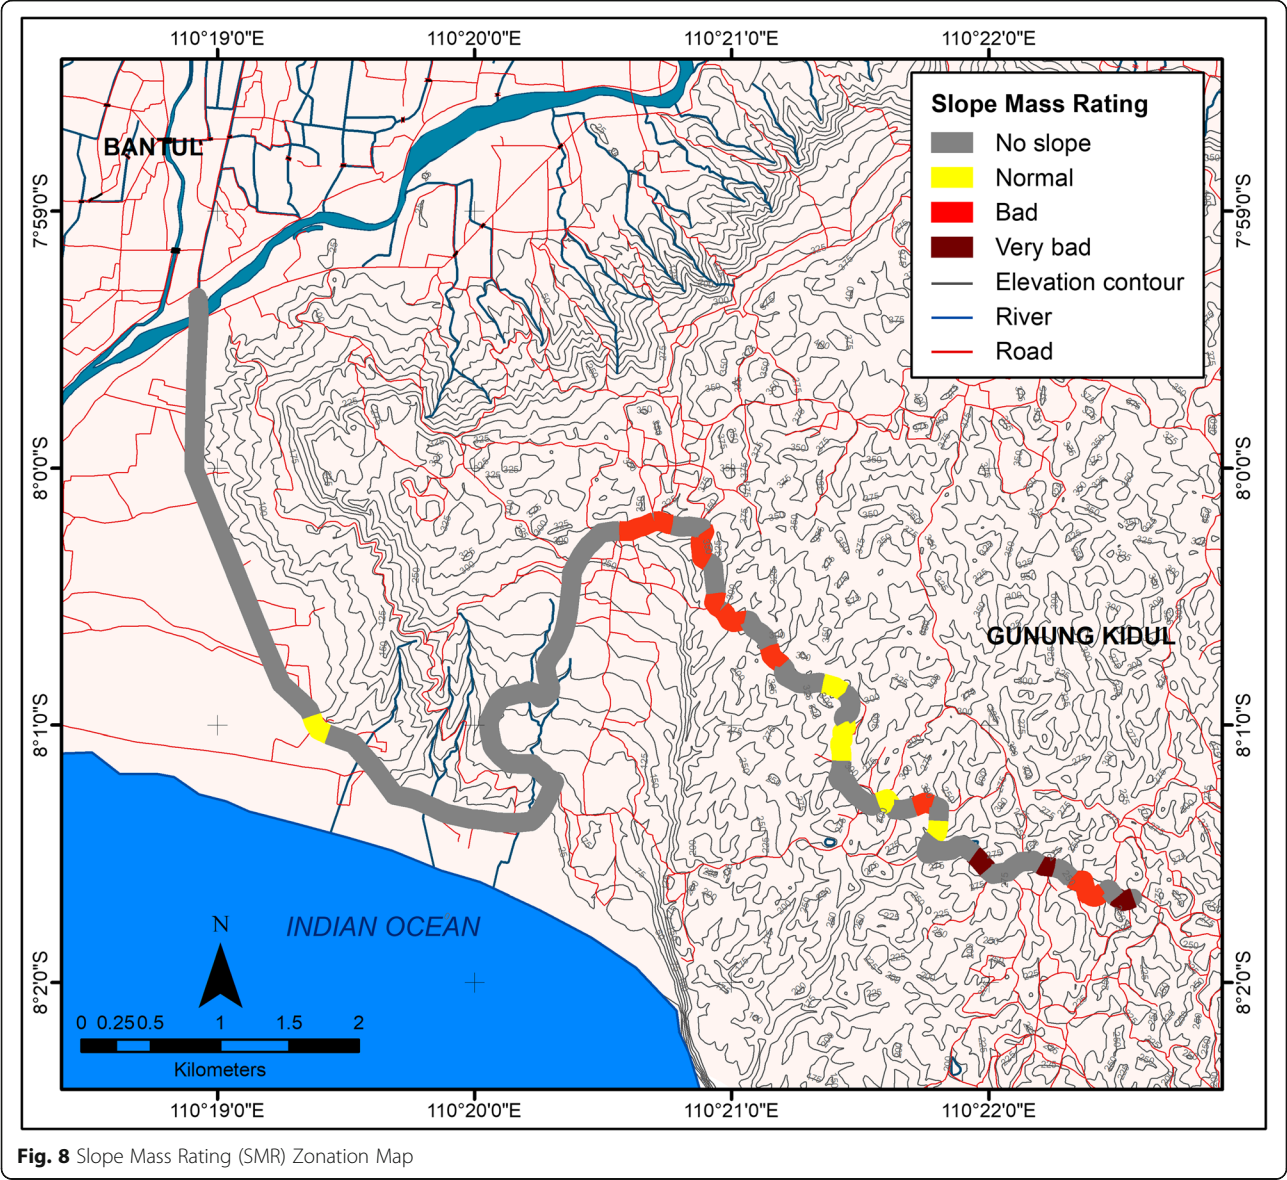
Fig. 8 Slope Mass Rating (SMR) Zonation Map

dissolution, and complex condition of the developed discontinuous planes. The result of the SMR zonation is shown in Fig. 8.

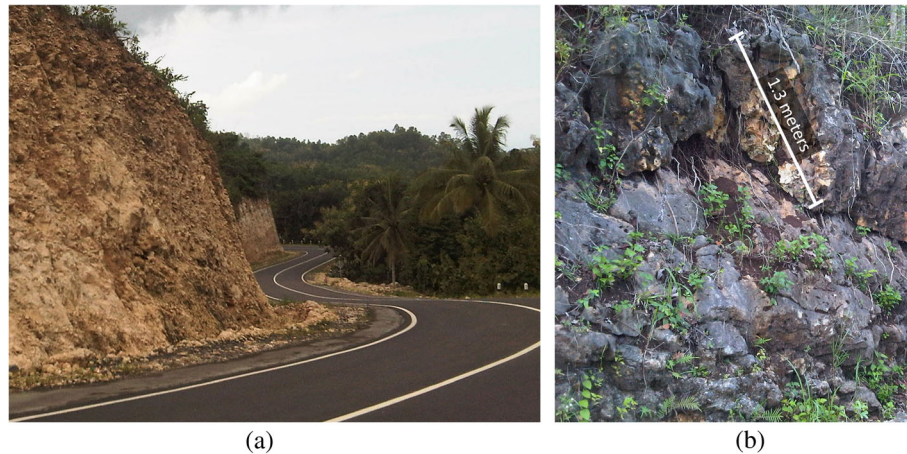
Fig. 9 Figure (a) shows a slope formed by crystalline limestone at Station 6 with a 191 m of length and ± 9 m of height. Figure (b) shows a slope formed by reefal limestone at Station 13 with a 1.3 m of rock block size. Rockfall was indicated to have occurred in both locations

slopes varies with the rock diameter size of 0.2 to 1.3 m. A very high hazard category of rock block size was found in Station 13 (Fig. 9b). From the evidence and remnants, rockfall was indicated to have occurred in the location. Rock block size in other stations varies with a very low to high hazard category. Combined with SMR and slope height values, the weighting of rock block size will result in more variations of the rockfall hazard assessment.

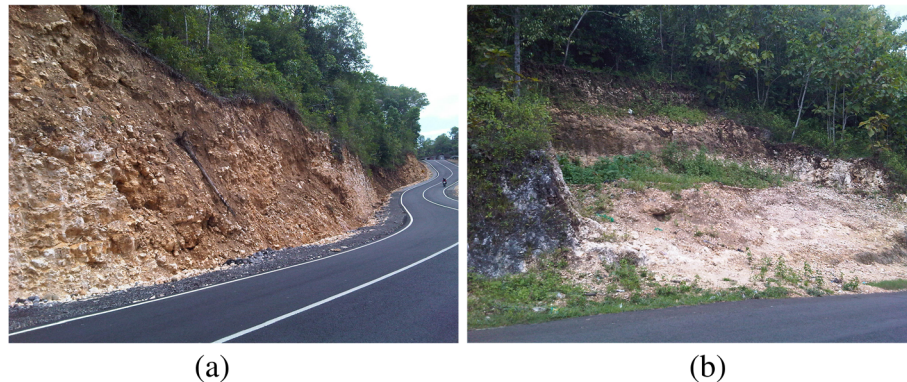
Fig. 11 Landslides evidence at coordinate (a) 110°20'27.60"E, 8°0'16.24"S and b 110°22'15.60"E, 8°1'33.60"S. None of slope reinforcement installed at the locations

should consider to re-excavating or at least covering the slopes with an anchored wall. Figure 11 below shows the occurred landslides at several locations in the study area.

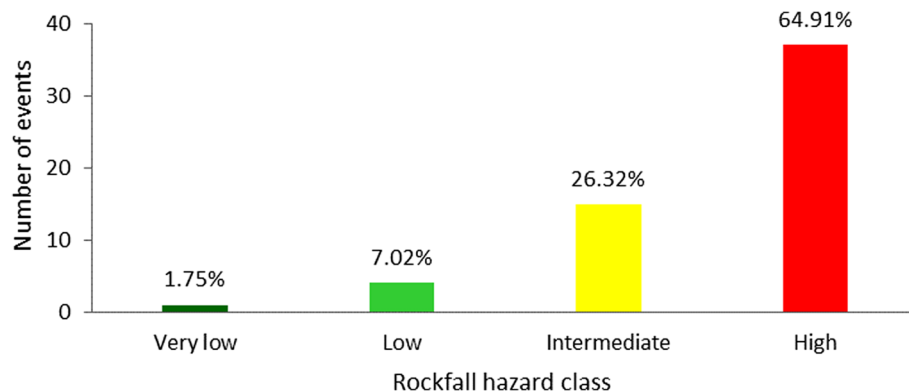
Fig. 12 Percentage of rockfall occurred in each rockfall hazard class
