SHORT REPORT

# Effects of topographic and geological features on building damage caused by 2015.4.25 Mw7.8 Gorkha earthquake in Nepal: a preliminary investigation report

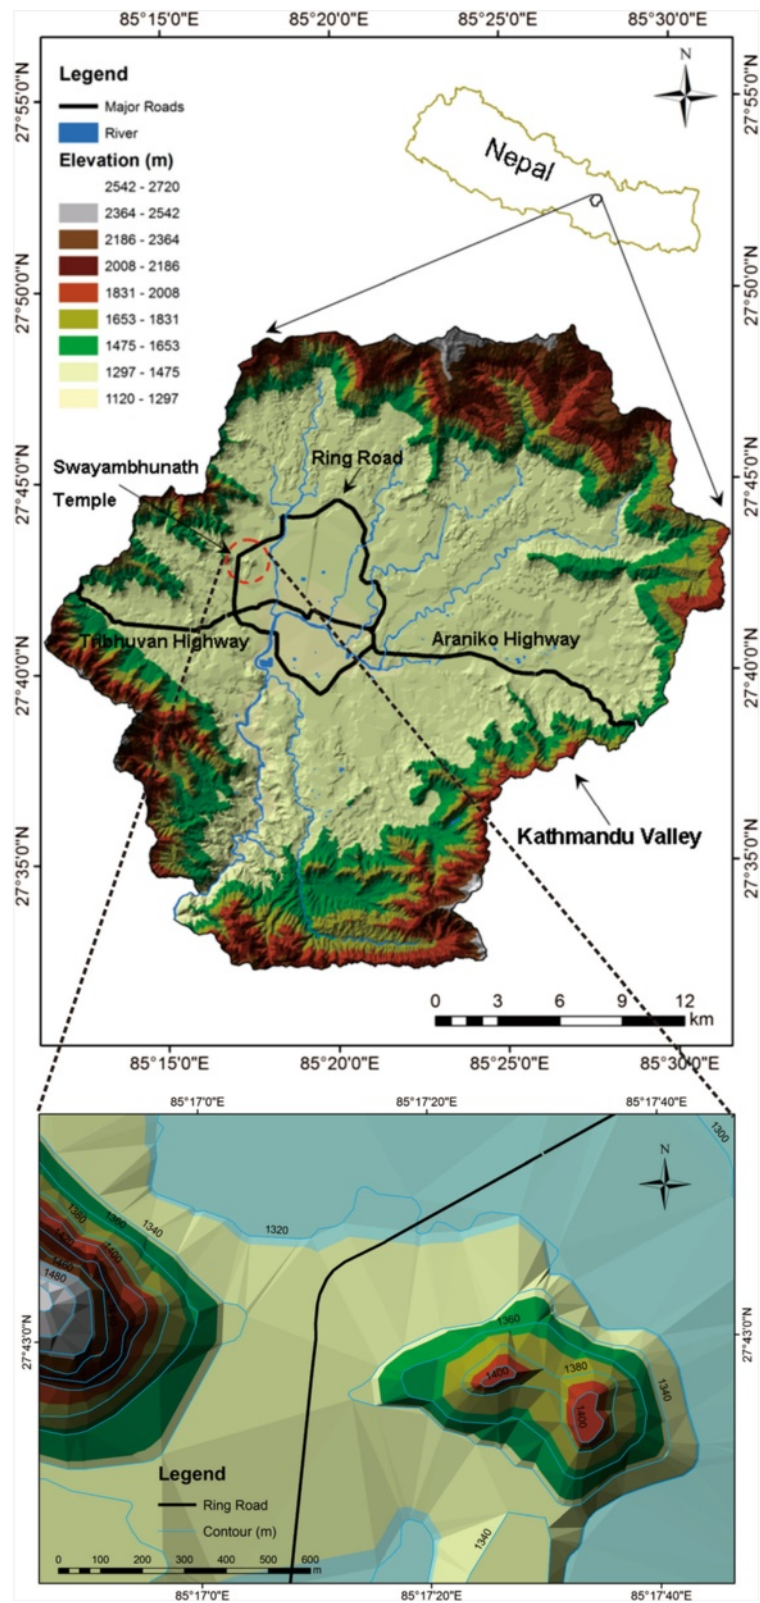
**Fig. 2** The location map of the Swyambhunath World Heritage site and surrounding area

Figure 2 shows the topography of the Swyambhunath World Heritage site and its surrounding area. It is located on an isolated hill near the mountainous area in the west side of Kathmandu city. On the hill, there was a pond named Peace Pond. The local Buddhist monks in the temple told us they have felt strong shaking during the earthquake. In this investigation, we found distinctively crooked trees, known as "drunken" trees, widely distributed on the north slope of the heritage site (Fig. 3). These types of trees often indicate slope movement and probable slow-moving landslide activity, known as creep, a process which usually occurs over an extended period of time.

During the investigation, it is found that the damages are more severe where the buildings and temples are closer to the slope. It may mean that the shaking is much stronger at the slope shoulder than at the mountain top. After the investigation in the same site, Hashash et al. (2015) pointed out that the topography effects refer to the modification (frequently amplification) of incident ground motion due to energy focusing effects at convex topographic features (hills, ridges, canyons, cliffs, and slopes), complicated subsurface topography (sedimentary basins, alluvial

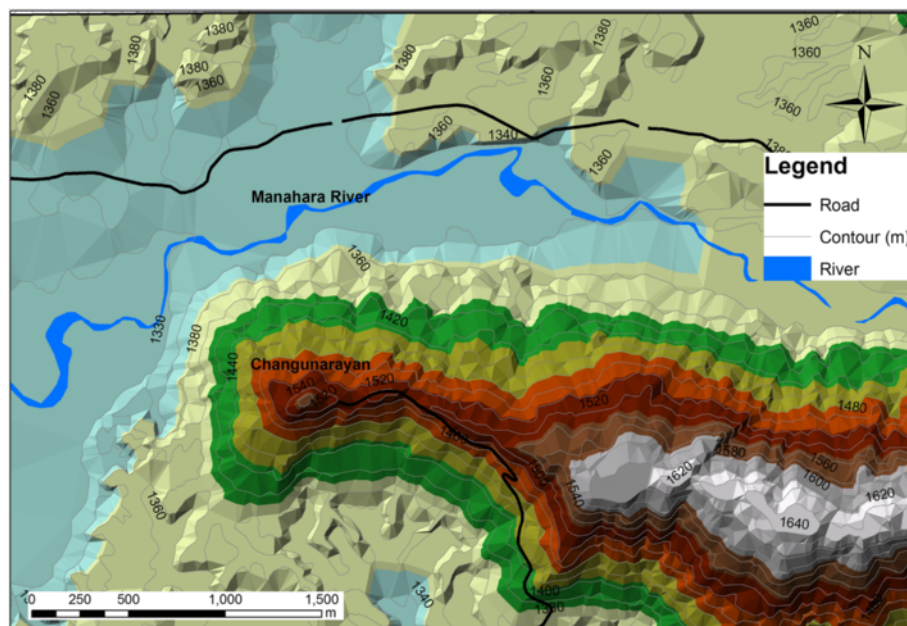
**Fig. 14** Topography of Changu Narayan

The Changu Narayan temple is considered to be the oldest temple in Nepal. Figure 14 shows the topography of Changu Narayan. It is located on an isolated hill. At both sides of the hill ridge, typical topography of a landslide was confirmed.

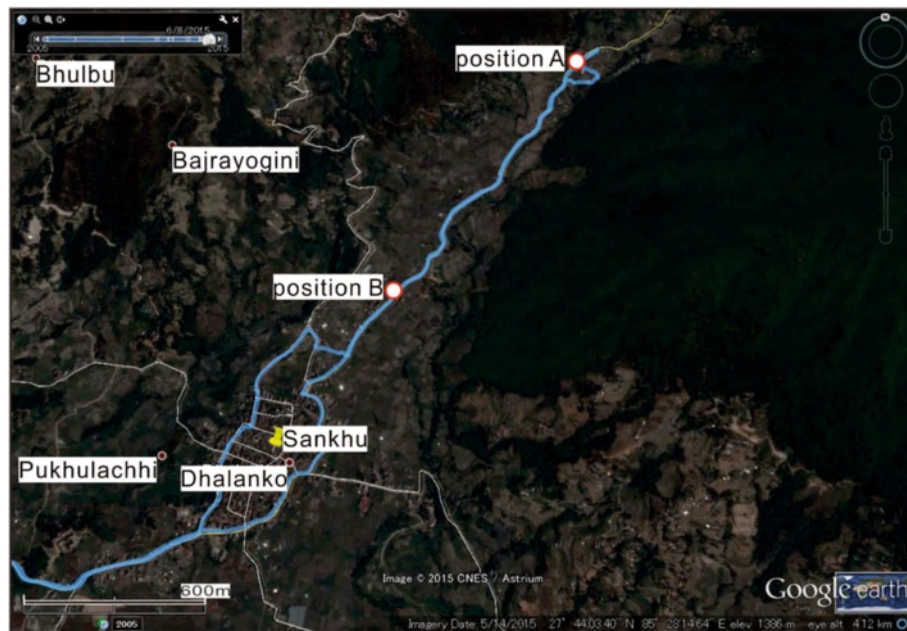
**Fig. 19** Investigation route around the Sankhu area

To find the reason why the building were more heavily damaged than the surrounding villages, we observed areas around the residential section and then traveled in a northerly direction. Figure 19 shows the trace of the investigation route. It is found that this area is an alluvial fan. At Position A, we found large boulders in the shallow valley, and flowing water (Fig. 20a). On the terrace, two-floors or higher building were in good condition. At position B, there were rice paddies, surrounded by concrete buildings of two to four stories. The damage at point B was not so severe. It was observed that the most severe damage occurred at the middle-lower part of the alluvial fan. It is estimated that at that part, ground deformation has been amplified by the specified soil layer structure, and caused the concentrated collapses in the old buildings.

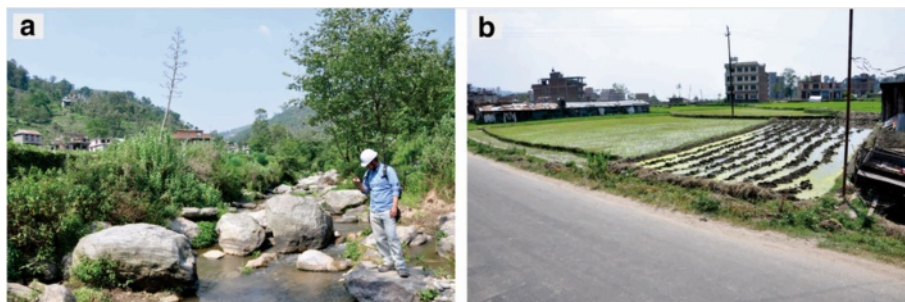
**Fig. 20** Evidences of the alluvial fan near Sankhu. **a** Large boulders and flowing water in the valley; **b** Rice paddies at the upslope side of high buildings

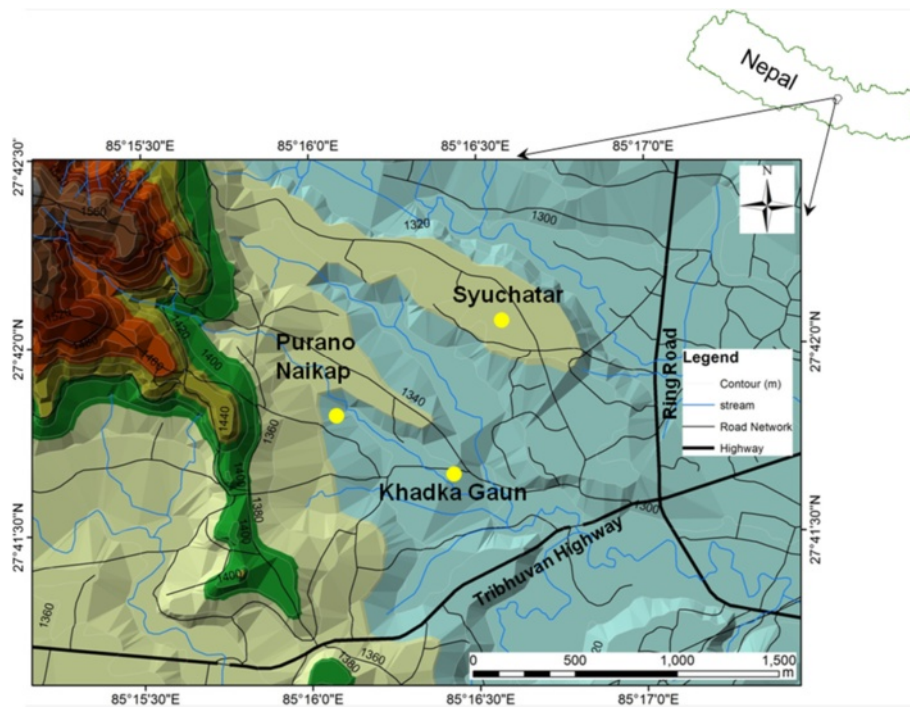
**Fig. 21** Location of the Purano Naikap area

During the investigation, we were reported that some strong shaking and failure occurred to the residential buildings in Purano Naikap area (Fig. 21). This area

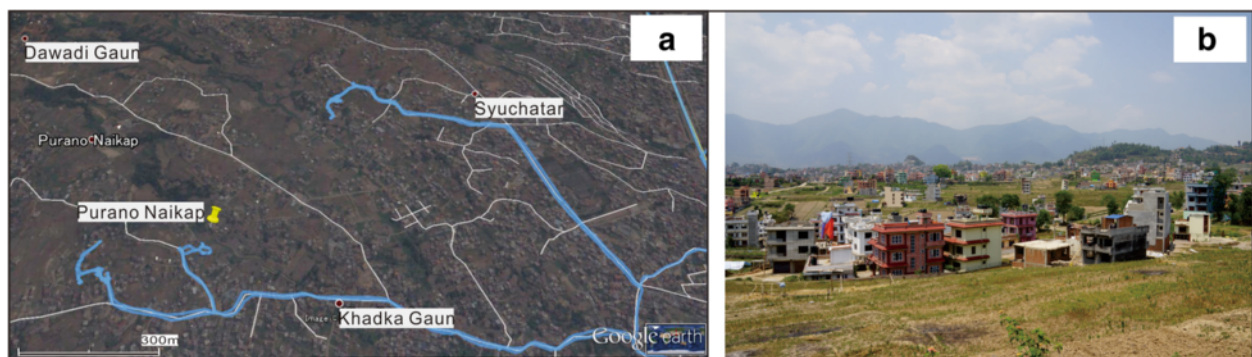
is located at southwest part of the Kathmandu basin and inclined to the basin center. As can be seen from Fig. 22, this area is occupied by residential buildings and agriculture fields on gentle slopes.

**Fig. 22** Investigation route and topographic situation in Purano Naikap area. **a** the investigation route; **b** typical scene with residential buildings on gentle slopes
