Torrent rainfall-induced large-scale karst limestone slope collapse at Khanh waterfall, Hoa Binh Province, Vietnam

Ngoc Ha Do^{1,4}, Satoshi Goto^{2*}

Abstract

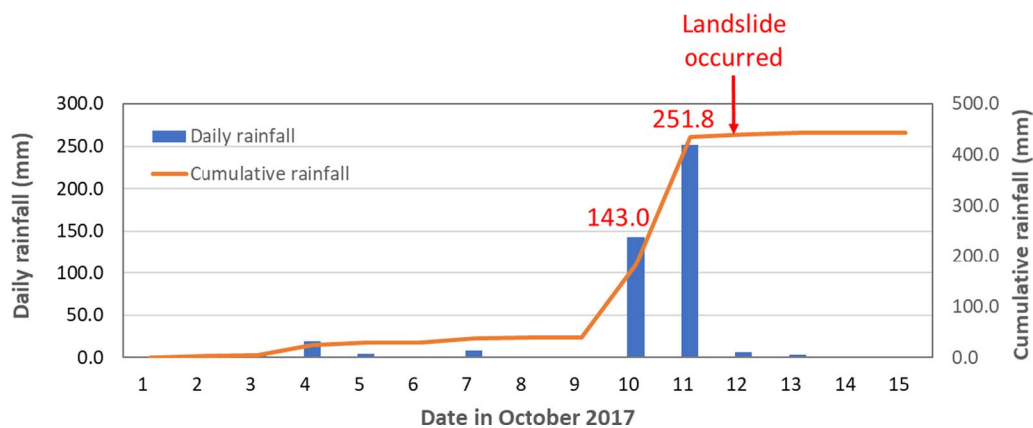
The Khanh waterfall landslide occurred around 01:00 am local time on October 12, 2017 after 48 h of a heavy rainfall of 394.8 mm on October 10 and 11, 2017 (Fig. 3). The rainfall data was collected at Mai Chau district rain gauge station, which is located 12 km from Khanh waterfall (Vietnam Meteorological and Hydrological Administration 2019). At the Khanh waterfall, there were two

Fig. 3 Daily rainfall in October 2017 when the Khanh waterfall landslide occurred (Vietnam Meteorological and Hydrological Administration 2019)

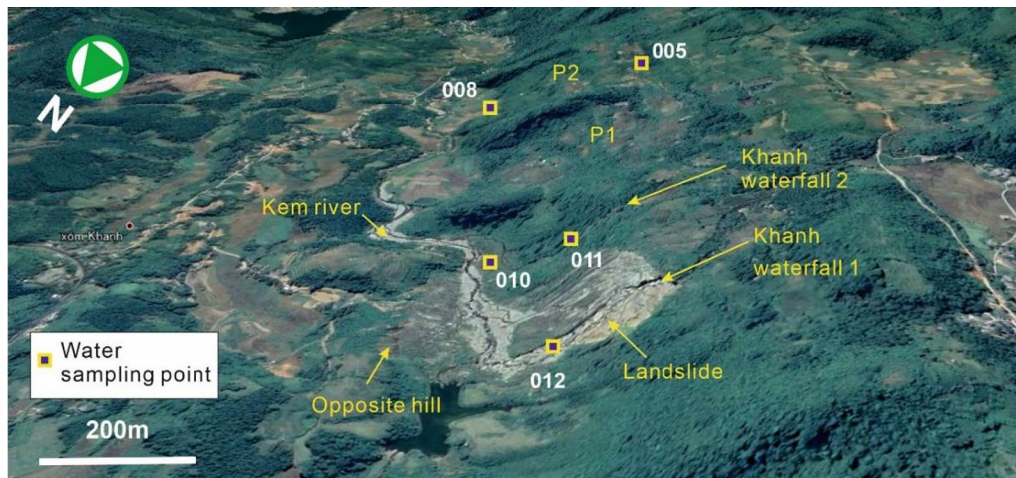
Field surveys were conducted to understand the geology, topography and hydrogeology around Khanh waterfall landslide (Fig. 7). The range of movement and the amount of moving mass were estimated based on the actual geological evidence, information provided by the local residents, and the images taken by an Unmanned Aerial Vehicle (UAV).

Fig. 7 Field survey area including the location of water sampling points around Khanh waterfall (KW) landslide. Sample 012 (surface water) was collected from KW1. Samples 010 (surface water), 011 (spring water) were collected from KW2. Samples No. 005 and 008 (spring water) were collected from P1 and P2 areas

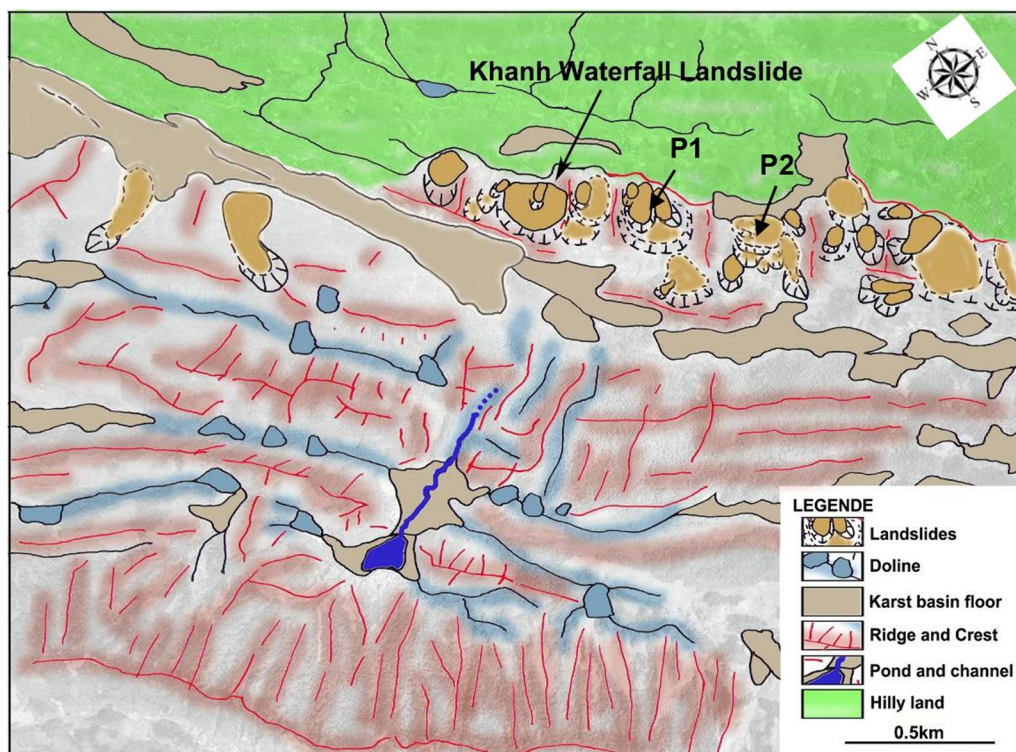
Figure 8 shows the topographic classification map and the distribution map of the landslides in the Khanh waterfall area. The soil layers between the collapsed and the non-collapsed areas were investigated to determine the position of the collapsed surface. On the right bank of Kem river 200 m downstream from Khanh waterfall landslide, there were two areas P1 and P2 which were parallel concave terrains similar to the traces of past landslides. There was no movement at these points when the landslide occurred at Khanh waterfall. Water quality analysis and geology investigation at P1 and P2 areas were conducted to compare these condition with Khanh waterfall.

Fig. 8 Topographic classification and landslide distribution map around Khanh waterfall

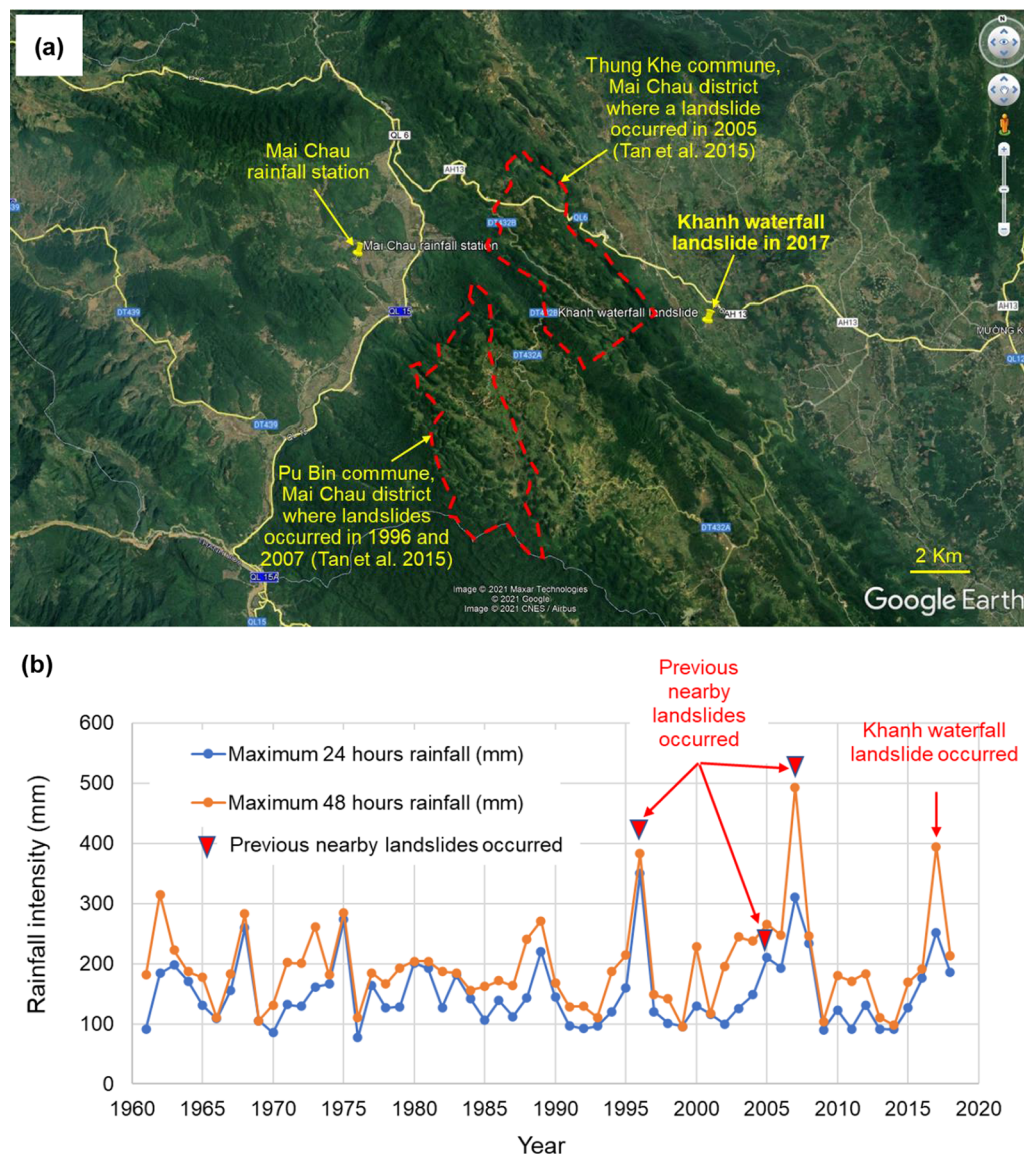
Figure 9 shows the position of Khanh waterfall landslide in 2017 and areas in close proximity where landslides occurred previously (Tan et al. 2015) plotted on Google Earth, and a rainfall data graph from 1961 to 2018. In Fig. 9a, the location of Khanh waterfall, Mai Chau rainfall station and the previous nearby landslides areas in Pu Bin commune and Thung Khe commune, Mai Chau district, Hoa Binh province are shown. There were two landslides in 1996 and 2007 in Pu Bin commune and one landslide in Thung Khe commune in 2005. The exact locations, sizes and types of these landslides were not specified. However, the time when the landslides occurred has been reported. Figure 9b shows the maximum 24 h, 48 h rainfall data at Mai Chau rainfall station from 1961 to 2018 with the time when Khanh waterfall landslide and

previous nearby landslides occurred. It shows that the 48 h rainfall higher than 300 mm caused landslides that occurred in Pu Bin commune in 1996, 2007 and Khanh waterfall landslide in 2017. The 24 h rainfall higher than 200 mm caused a landslide in Thung Khe commune in

2005. The data of the previous landslides and the current one at Khanh waterfall in the context of the rainfall data for 58 years indicates that torrent rainfall in 24 h and 48 h is an important factor causing landslides around Khanh

Fig. 9 **a** Location of Khanh waterfall (2017) and previous nearby landslides in Pu Bin commune and Thung Khe commune, Mai Chau district, Hoa Binh province (Tan et al. 2015); **b** data of maximum 24 h and 48 h rainfalls from 1961 to 2018 (Vietnam Meteorological and Hydrological Administration 2019)

waterfall. Rainfall in 48 h greater than 300 mm should be considered a warning landslides around this area.

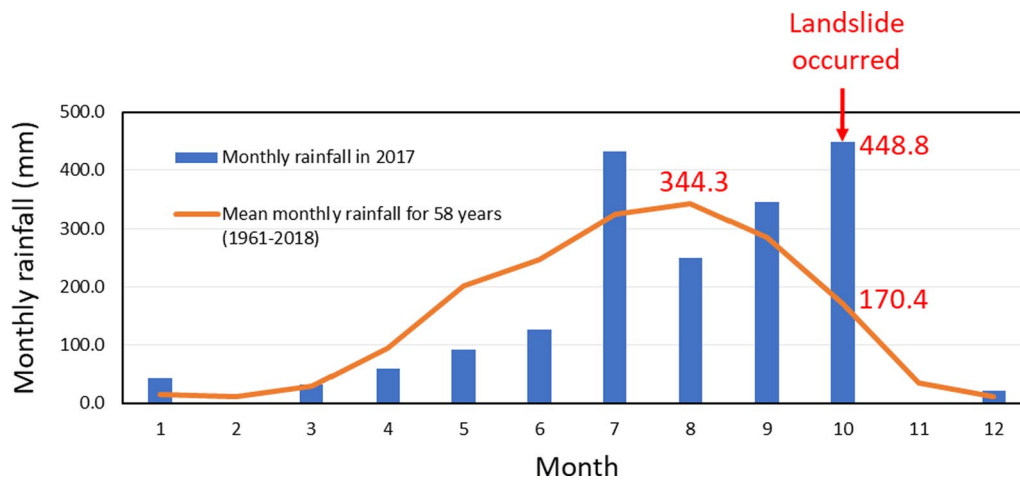
In 2017, when the landslide occurred, there were large typhoons in October in Vietnam. The monthly rainfall in October of 448.8 mm was 2.6 times the usual amount of 170.4 mm (Fig. 10). On October 10 and 11, 2017, 48 h before the landslide occurred, the rainfall was recorded at 394.8 mm. A maximum of 44.1 mm/h was recorded at 4 am on October 11 (Fig. 11). This hourly rainfall value was used to calculate the flow discharge in the upstream area of Khanh waterfall. The watershed behind the landslide

Fig. 10 Comparison of an average monthly precipitation and 2017 monthly precipitation in 1961–2018 (Vietnam Meteorological and Hydrological Administration 2019)

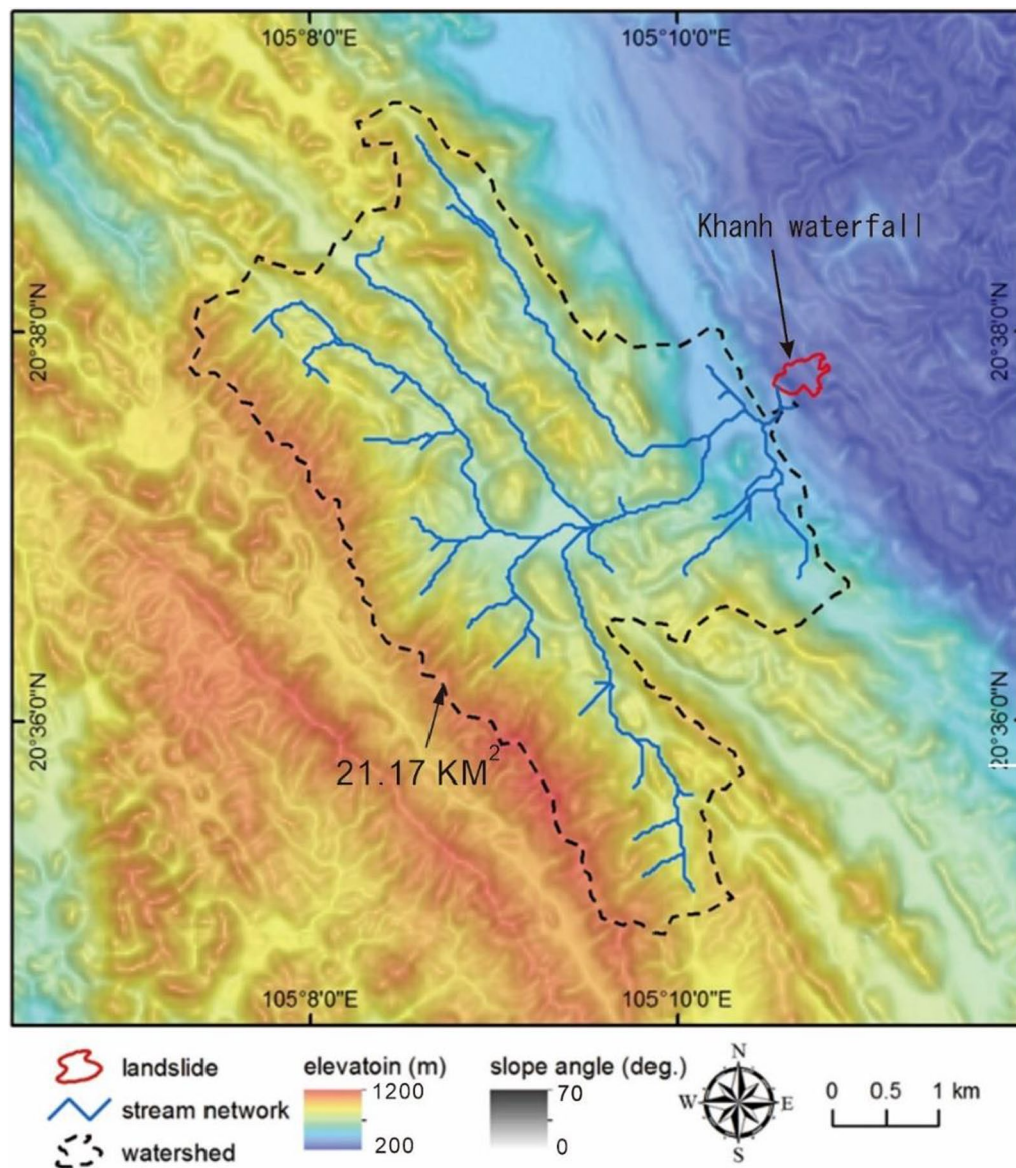
area was 21.17 km². The water was gathered behind the Khanh waterfall and flowing down to the Khanh waterfall (Fig. 12).

Fig. 12 The upper stream network channel and watershed of Khanh waterfall landslide

From the above calculation results, the amount of water collected around the waterfall during the peak rainfall on October 11 is about 181.5 m^3/s . While the allowable flow is about 3.55 m^3/s , which is about 51 times smaller than peak flow. That causes the water to overflow at Khanh waterfall. This is consistent with the situation around the waterfall before the landslide in Fig. 6b.

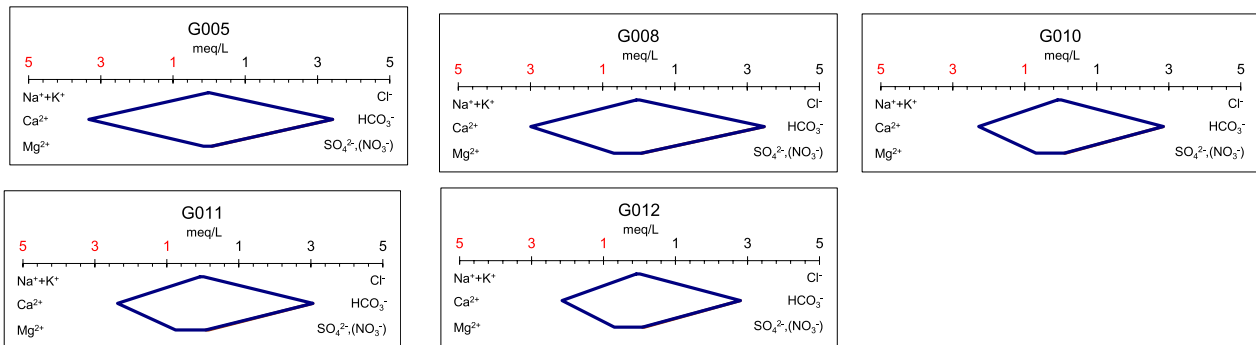
The water quality analysis results were organized as a stiff diagram (Fig. 21). G005, G008 collected from spring water has less silica and more calcium ions than G010, G011, G012. It is highly possible that it was cultivated in limestone. Silica-rich G010, G011, and G012 are greatly affected by weathering of non-limestone as well as limestone (Fig. 22). These differences are consistent with the different collection basins at Khanh waterfall landslide and areas P1 and P2. The surface and groundwater in areas P1 and P2 and the Khanh waterfall landslide area were considered to have different water supply channels due to differences in water quality.

Fig. 21 Stiff diagrams

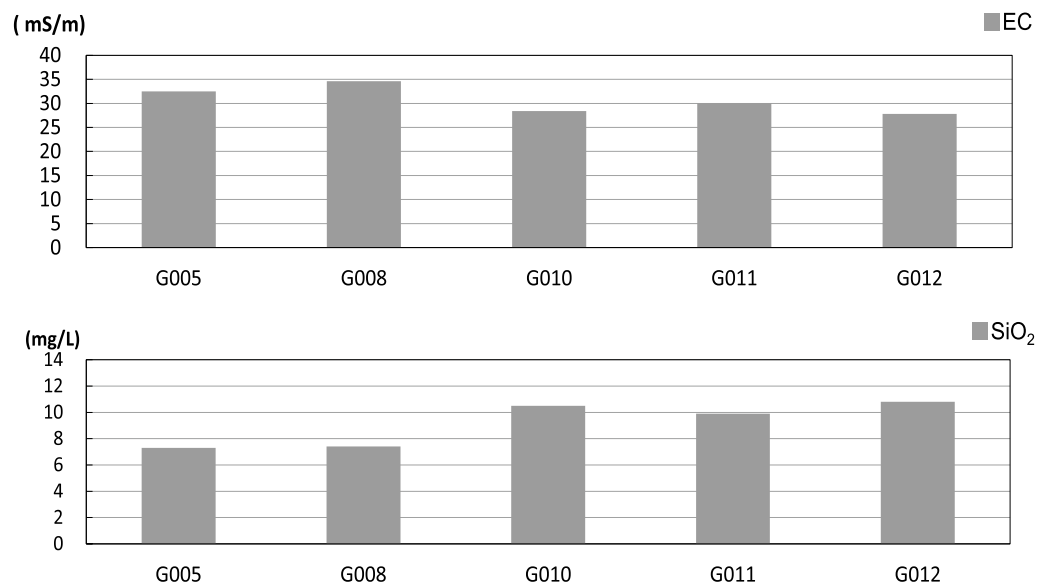
Fig. 22 Electrical conductivity (EC) and silica concentration (SiO₂)
