# Effect of climate change on earthworks of infrastructure: statistical evaluation of the cause of dike pavement cracks

Zsombor Illés<sup>1,2\*</sup> and László Nagy<sup>1</sup>

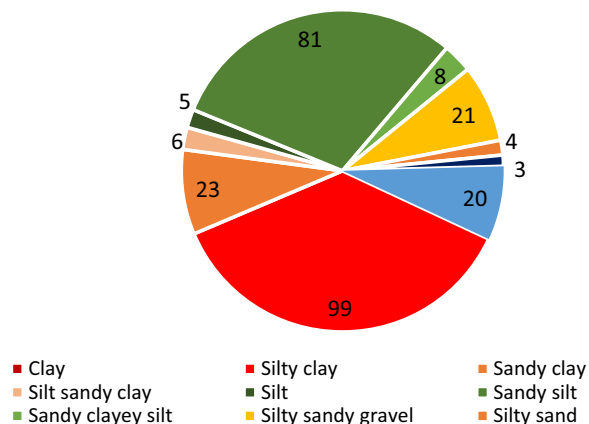
**Fig. 8** Proportion of non-clay embankment material

If we consider silty and sandy clays as well, the percentage rises to 92.9% of all the documented pavement crack cases. Dike sections might contain different layers, mainly clays and silts. It is not so easy to characterise a dike with a single material. In the territory of the North-Transdanubia Water Directorate (01.), the levees have a clay cover, but their core is less impervious. The material of the dike section under the pavement cracks is summarised for the two river basins in Table 5. The territorial water directorates indicated the type of soil under the sections with the fissured pavement. The ratio of the not fully clay embankments is presented in Fig. 8.

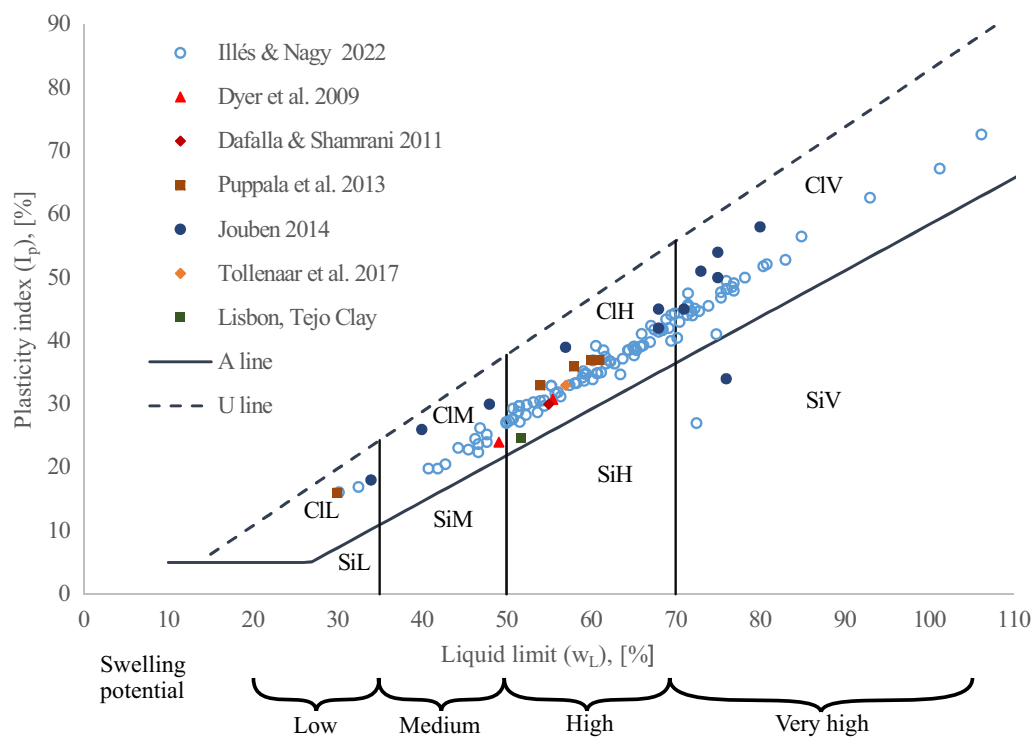
**Fig. 11** Plasticity chart after Casagrande, according to ISO 14688-2:2017, samples from investigations: Dyer et al. 2009; Dafalla and Shamrani 2011; Puppala et al. 2013; Jouben 2014; Tollenaar et al. 2017, are marked

Atterberg limits of the soil sample data set (places with desiccation cracks) along with the samples available in the literature are presented on the Plasticity chart (Fig. 11). It is difficult to compare samples from different places. In Hungary, linear shrinkage is used to evaluate shrinkage properties, while in the USA, clay activity (Skempton 1953), which is the fraction of plasticity index and the clay fraction and shrinkage limit, is also a common index number.

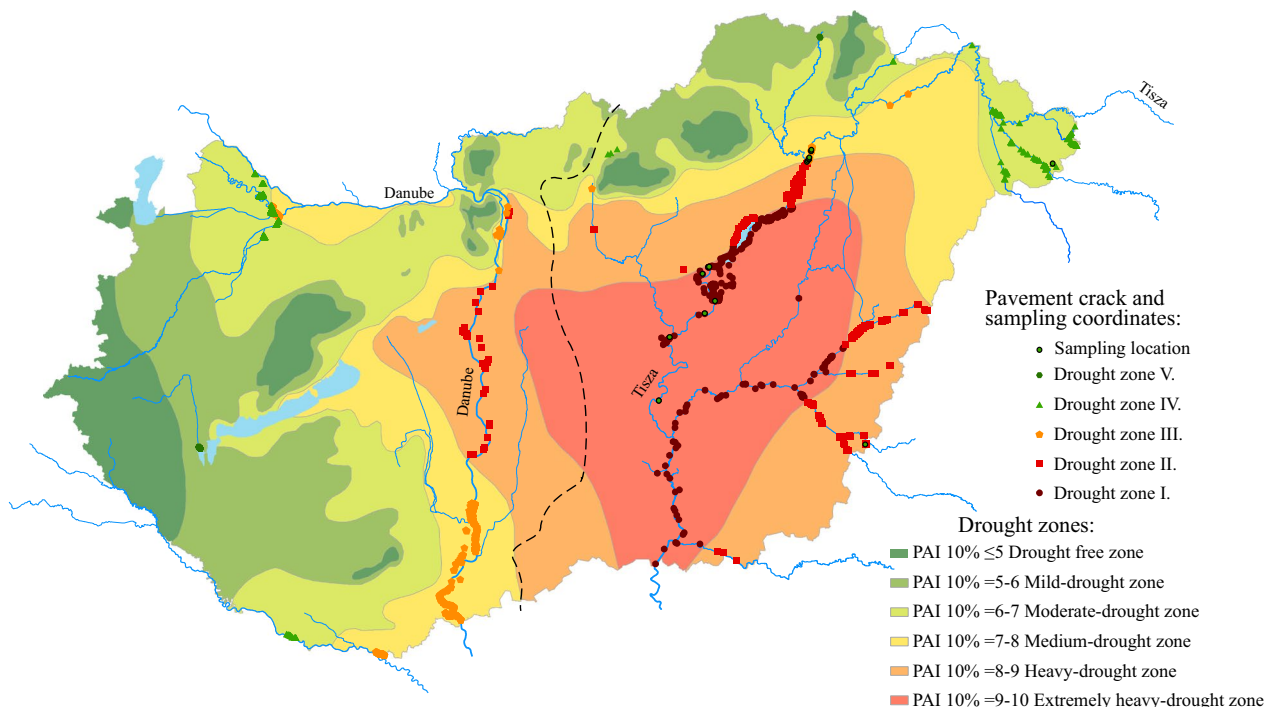
**Fig. 13** Aridity map of Hungary (provided by OVf) and the coordinates of the pavement cracks presented

According to PAI, Hungary's aridity zones are presented in Fig. 13; the dashed line is the border between the Danube (to the west) and the Tisza (to the east) catchment area. The two main rivers (Danube and Tisza) and their tributaries flow on the lowland, such as the Small Hungarian Plain and the Great Hungarian Plain. A considerable part of the dike system lies here. The documented cracks and the locations of soil mechanical investigations are also marked on the map (Fig. 13).

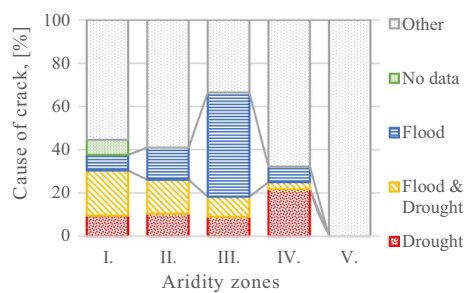
**Fig. 14** Aridity zones and causes of cracks

According to Fig. 14, in heavy and extremely-heavy drought zones (I. & II.), floods and droughts are responsible for approximately 30% of the damage, while in zone III. it is much less because a large part of the Danube valley is included, where silty and sandy soils are present (see Table 5), so the dikes are less sensitive to the drought-induced shrinkage. Also, the lower course of the

In regions with heavy drought, the deterioration of flood protection embankments caused by desiccation can be as relevant as the damage caused by floods (see Fig. 14).

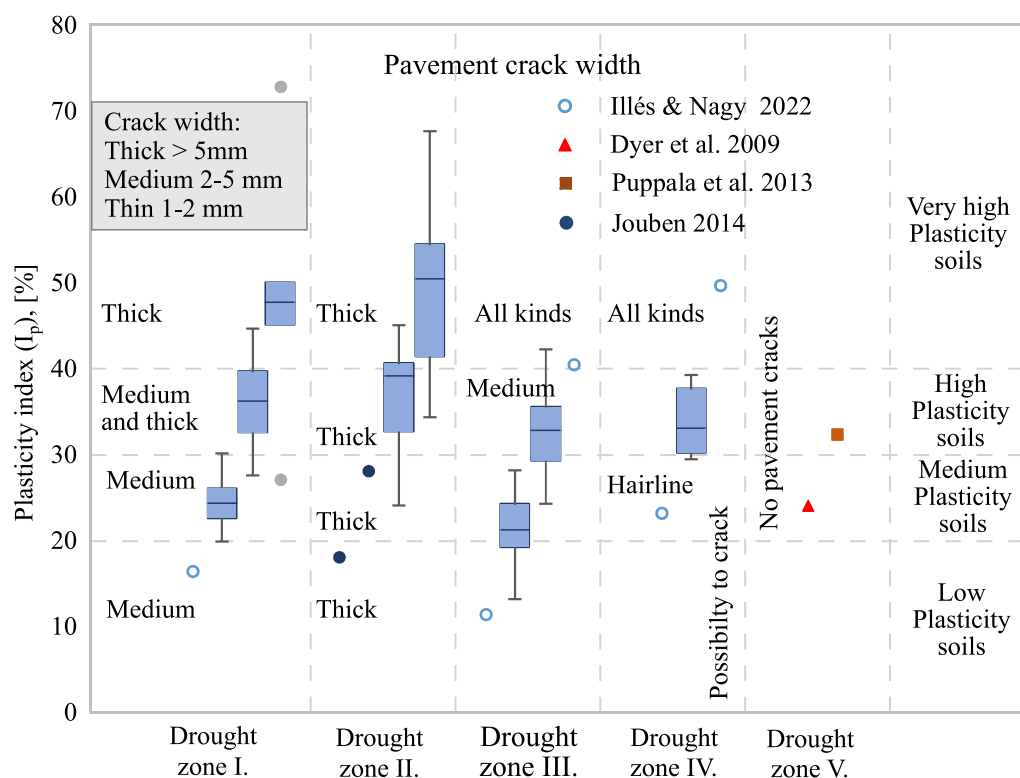
**Fig. 15** Drought zones (I. to V.), soil plasticity of the embankment and pavement cracks

A Matrix was created (Fig. 15), drought (aridity zones) on the horizontal axis, while the samples were categorised by their liquid limit into; low to very high plasticity soil, and their plasticity index is presented on the vertical axis. The observed crack width is mentioned in each zone, according to Fig. 6.

At places of the most severe drought (Zone I.) the crack width increases with the plasticity of the materials. The same trend was not captured in the case of drought zone II., as there were only a few samples of medium and low plasticity soils from Texas (Jouben 2014). In the case of drought zones III. and IV. (medium and moderate) dikes

When aridity (heavy and very heavy drought zones I. and II.) is associated with a reach swelling embankment material and high plasticity soils, the desiccation fissures are more pronounced. This observation is supported by the cases documented in Hungary and by the results of studies made in other countries and regions (see Fig. 15).

As a general statement, if the embankment has one meter thick high or very high plasticity clay acts as a determinate layer, the formation of pavement cracks is more or less inevitable. If the flood protection embankment is constructed of low and medium plasticity clay layers and some silty layers, preferably one below the pavement, it is less likely to form thick pavement fissures. However, as a result of climate change, arid areas will increase, causing the previously uncracked low plasticity clays to form desiccation fissures. The earthworks' water balance can tumble due to prolonged drought experienced in the past decades and they can desiccate beyond repair.
