# Preliminary report of field reconnaissance on the 6 February 2023 Kahramanmaras Earthquakes in Türkiye

**Keywords** Field investigation, Kahramanmaras earthquakes, Seismic damage, Liquefaction, Ground failure

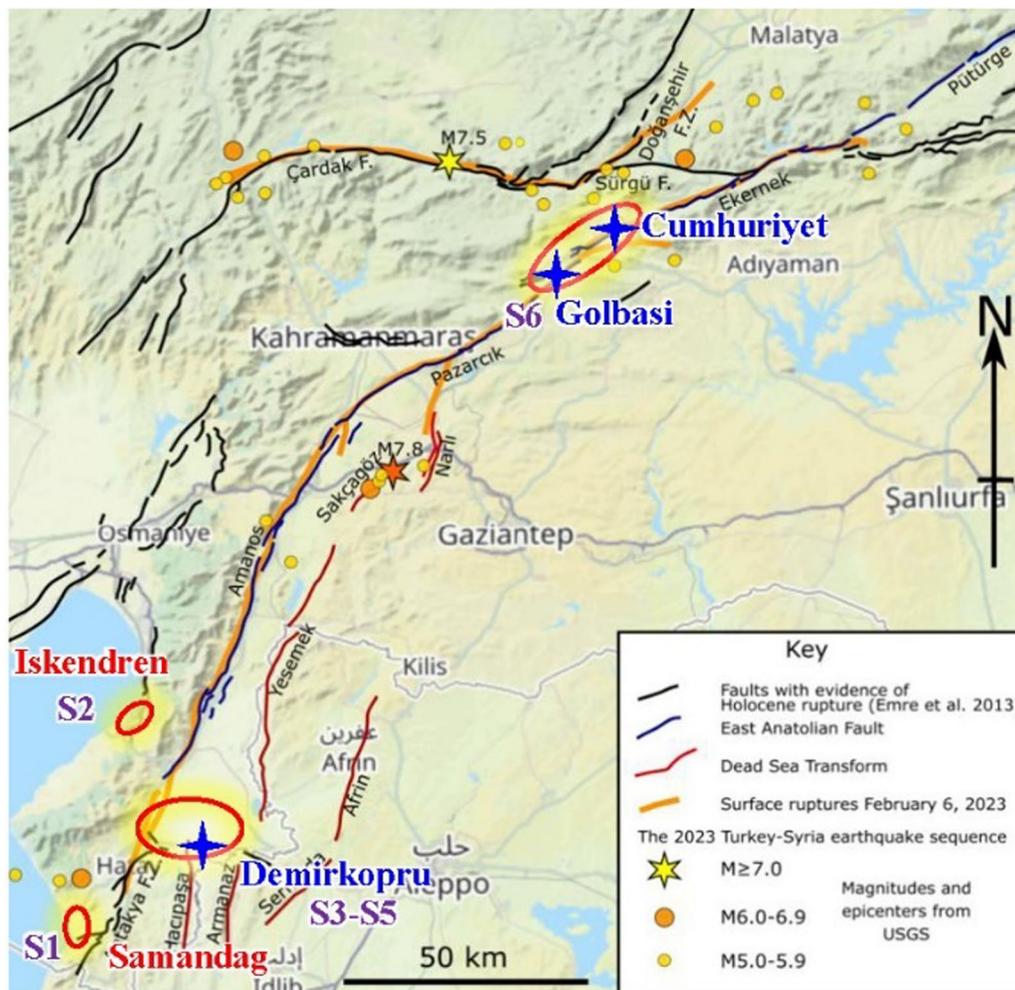
After the major earthquakes, massive liquefaction and its secondary ground failures in various places were investigated along the main faults (Fig. 9). Four major regions suffered severe liquefaction damage were investigated in

this reconnaissance as circled in red in Fig. 9. The liquefaction mainly occurred at coastal regions (Samandag and Iskenderun in Hatay), riverside areas (Demirköprü in Hatay and Cumhuriyet in Adiyaman), lakeside area (Golbasi in Adiyaman) and some fault rupture surface (Kumlu in Hatay), as shown in Figs. 10, 11 and 12.

**Fig. 9** Distribution of investigated liquefaction sites (based on Mike Norton 2023)

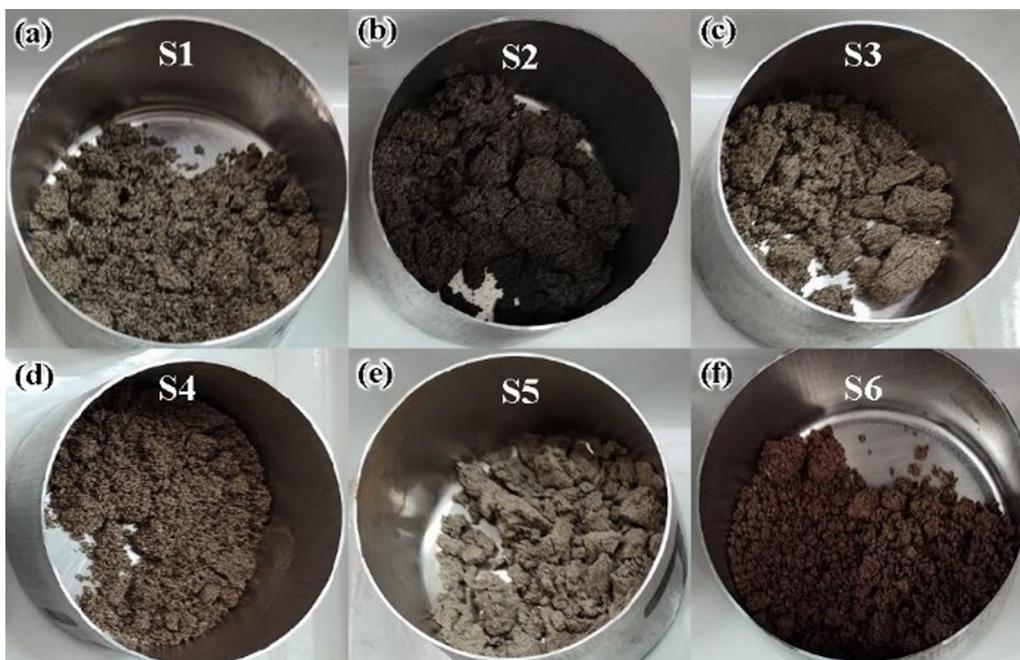
In this field reconnaissance, six liquefaction samples, involving coastal, riverside and lakeside regions and fault rupture zone, were collected from Samandag to Golbasi as shown in Figs. 9, 14. Detailed information on gradation parameters of the samples with the sampling location was listed in Table 1. According to grain sieve analysis for the six samples (Fig. 15), most of the samples were poorly

**Fig. 14** Dried samples (a-f) from major liquefaction sites with detailed information listed in Table 1

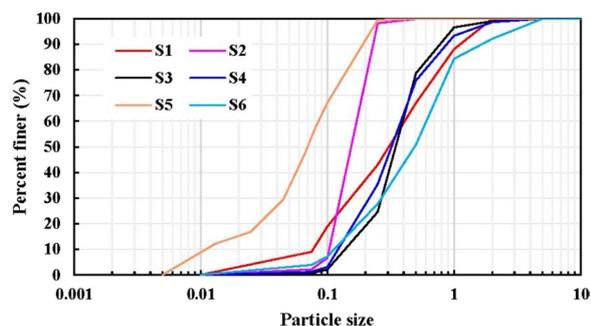
(Fig. 13). Figure 10a illustrates an orchard of oranges at the coastal region in Samandag was covered by massive sandboiling, while a sandboiling belt was also observed along a long ground rupture at a wheat field in Kumlu as shown in Fig. 10b. The erupted sands were collected as S1 and S3 whose gradation curves were illustrated in Fig. 15 with detailed gradation parameters in Table 1. The S3 was poorly graded compared to S1 although they

in the downtown Golbasi which is located close to the Golbasi Lake. Compared to the S1 and S3, the liquefied sand in Iskenderun was finer and poorly graded, with a median diameter of 0.17 mm and a smaller uniformity coefficient of 1.78. It is slightly different from the S6 samples collected from Golbasi, which is much coarser ( $d_{50}=0.49$  mm) and has a similar gradation with the S1.

**Fig. 15** Grain size distribution curves of the investigated liquefaction samples

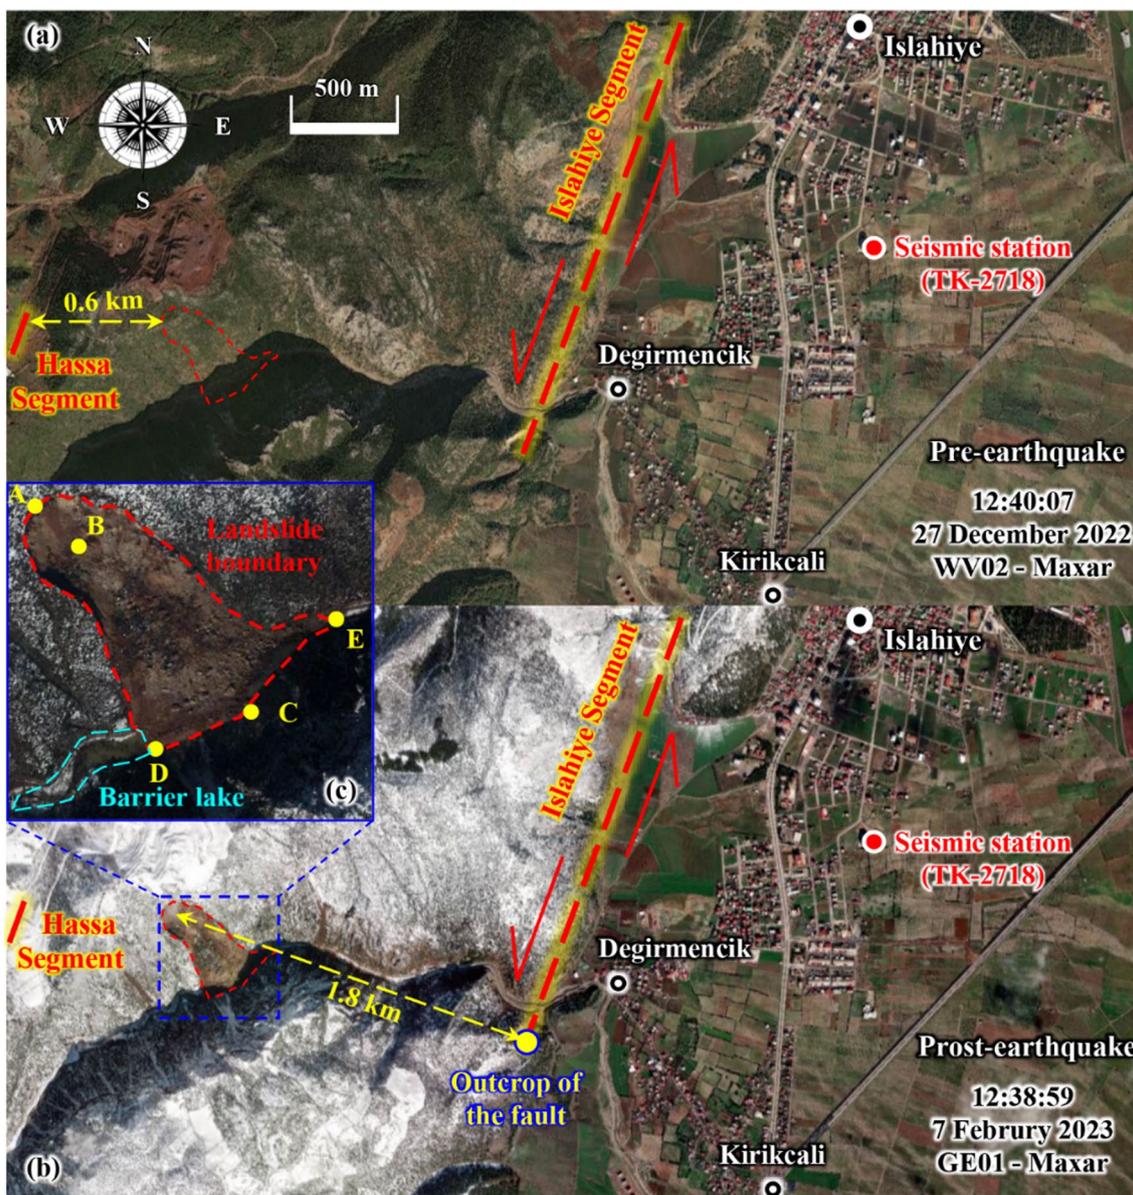
The Islahiye landslide is located between two minor fault segments, 1.8 km from the south end of Islahiye segment and about 0.6 km from the north end of the Hassa segment (Fig. 19), according to geological information from general directorate mineral research and exploration directed by Mehmet UZER. From the pre-landslide image (Fig. 19a), a large area of excavation existed at mount peak of the slope. According to local contour map (Fig. 20), based on data from the Open-TopoMap, the landslide dropped from an altitude of 900 m above sea level (a.s.l.) to 639 m a.s.l. at the valley

The Islahiye landslide, directly triggered by mainshock of the Kahramanmaraş earthquakes, was just about 3 km away from a seismic station (TK-2718) in downtown of Islahiye (Fig. 19). In this case, dynamic stress status on the sliding surface could be briefly calculated by a simplified method as shown in Fig. 22 based on the original acceleration records from TK-2718.

**Fig. 19** Satellite images surrounding the Islahiye landslide (a) before and (b & c) after the earthquakes. The satellite images were collected from OPEN DATA PROGRAM of Maxar (<https://www.maxar.com/open-data/turkey-earthquake-2023>)

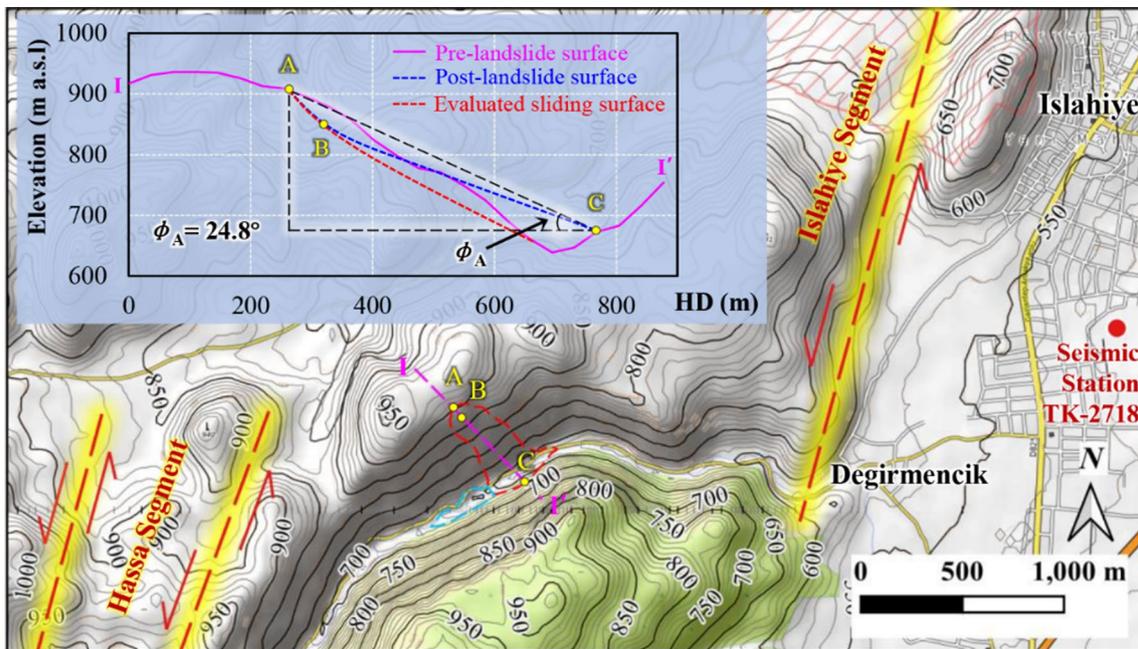
bottom. The landslide has an estimated sliding surface with a dip angle of 35° and finally reposed at 24.8° according to its longitudinal profile (Fig. 20). Moreover, the landslide is located in a geologically complex region with various lithology and active tectonics, surrounded by minor left-lateral strike-slip faults and overthrusts. The geological map (Fig. 21) suggests that the landslide occurred in a formation of Kurici dolomite involving dolomite and dolomitic limestone between the upper Triassic and the lower Jurassic.

**Fig. 20** Contour map and longitudinal profile variation of the Islahiye landslide (based on OpenTopoMap)

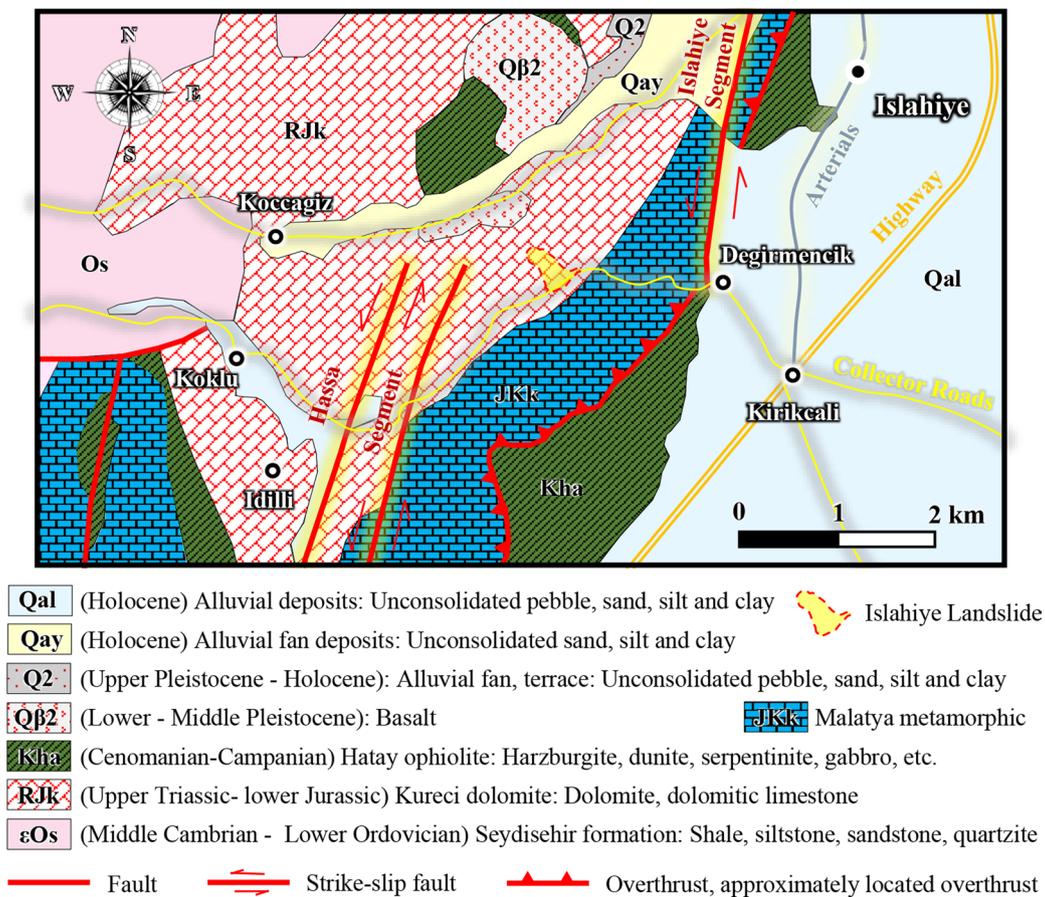
**Fig. 21** Geological settings surrounding the Islahiye landslide (based on general directorate mineral research and exploration directed by Mehmet UZER)

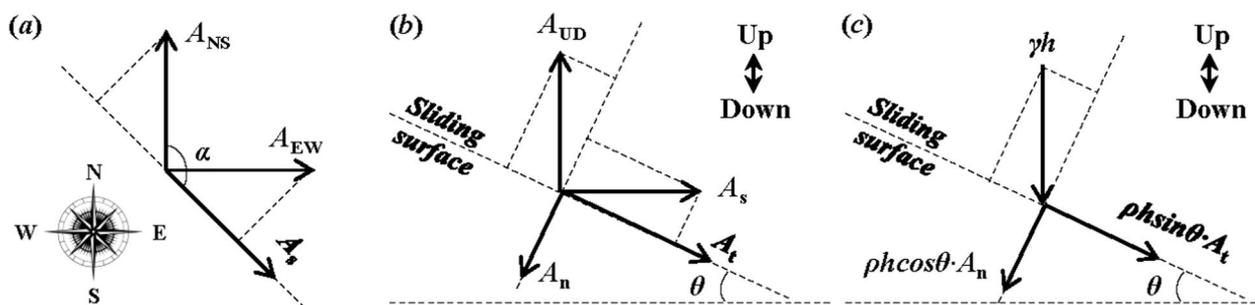
The calculation was processed by the Eqs. (1)–(5) according to the procedure from Fig. 22a–c. Firstly, the horizontal acceleration on the sliding direction ( $A_s$ ) could be calculated by Eq. (1) from original acceleration records on horizontal direction of NS and EW. Then, the accelerations perpendicular to and parallel to the sliding surface ( $A_n$  and  $A_t$ ), with a dip angle of  $\theta$ , were calculated by Eqs. (2) and (3) from original vertical seismic component ( $A_{UD}$ ) and extrapolated horizontal acceleration ( $A_s$ ). Finally, combining estimated property of sliding mass, such as unit weight ( $\gamma$ ), density ( $\rho$ ) and depth ( $h$ ), normal and shear stresses on the sliding surface could be extrapolated by the Eqs. (4) and (5), respectively.

**Fig. 22** Calculation of dynamic normal and shear stresses on the sliding surface by the procedure from (a) to (c)

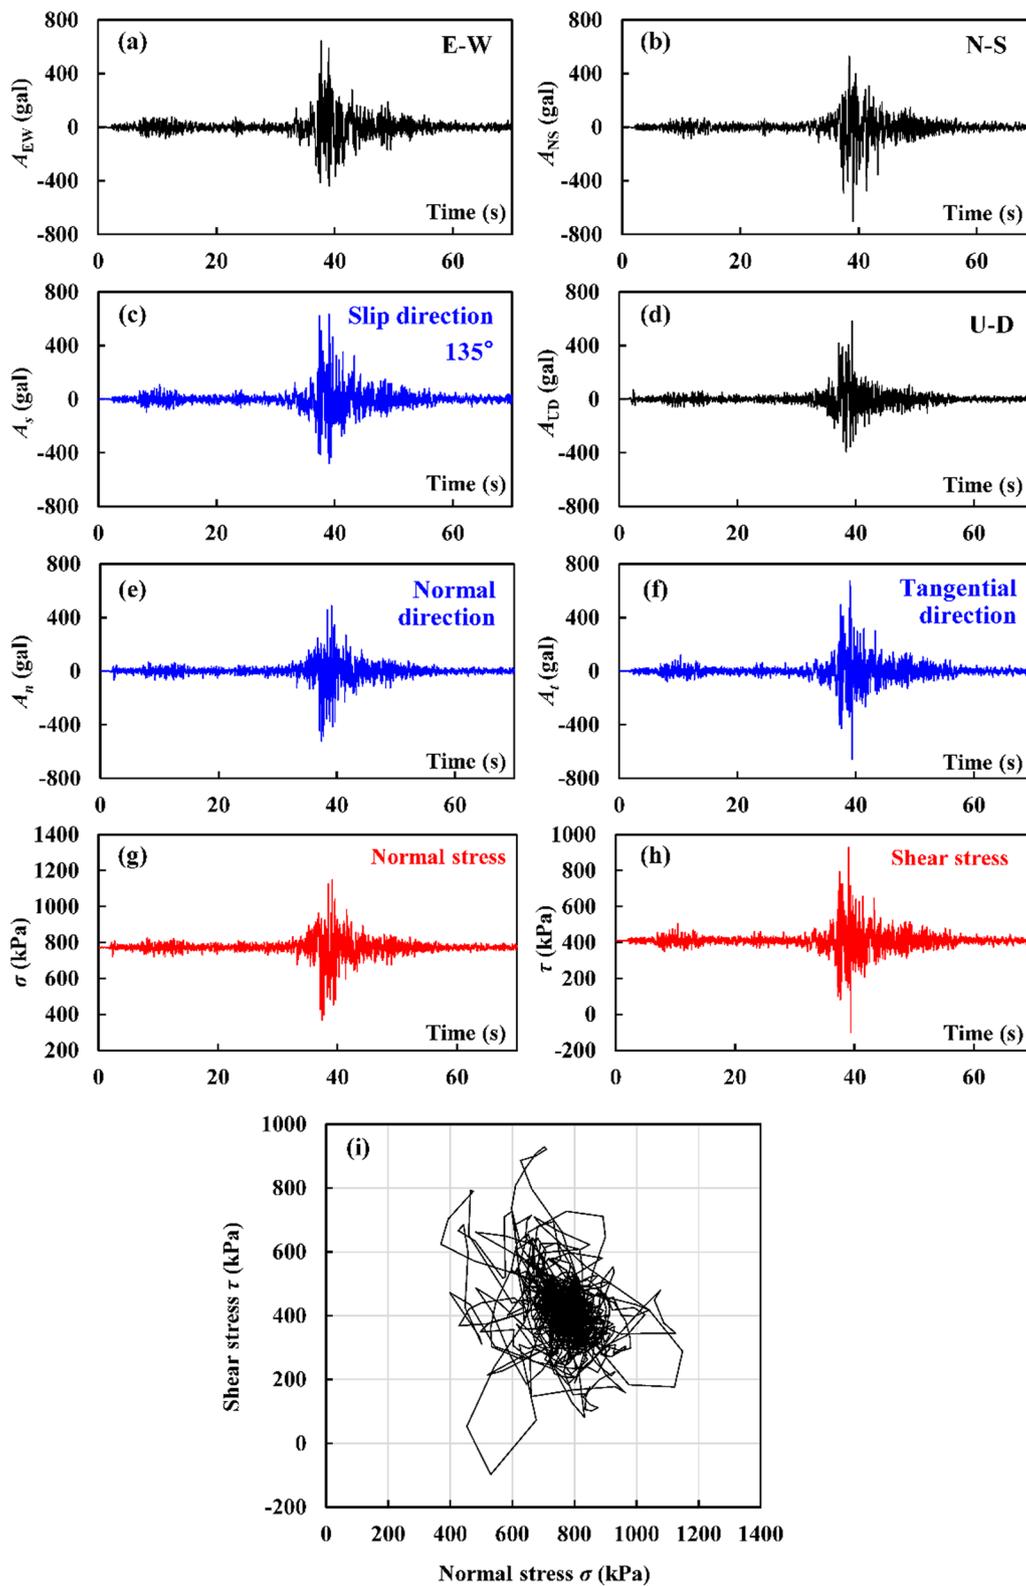
By above calculation procedure, a simplified dynamic stress path was obtained as shown in Fig. 23i, with time-histories of normal and shear stresses (Fig. 23g, h), and extrapolated acceleration components on sliding direction and sliding surface (Fig. 23c, e, f), from original seismic records at TK-2718 (Fig. 23a, b, d).

**Fig. 23** Acceleration and stress path on sliding surface based on seismic record from TK-2718. **a, b & d** are original seismic record; **(c)** is acceleration on horizontally slip direction and calculated by **(a & b)**; **e & f** are acceleration on sliding surface in normal and tangential direction, respectively, while **g** and **h** are correspondingly normal and shear stresses which generate the final stress path **i** on the sliding surface

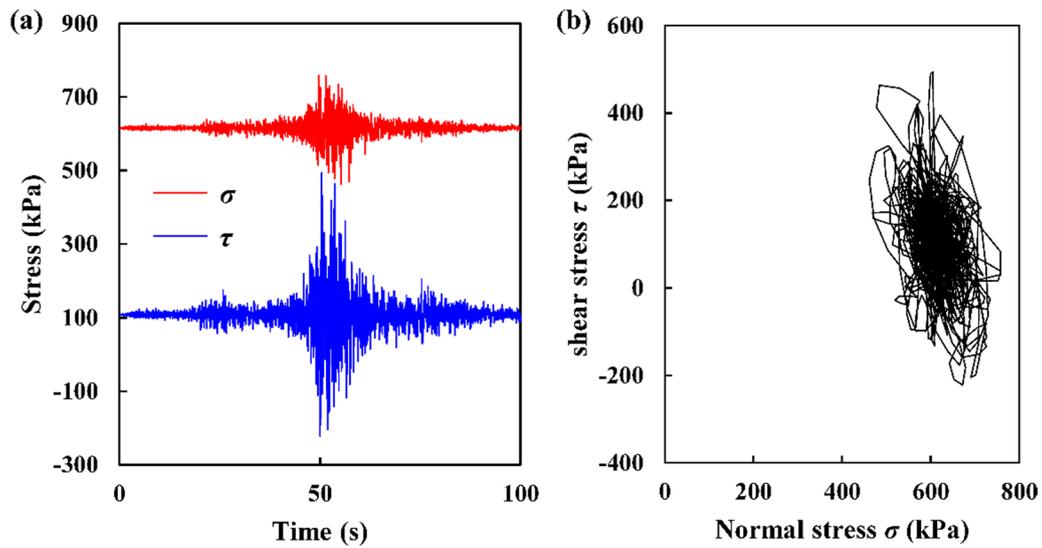
whether the slope failed within the mudstone layer or at the interface of bedding layers could be explored through laboratory test, such as ring shear test on the mudstone (Fig. 26). The input dynamic stresses, including normal stress and shear stress (Fig. 25), were estimated based on earthquake records from a nearby seismic station

**Fig. 25** Normal and shear stresses (a) and the final stress path (b) on the sliding surface of the Tepehan Landslide based on seismic records by TK-3136

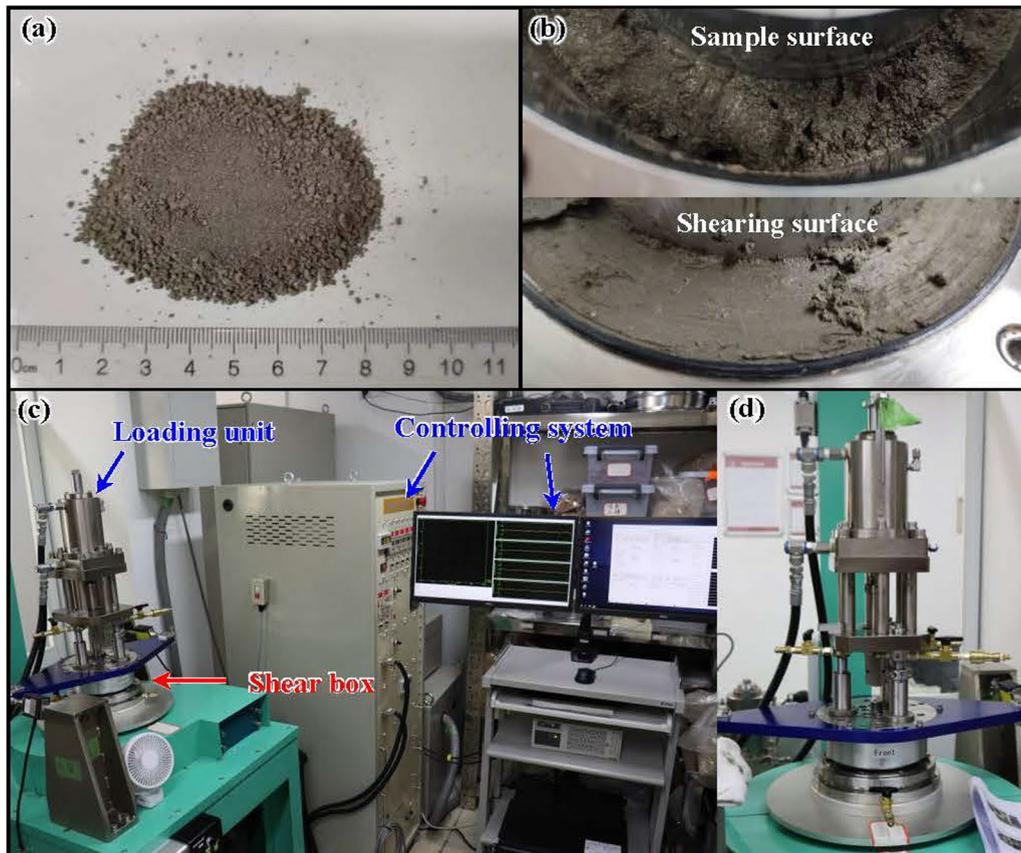
(TK-3136). The collected mudstone sample was finely crushed (Fig. 26a) and subsequently sheared using the ICL-2 apparatus, as shown in Fig. 26b–d).

**Fig. 26** Ring shear test on the mudstone sample: **a** Dried and crushed sample; **b** Sheared sample after test; **c** ICL-2 ring shear apparatus and **d** shear box

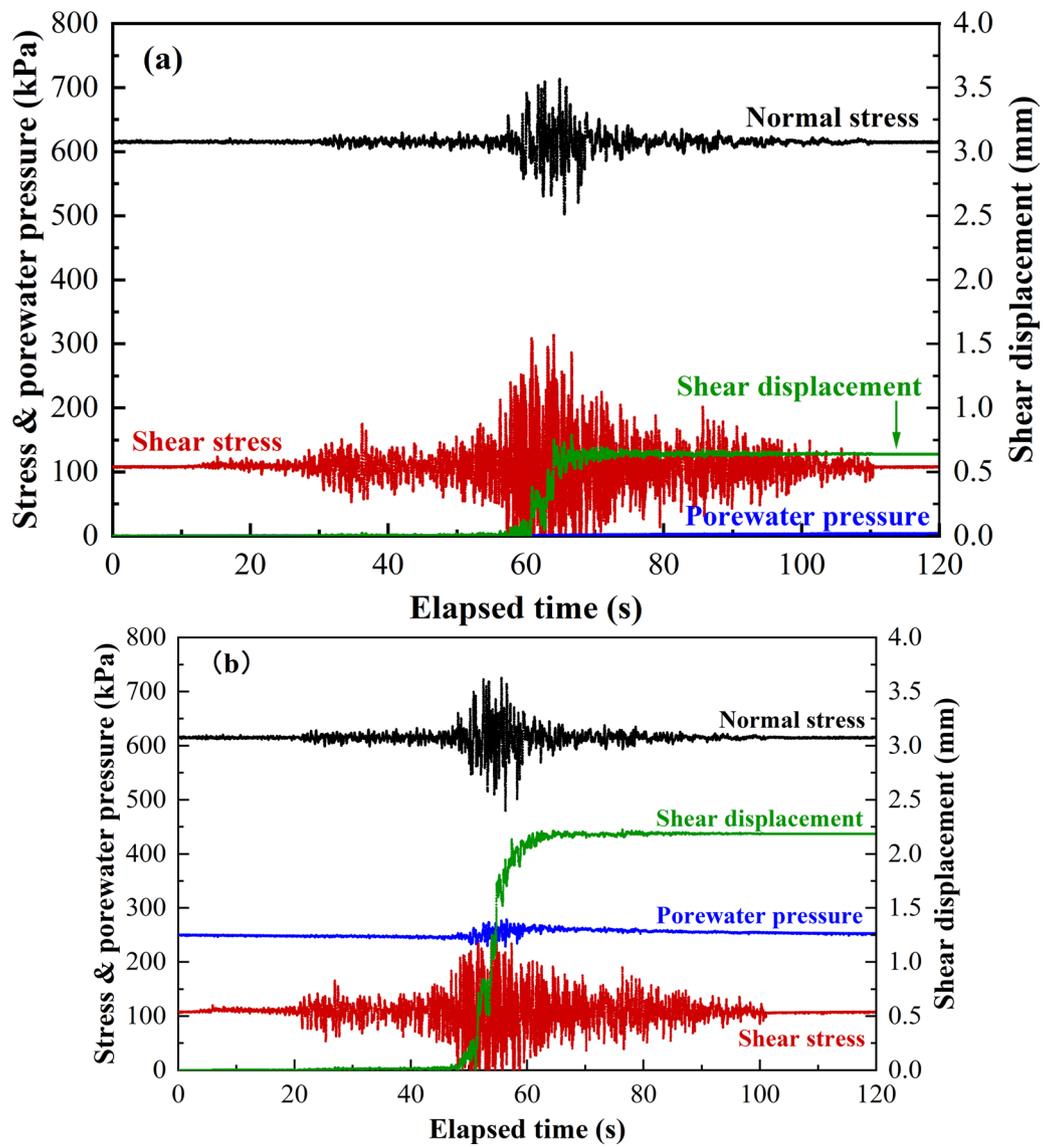
The crushed mudstone initially underwent testing in a saturated condition without porewater pressure (Fig. 27a). Both ESP and TSP did not reach the strength line of the saturated sample, suggesting that the mudstone cannot fail under collaborative effect of seismic loading and lower groundwater. Then, increasing the porewater pressure to 250 kPa, representing a high groundwater level even reaching the ground surface, caused the ESP to reach the strength line. This implies that the mudstone could fail under the earthquake loads if the porewater pressure reaches 250 kPa. However, based on the field investigation, there was no high level of groundwater inside the sliding mass. Therefore, the sliding surface of the Tepehan Landslide could not be within the mudstone layer, but might be at the interface of two bedding layers (Fig. 28).

**Fig. 27** Time histories of normal and shear stresses, shear displacement and porewater pressure by ring shear test in non-porewater condition (a) and proposed 250-kPa-porewater condition (b)

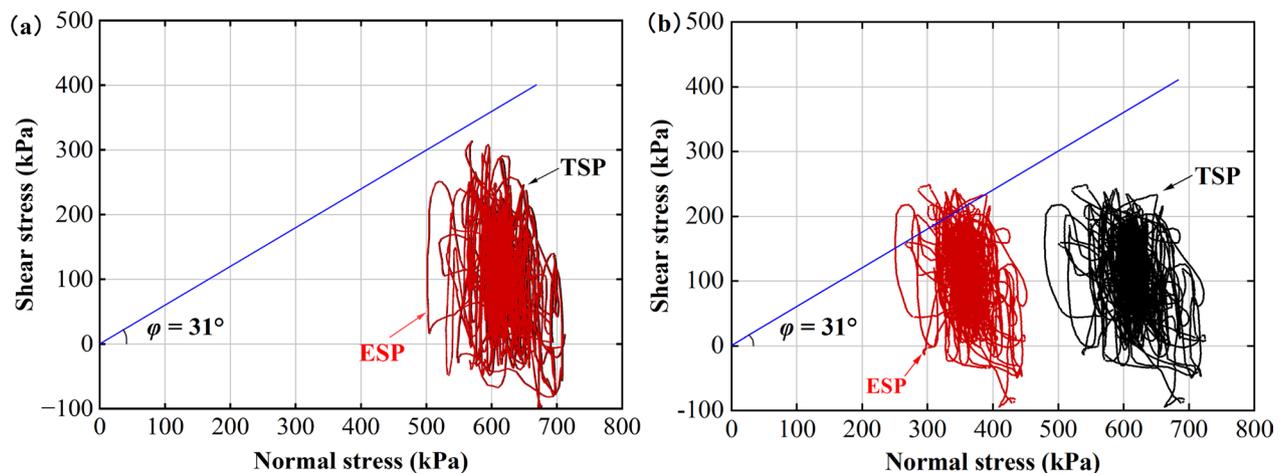
**Fig. 28** Stress path of the mudstone sample by ring shear test in non-porewater condition (a) and proposed 250-kPa-porewater condition (b). TSP and ESP represent total stress path and effective stress path, respectively. The blue line is shear strength line of the saturated sample by the shear ring test
