A successful case of emergency landslide response - the Sept. 2, 2014, Shanshucao landslide, Three Gorges Reservoir, China

Bolin Huang^{1*}, Wangjun Zheng², Zuzhan Yu² and Guangning Liu¹

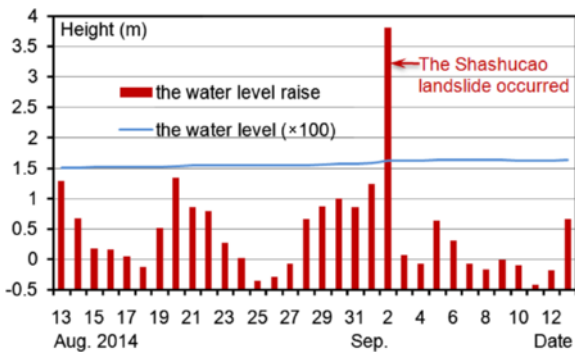
Water level fluctuation in the toe of the landslide produced by regulation of the Three Gorges Reservoir was naturally considered to be the trigger of the landslide. Due to onset of the seasonal autumn floods, water level in the reservoir fluctuates significantly. Fig. 11 shows the changes in water level over the period from Aug. 13, 2014 to Sep. 13, 2014. Water level rose by 3.8 m between 8:00 am, Sep. 1 and 8:00 am, Sep. 2. A rise of this magnitude is unprecedented. The failure was probably triggered by the direct reduction in normal load within the toe of the slope and dynamic hydraulic pressure of underground water caused by the rising water level (Wang et al. 2004, Singh et al. 2012).

Fig. 11 Daily water level change of the Three Gorges Reservoir between August 13, 2014 and September 12, 2014

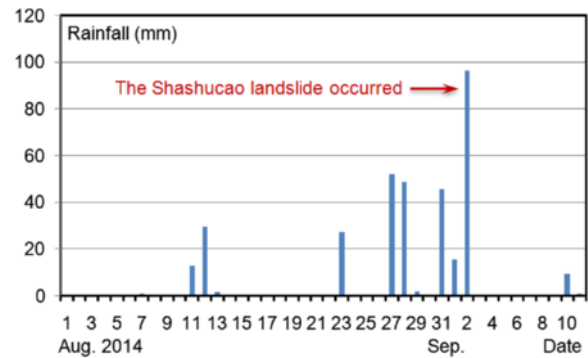
Precipitation is monitored in Shazhenxi Town. Intense rain fell from Aug. 27 to Sept. 2, and maximum rainfall occurred on Sep. 2, with a 24 hour fall of 96.5 mm (Fig. 12). Intense rain may saturate the sliding mass, increase its unit weight, and decrease its strength (He et al. 2009, Miller et al. 2009). More importantly in this case, torrential rain may generate dynamic hydraulic pressure, which would reduce the anti-slide force, and increase the slide force.

Fig. 12 Precipitation recorded at Shazhenxi Town between August 1st, 2014 and September 10, 2014

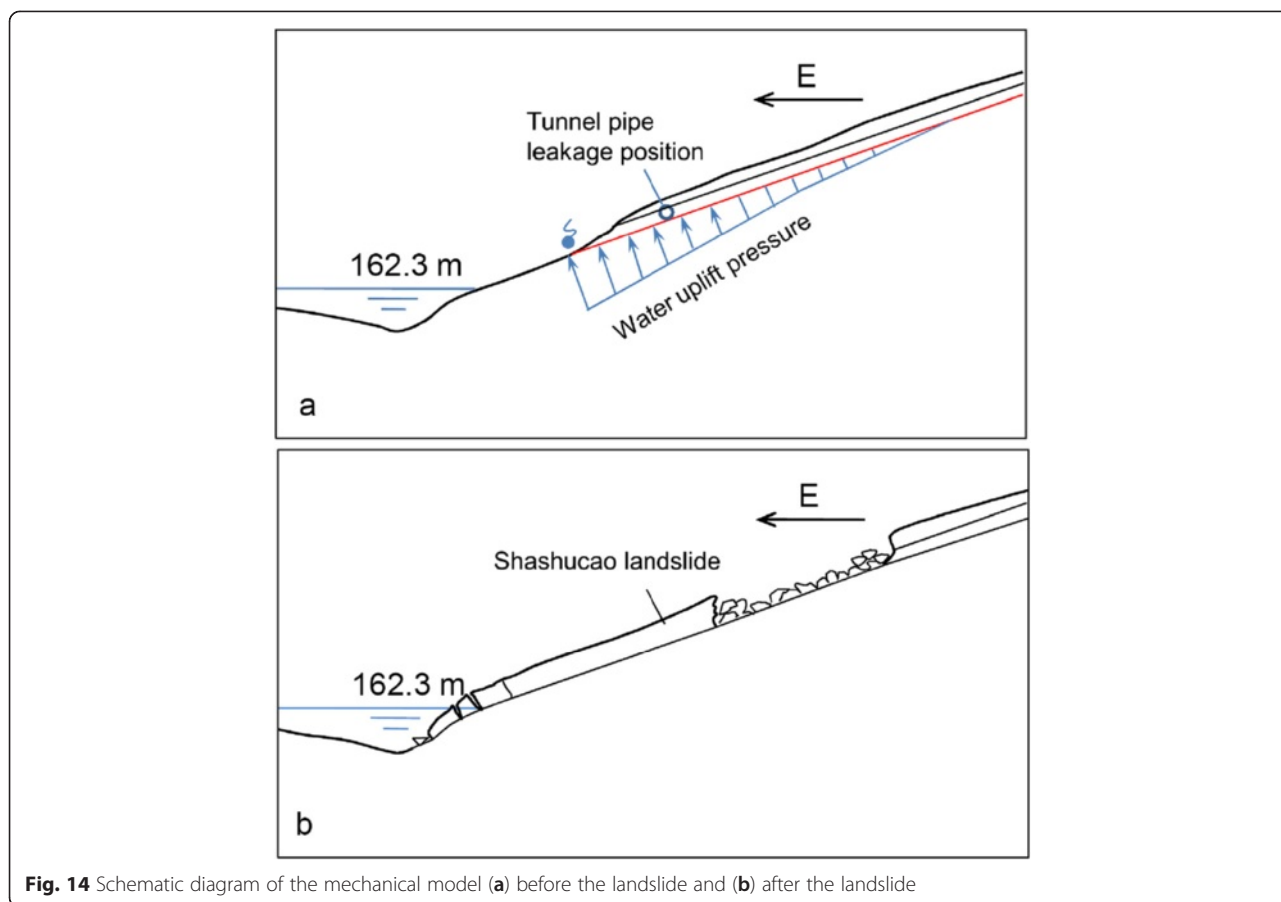
The mechanical model for the translational landslide with intact rocky mass can be simplified as a two-dimensional longitudinal section, as shown in Fig.14a. The situation of the landslide after failure is sketched in Fig. 14b.

Fig. 14 Schematic diagram of the mechanical model (a) before the landslide and (b) after the landslide
